**Report: TAB REPORT**  
**Function: Test, Adjust, & Balance**  
**Date: 10/03/2023**

**PROJECT**  
**09-25-23 FREDDY'S BURLESON, TX**

JRI Hospitality Management  
621 Westport Blvd  
Salina, KS 67401

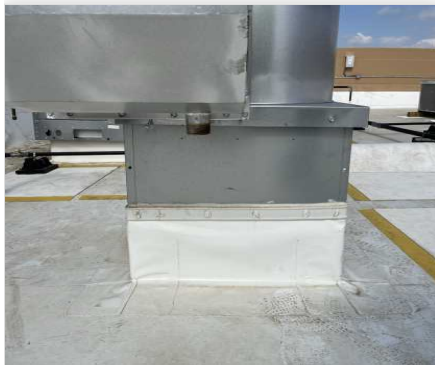
**KEF\_1\_GREASE\_TRAP\_ISS..**  
**09/25/2023**

**Issue Name :** KEF GREASE TRAPS NOT INSTALLED  
**Description :** KEF-1, KEF-2 AND KEF-3 DO NOT HAVE THEIR GREASE TRAPS INSTALLED ON THE ROOF.  
**Created By :** National TAB                      **Assigned To :** National TAB - Will Turnbough  
**Status :** Open  
**Originated Date :** 09/25/2023 - Bayley Morvant - National TAB

NO, KEF-1, KEF-2 AND KEF-3 DO NOT HAVE GREASE CUPS INSTALLED. ISSUES HAVE BEEN MADE ON FACILIBUILD NAD GC HAS BEEN NOTIFIED.

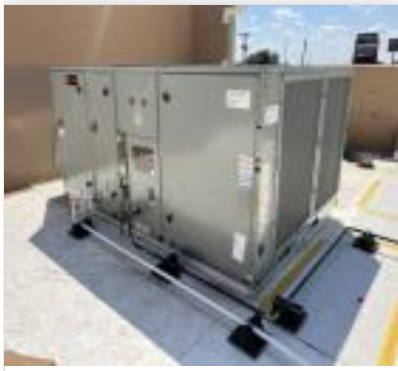
**RTU\_1**  
**09/26/2023**

RTU-1 HAS VERY NOTICABLE NOISE WHEN FIRST TURNING ON FAN.

YES, EXCEPT FOR THE NOISE CREATED BY RTU-1 WHEN FIRST STARTING THE FAN. OTHERWISE IT IS FREE OF NOISE.

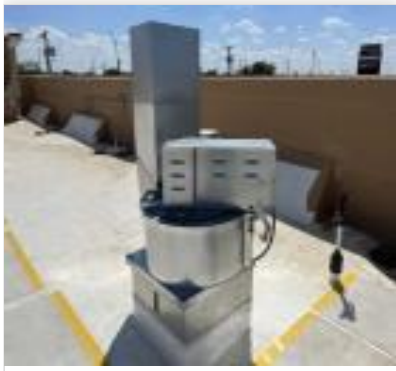
**KEF\_1**  
**09/26/2023**

KEF-2 HAS HINGE KIT BUT KEF-1 ONLY HAS A HINGE KIT ON THE FAN MOTOR AND FAN, NOT ON THE WHOLE FAN HOUSING. KEF-3 IS THE DISH HOOD FAN, BUT ALSO DOES NOT HAVE A HINGE KIT INSTALLED.

ON KEF-2 YES, UNABLE TO VERIFY DUCT BELOW KEF-1 AND KEF-3.

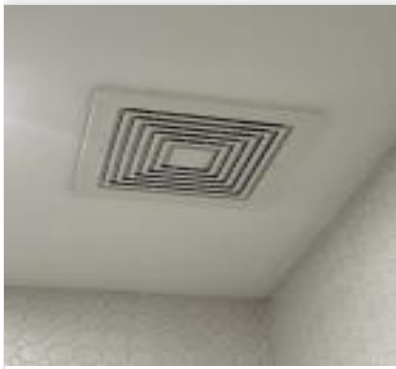
**EF\_2**  
**09/26/2023**

Notes:  
 \*1 NO SPEED CONTROLLER INSTALLED. FAN IS OPERATING AT 77% OF DESIGN.  
 \*2 NO ACCESS TO DISCHARGE DUCT DUE TO SHEET ROCK CEILING.
