Report: TAB Report
Function: Test, Adjust, & Balance
Date: 01/29/2026
Completed By: National TAB

02-16-26 CHIPOTLE #5777 LEVITTOWN, PA

Project: 02-16-26 CHIPOTLE #5777 LEVITTOWN, PA

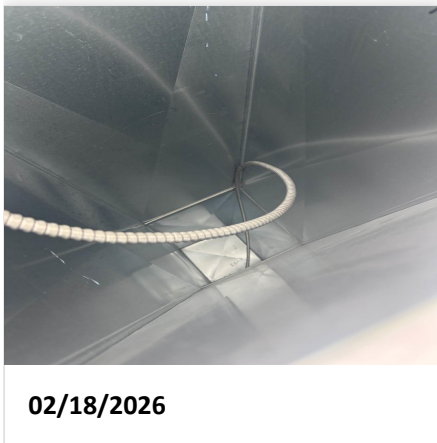
Issue Name : EF-2 Backdraft Damper
Description : A backdraft damper was not installed in EF-2.
Created By : National TAB **Assigned To :** National TAB - Dan Hertenstein
Status : Open
Priority : Low **Asset Tag :**
Originated Date : 02/18/2026 - Roman Ilovski - National TAB

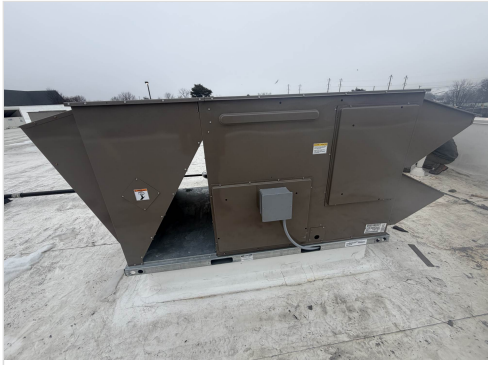
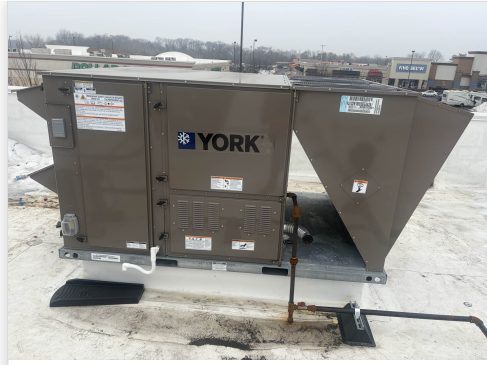
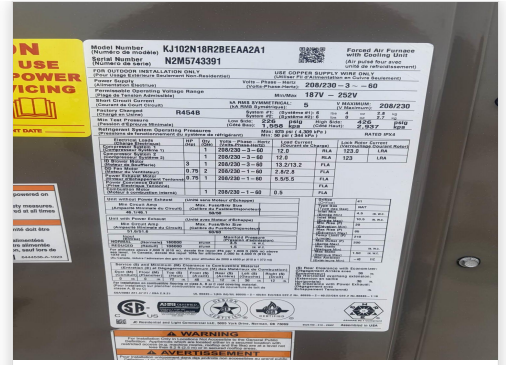
Unit Data - PHOTO LOG

Unit Data		
	Design	Actual
MFG	YORK	YORK
Serial Num	-	N2M5743391
Model Num	KJ102	KJ102N18R2BEEAA2A1
Type	RTU	RTU
Configuration	VERTICAL	VERTICAL
Num OA Filters 1	-	1
OA Filter Size 1	-	30X23
Num Final Filter 1	-	4
Final Filter Size 1	-	20X24X2

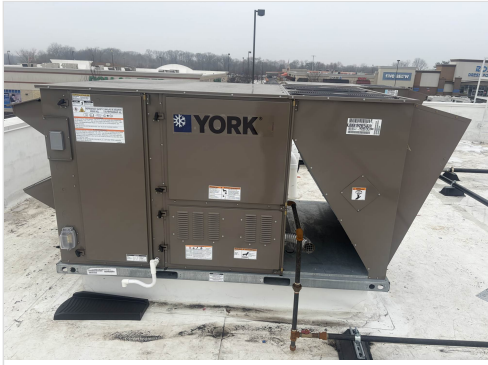
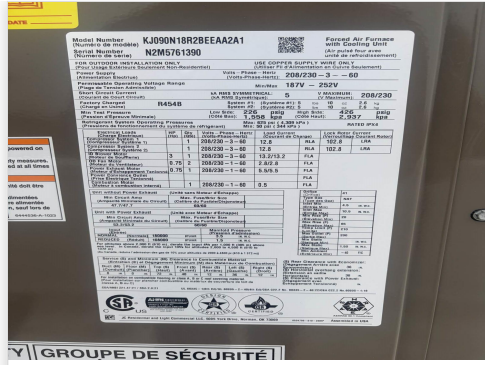
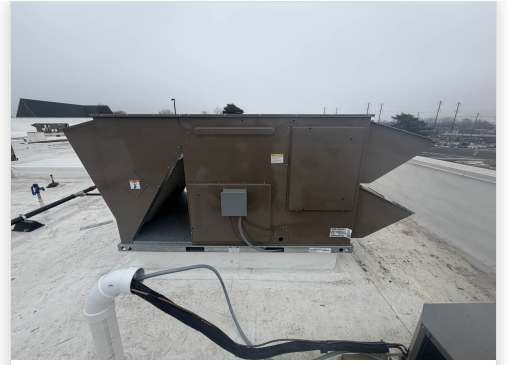
Unit Data - PHOTO LOG

Unit Data		
	Design	Actual
MFG	YORK	YORK
Serial Num	-	N2M5761390
Model Num	KJ090	KJ090N18R2BEEAA2A1
Type	RTU	RTU
Configuration	VERTICAL	VERTICAL
Num OA Filters 1	-	1
OA Filter Size 1	-	30x23
Num Final Filter 1	-	4
Final Filter Size 1	-	20X24X2

[1] Unable to proportionally balance supply grilles. Grilles do not have proper dampers, only scoop dampers, which are not effective for balancing. Unit total supply is set.

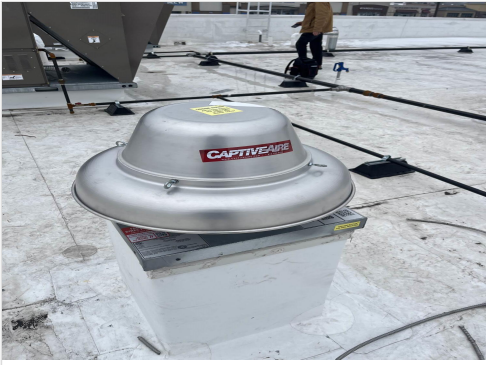
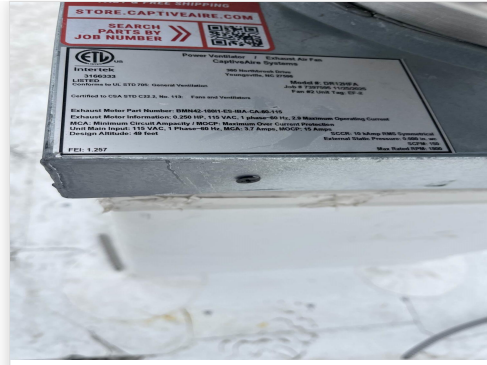
Unit Data - PHOTO LOG

No

Unit Data		
	Design	Actual
MFG	CAPTIVEAIRE	CAPTIVEAIRE
Model Num	DR12HFA	DR12HFA
Serial Num	-	7397595
Type	DOWNBLAST	DOWNBLAST
Configuration	VERTICAL	VERTICAL

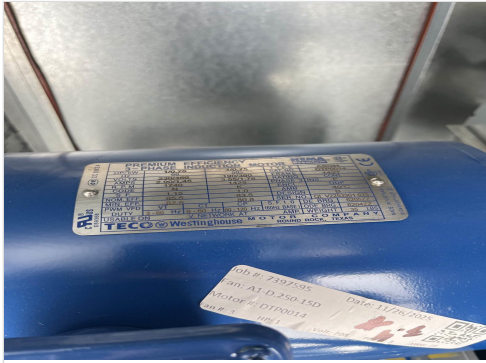
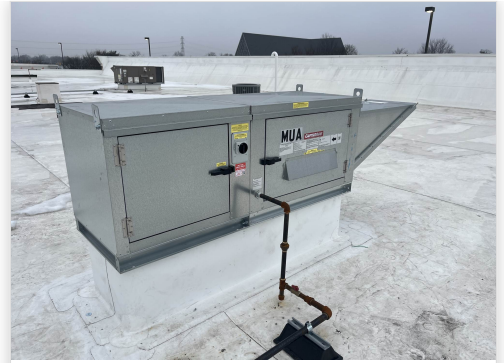
Unit Data - PHOTO LOG

Unit Data		
	Design	Actual
MFG	CAPTIVEAIRE	CAPTIVEAIRE
Model Num	A1-D.250-15D	A1-D.250-15D
Serial Num	-	7397595
Type	MAU	MUA
Configuration	VERTICAL	VERTICAL
