Report: TAB Report
Function: Test, Adjust, & Balance
Date: 11/05/2025
Completed By: National TAB

10-27-25 CHIPOTLE # 5650 Cumberland, MD

Project: 10-27-25 CHIPOTLE # 5650 Cumberland, MD

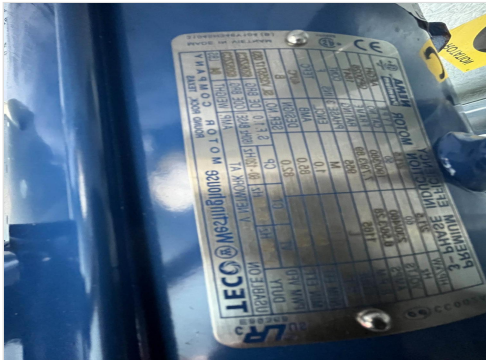
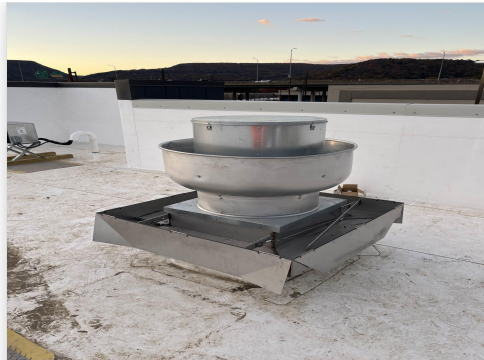
Unit Data - PHOTO LOG

Unit Data		
	Design	Actual
MFG	CAPTIVE-AIRE	CAPTIVE-AIRE
Model Num	DU180HFA	DU180HFA
Serial Num	-	-
Type	UPBLAST	UPBLAST
Configuration	VERTICAL	VERTICAL

Test Data		
	Design	Actual
CFM	2550	
Fan RPM	-	
Fan Rotation	-	
Motor RPM	-	
System SetPt	-	
RL Voltage	-	
RL Amperage	-	
Total ESP	1.20"	
Fan Inlet SP	-	
Fan Discharge SP	-
