Report: TAB Report
Function: Test, Adjust, & Balance
Date: 11/05/2025
Completed By: National TAB

10-27-25 CHIPOTLE # 5650 Cumberland, MD

Project: 10-27-25 CHIPOTLE # 5650 Cumberland, MD

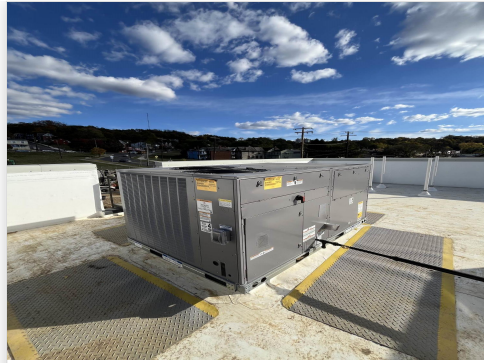
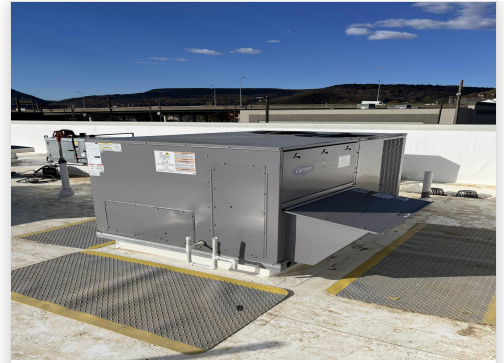
Asset: RTU1

General	
	Actual
Fan Rotation Correct	YES
Unit Filters Clean	NO
Condensate Drain Installed	YES

Issue Name : RTU1 & RTU2: Filters Dirty
Description : Filters in both RTUs are dirty. Replace before return TAB.
Created By : National TAB **Assigned To :** National TAB - Dan Hertenstein
Status : Open
Priority : Low **Asset Tag :**
Originated Date : 11/05/2025 - Ryan Smith - National TAB

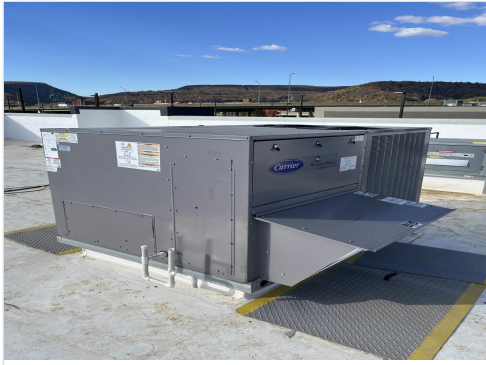
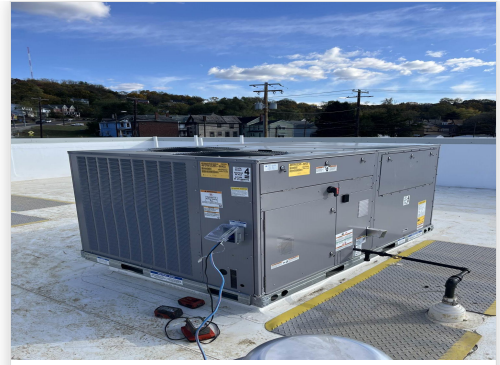
Asset: RTU2

General	
	Actual
Fan Rotation Correct	YES
Unit Filters Clean	NO
Condensate Drain Installed	YES

[1] Diffuser 2-3 and 2-7 are low. Dampers are fully open. Unit total meets design. No noise, vibration, or comfort issues.

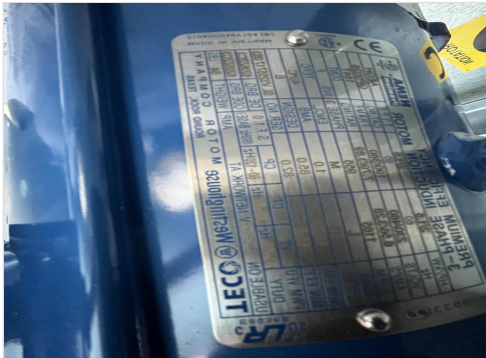
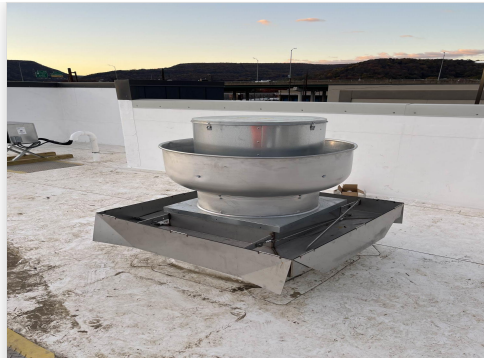
Asset: EF1

YES / Restroom Fan. Hood exhaust dismantled and shut down due to fixing leaks, unable to test.

Issue Name : HD1: KVS Shut Down Due to Duct Repairs
Description : Due active welding to fix leaks in exhaust ductwork, KVS system was powered down and partially dismantled. Schedule return after KVS has been reassembled and passed leak test.

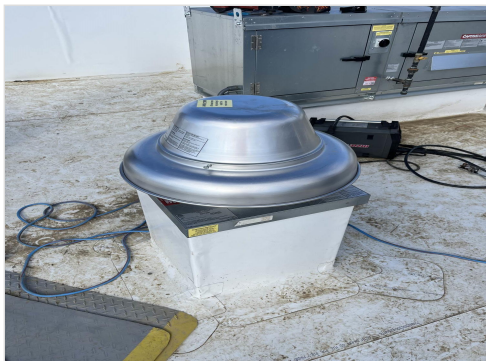
Asset: EF2

No backdraft damper installed.

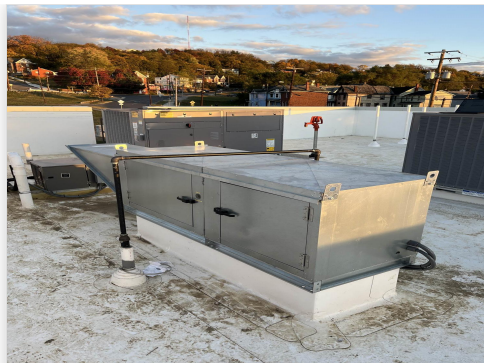
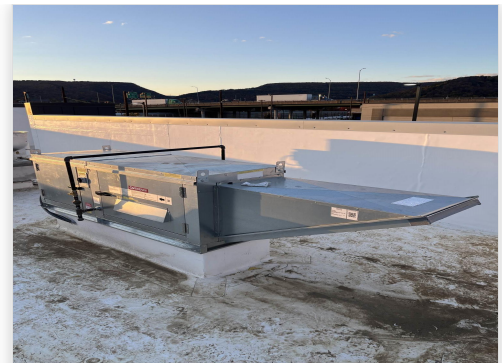
Asset: MAU1

MUA shut down due to fixing leaks in HOOD, unable to test.

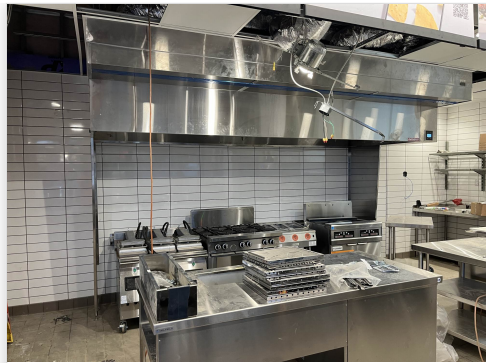
Asset: HD1

Not all filters were installed into unit.

HOOD shut down due to fixing leaks, unable to test.
