Report: TAB

Function: Test, Adjust, & Balance

12-09-24 WAWA #6109 GREENVILLE, NC

Project: 12-09-24 WAWA #6109 GREENVILLE, NC

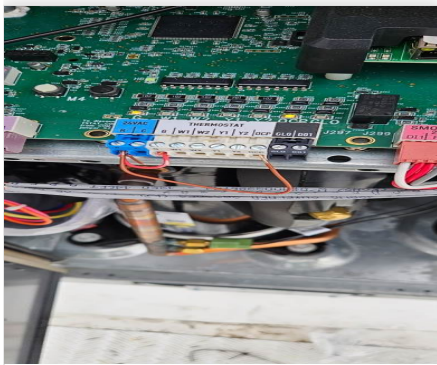
Project Issue File Details

Issue Name : All RTU's thermostat not wired
Description : Thermostats not installed yet. Units are wire jumped at the control panel to be able to TAB. Recommend finishing wiring to ensure correct operation.
Created By : National TAB **Assigned To :** National TAB - Brianna Biggs
Status : Open
Priority : Urgent **Asset Tag :** RTU1
Originated Date : 12/10/2024 - Jearod Ferrette - National TAB

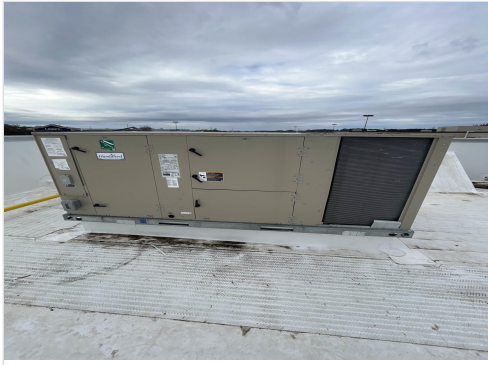
Unit Data - PHOTO LOG

Asset: RTU1

Unit Data		
	Design	Actual
MFG	LENNOX	LENNOX
Serial Num	-	5624G03633
Model Num	LCT150H4E	LCT150H4E
Type	RTU	RTU
Configuration	VERTICAL	VERTICAL
Num OA Filters 1	-	2
OA Filter Size 1	-	14X23
Num Final Filter 1	-	4
Final Filter Size 1	-	20X25X2

Test Data		
	Design	Actual
SF CFM	4500	4524
SF RPM	-	DD/ 85%
MOTOR RPM	-	DD/ 85%
RA CFM	3800	3839
OA CFM	700	685
RL Voltage	-	215/216/215
RL Amperage	-	5.9/6.0/5.9
SF System SetPt	-	85%
RA Damper Position	-	71%
RA Damper Type	-	OBD
OA Damper Position	-	29%
OA Damper Type	-	ECONOMIZER

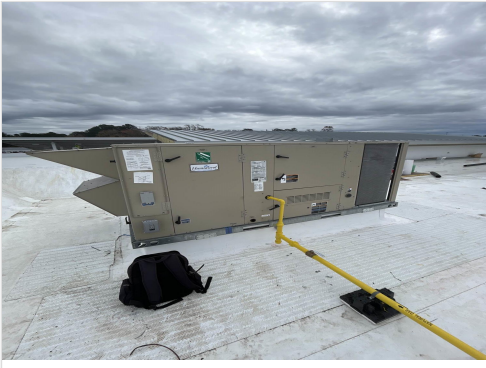
Unit Data - PHOTO LOG

Asset: RTU2

Unit Data		
	Design	Actual
MFG	LENNOX	LENNOX
Serial Num	-	5624G03636
Model Num	LGT102H4E	LGT102H4E
Type	RTU	RTU
Configuration	VERTICAL	VERTICAL
Num OA Filters 1	-	2
OA Filter Size 1	-	14X23
Num Final Filter 1	-	4
Final Filter Size 1	-	20X25X2

Test Data		
	Design	Actual
SF CFM	3400	3350
SF RPM	-	DD/60%
MOTOR RPM	-	DD/60%
RA CFM	3020	2961
OA CFM	380	389
RL Voltage	-	215/215/216
RL Amperage	-	2.43/ 2.38/ 2.3
SF System SetPt	-	60%
RA Damper Position	-	78%
RA Damper Type	-	OBD
OA Damper Position	-	22%
OA Damper Type	-	OBD

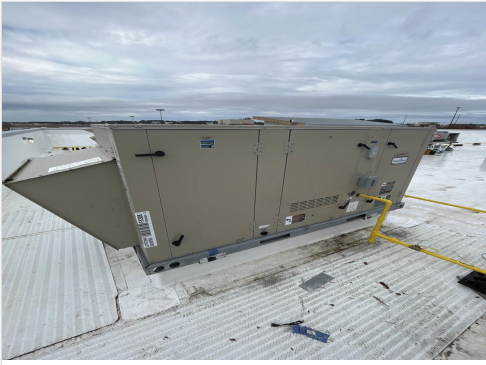
Unit Data - PHOTO LOG

Asset: RTU3

Unit Data		
	Design	Actual
MFG	LENNOX	LENNOX
Serial Num	-	5624H0787
Model Num	LGT072H4E	LGT072H4E
Type	RTU	RTU
Configuration	VERTICAL	VERTICAL
Num OA Filters 1	-	1
OA Filter Size 1	-	14.5X23.25
Num Final Filter 1	-	4
Final Filter Size 1	-	20X20X2

Test Data		
	Design	Actual
SF CFM	2400	2436
SF RPM	-	DD/84%
MOTOR RPM	-	DD/84%
RA CFM	2200	2233
OA CFM	200	203
RL Voltage	-	214/215/214
RL Amperage	-	3.3/3.2/3.3
SF System SetPt	-	84%
RA Damper Position	-	81%
RA Damper Type	-	OBD
OA Damper Position	-	19%
OA Damper Type	-	OBD

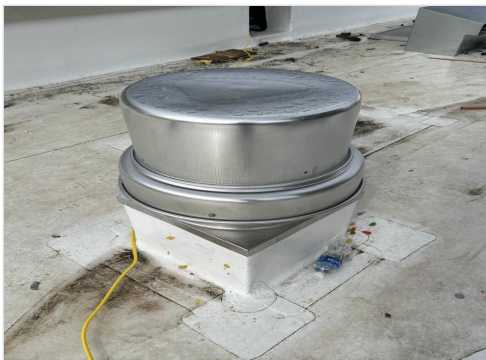
Unit Data - PHOTO LOG

Asset: EF1

Unit Data		
	Design	Actual
MFG	GREENHECK	GREENHECK
Model Num	GB-098-6	GB-098-6
Serial Num	-	25718475
Type	DOWNBLAST	DOWNBLAST
Configuration	VERTICAL	VERTICAL

EFs ARE THE SAME MODEL, JUST INSTALLED BACKWARDS ON ROOF

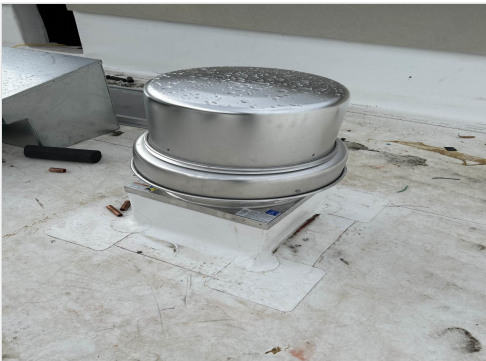
Unit Data - PHOTO LOG

Asset: EF2

Unit Data		
	Design	Actual
MFG	GREENHECK	GREENHECK
Model Num	GB-098-6	GB-098-6
Serial Num	-	25718476
Type	DOWNBLAST	DOWNBLAST
Configuration	VERTICAL	VERTICAL

Test Data		
	Design	Actual
CFM	400	433
Fan RPM	-	998
Fan Rotation	-	CW
Motor RPM	-	1752
System SetPt	-	4 TO
RL Voltage	-	120
RL Amperage	-	NA
Total ESP	0.38"	0.35"
Fan Inlet SP	-	-0.35"
Fan Discharge SP	-	ATM

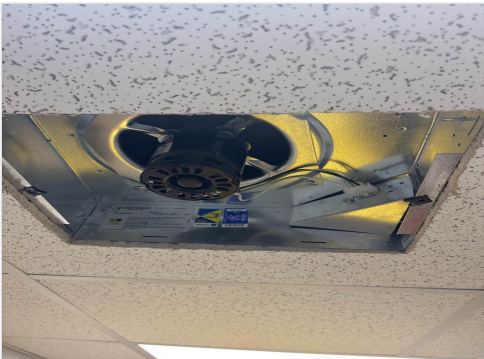
Unit Data - PHOTO LOG

Asset: EF3

Unit Data		
	Design	Actual
MFG	GREENHECK	GREENHECK
Model Num	SP-B200	SP-B200
Serial Num	-	188135100-002
Type	INLINE	INLINE
Configuration	HORIZONTAL	HORIZONTAL

Test Data		
	Design	Actual
CFM	200	215
Fan RPM	-	DIRECT DRIVE
Fan Rotation	-	CW
Motor RPM	-	1000
System SetPt	-	1 SPEED
RL Voltage	-	120
RL Amperage	-	2.7
Total ESP	0.50"	0.07"
Fan Inlet SP	-	-0.07"
Fan Discharge SP	-	ATM
