Report: TAB

Function: Test, Adjust, & Balance

Date: 07/01/2025

06-23-25 WAWA #6112 FAYETTVILLE, NC

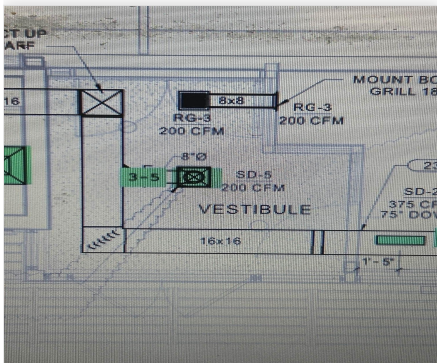
Issue Name : Diffuser damper out of reach
Description : RTU 3 diffuser 3-5 damper out of reach, unable to lower diffuser. Currently sitting at 125% of design.
Created By : National TAB **Assigned To :** National TAB - Brianna Biggs
Status : Open
Priority : Low **Asset Tag :**
Originated Date : 06/24/2025 - Jearod Ferrette - National TAB

Notes:
SD-5 3-5 Damper out of reach, unable to lower.

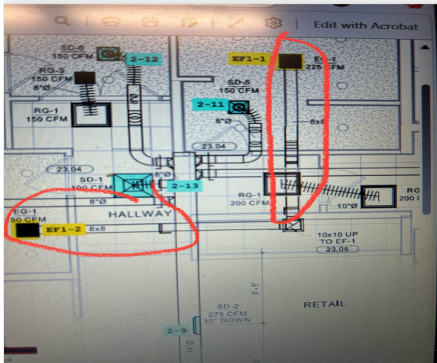
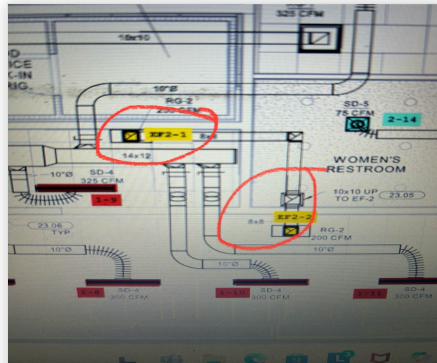
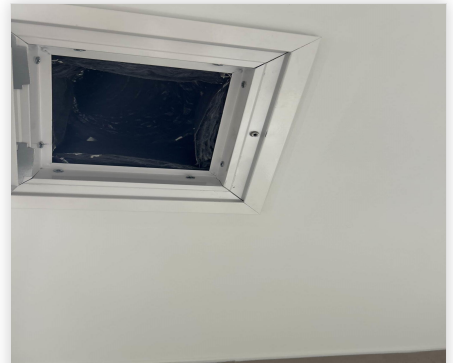
Issue Name : EF 1/2 missing dampers
Description : EF1 (Restroom) and EF2 (Kitchen) are missing dampers. No face dampers.
Created By : National TAB **Assigned To :** National TAB - Brianna Biggs
Status : Open
Priority : Urgent **Asset Tag :** HVAC EQUIPMENT 1
Originated Date : 06/23/2025 - Jearod Ferrette - National TAB

DAMPER NOT INSTALLED ON EF 1/2

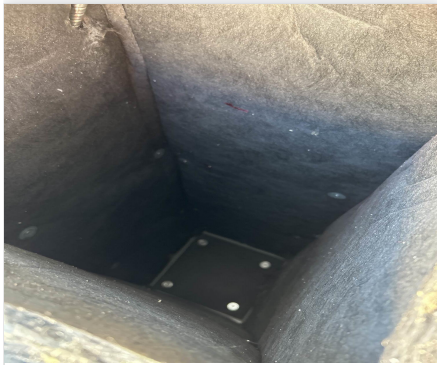
Issue Name : No backdraft dampers on EF 1/2
Description : Backdraft dampers not installed
Created By : National TAB **Assigned To :** National TAB - Brianna Biggs
Status : Open
Priority : Urgent **Asset Tag :** HVAC EQUIPMENT 1
Originated Date : 06/24/2025 - Jearod Ferrette - National TAB

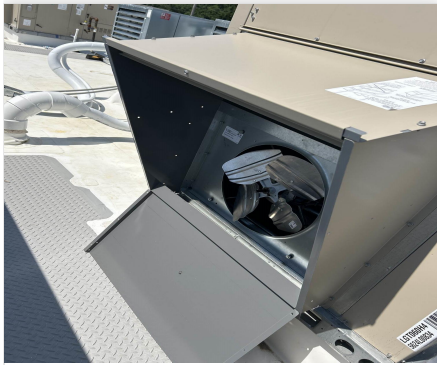
Issue Name : RTU3 OA filter and blower plate not installed
Description : OA filter and blower plate not installed
Created By : National TAB **Assigned To :** National TAB - Brianna Biggs
Status : Open
Priority : Urgent **Asset Tag :** RTU3
Originated Date : 06/23/2025 - Jearod Ferrette - National TAB

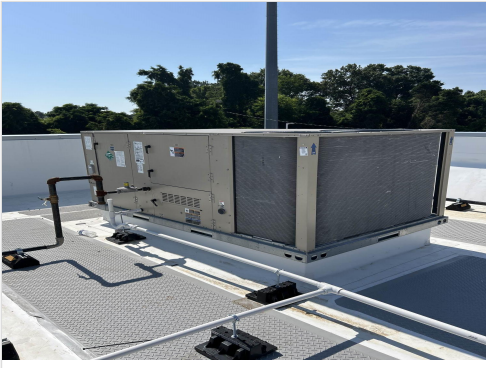
Unit Data - PHOTO LOG

Unit Data		
	Design	Actual
MFG	LENNOX	LENNOX
Serial Num	-	5624J02939
Model Num	LGT120H4E	LGT120H4ES1Y
Type	RTU	RTU
Configuration	VERTICAL	VERTICAL
Num OA Filters 1	-	2
OA Filter Size 1	-	14X24
Num Final Filter 1	-	4
Final Filter Size 1	-	20X25

Test Data		
	Design	Actual
SF CFM	3600	3548
SF RPM	-	1034
MOTOR RPM	-	DD/63%
RA CFM	2900	2831
OA CFM	700	717
RL Voltage	-	215/216/215
RL Amperage	-	5.9/5.9/5.8
SF System SetPt	-	63%
RA Damper Position	-	78%
OA Damper Position	-	22%
OA Damper Type	-	ECON

RTU1 calls for 2,900 CFM return but the flow hood read just 1,960 CFM.
 With OA damper at 0%, duct traverse measured 2,432 CFM closer to design.
 No leaks, secure drops, return trunk sealed tight.
 System looks solid, but airflow still falls short

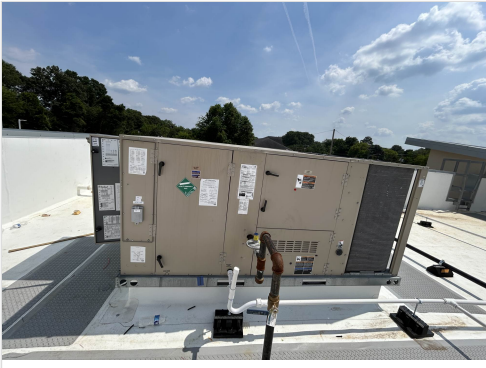
Unit Data - PHOTO LOG

Unit Data		
	Design	Actual
MFG	LENNOX	LENNOX
Serial Num	-	5624J02949
Model Num	LGT120H4E	LGT120H4ES1Y
Type	RTU	RTU
Configuration	VERTICAL	VERTICAL
Num OA Filters 1	-	2
OA Filter Size 1	-	14X24
Num Final Filter 1	-	4
Final Filter Size 1	-	20X25

Test Data		
	Design	Actual
SF CFM	3250	3207
SF RPM	-	946
MOTOR RPM	-	DD/43%
RA CFM	2870	2830
OA CFM	380	377
RL Voltage	-	216/215/215
RL Amperage	-	5.8/5.9/5.8
SF System SetPt	-	43%
RA Damper Position	-	73%
OA Damper Position	-	27%
OA Damper Type	-	ECON

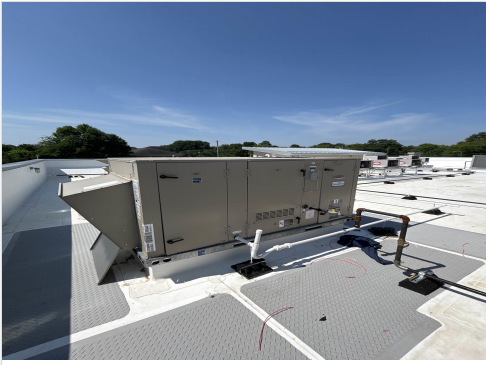
Unit Data - PHOTO LOG

Unit Data		
	Design	Actual
MFG	LENNOX	LENNOX
Serial Num	-	5624L00834
Model Num	LGT060H4E	LGT060H4EB1Y
Type	RTU	RTU
Configuration	VERTICAL	VERTICAL
Num OA Filters 1	-	1
OA Filter Size 1	-	14.5X28.25
Num Final Filter 1	-	4
Final Filter Size 1	-	20X20

Test Data		
	Design	Actual
SF CFM	2000	2010
SF RPM	-	2112
MOTOR RPM	-	DD/64%
RA CFM	1800	1806
OA CFM	200	204
RL Voltage	-	215/216/215
RL Amperage	-	3.3/3.2/3.2
SF System SetPt	-	64%
RA Damper Position	-	73%
OA Damper Position	-	27%
OA Damper Type	-	ECON

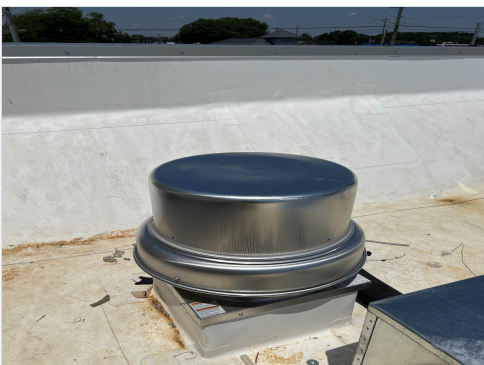
Unit Data - PHOTO LOG

Unit Data		
	Design	Actual
MFG	GREENHECK	GREENHECK
Model Num	GB-08-6	GB-08-6
Type	DOWNBLAST	DOWNBLAST
Configuration	VERTICAL	VERTICAL

Test Data		
	Design	Actual
CFM	375	388
Fan RPM	1334	1123
Fan Rotation	-	CW
Motor RPM	-	1725
System SetPt	-	3 TURNS OUT
RL Voltage	-	120
RL Amperage	-	NA
Total ESP	.375"	0.26"
Fan Inlet SP	-	-0.26
Fan Discharge SP	-	ATMO

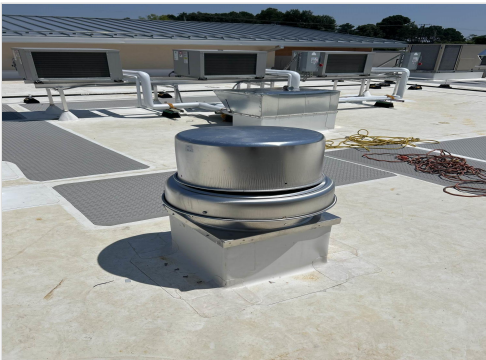
Unit Data - PHOTO LOG

Unit Data		
	Design	Actual
MFG	GREENHECK	GREENHECK
Model Num	GB-098-6	GB-098-6
Type	DOWNBLAST	DOWNBLAST
Configuration	VERTICAL	VERTICAL

Test Data		
	Design	Actual
CFM	400	410
Fan RPM	1334	1902
Fan Rotation	-	cw
Motor RPM	-	1769
System SetPt	-	3.5 turns out
RL Voltage	-	118
RL Amperage	-	NA
Total ESP	.375"	0.35"
Fan Inlet SP	-	-0.35"
Fan Discharge SP	-	ATMO

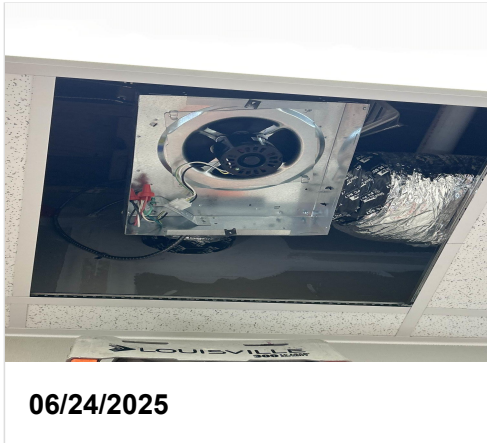
Unit Data - PHOTO LOG

Unit Data		
	Design	Actual
MFG	GREENHECK	GREENHECK
Model Num	SP-B200	SP-B200
Serial Num	-	193844723-0066
Type	CEILING	CEILING
Configuration	VERTICAL	VERTICAL

Test Data		
	Design	Actual
CFM	200	0
Fan RPM	-	0
Fan Rotation	-	0
Motor RPM	-	0
System SetPt	-	0
RL Voltage	-	0
RL Amperage	-	0
Total ESP	.50"	0
Fan Inlet SP	-	0
Fan Discharge SP	-	0

Notes:
NOT WIRED, NO SPEED CONTROLLER
