Report: FINAL TAB REPORT
Function: Test, Adjust, & Balance
Date: 09/26/2022

PROJECT
09-19 CULVERS - LOGANSPOORT, IN

09-19 CULVERS - LOGANSPORT, IN

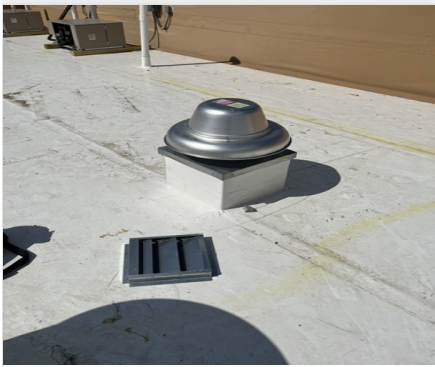
Project Issue File Details

Issue Name : BACKDRAFT DAMPER FOR RESTROOM EXHAUST
Description : The backdraft damper for PRV1 is beside the restroom fan and needs to be installed.
Created By : National TAB **Assigned To :** National TAB - Will Turnbough
Status : Pending
Originated Date : 09/19/2022 - Jack Bain - National TAB
