Report: FINAL TAB REPORT
Function: Test, Adjust, & Balance
Date: 09/26/2022

PROJECT
09-19 CULVERS - LOGANSPOORT, IN

Table Of Contents

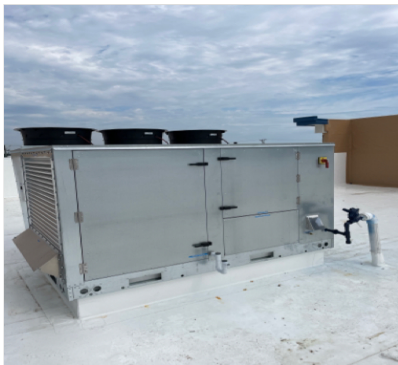
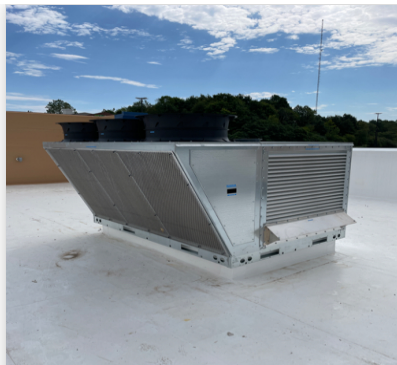
RTU-1

Unit Data		
	Design	Actual
MFG	LENNOX	CAPTIVEAIRE
Serial Num	-	5375083
Model Num	LGH 180 H4B	CASRTU3-I.400-24-20T-DOAS
Type	RTU	RTU
Configuration	VERTICAL	VERTICAL
Num OA Filters 1	-	4
OA Filter Size 1	-	16x25x2"
Num Final Filter 1	-	8
Final Filter Size 1	-	20x25x2"

Test Data		
	Design	Actual
SF CFM	6150	5975
SF RPM	-	1553
RA CFM	4400	4217
OA CFM	1750	1758
RL Voltage	-	188
RL Amperage	-	20.4
SF Rotation	-	CCW
Min OA Damper Position	-	OPEN
Min OA Damper Type	-	DOAS
OA Enthalpy Setpt	-	DOAS

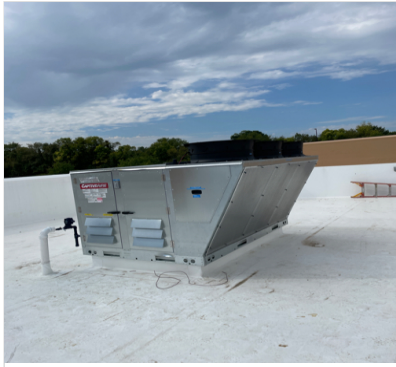
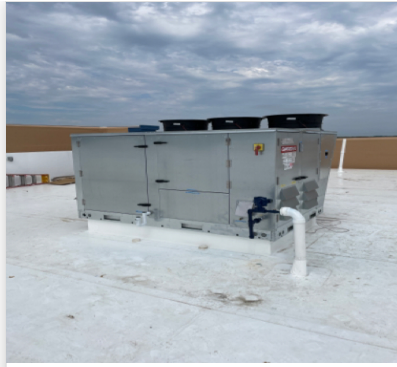
RTU-2

Unit Data		
	Design	Actual
MFG	LENNOX	CAPTIVEAIRE
Serial Num	-	5375083
Model Num	LGH 210 H4B	CASRTU3-I.400-24-20T-DOAS
Type	RTU	RTU
Configuration	VERTICAL	VERTICAL
Num OA Filters 1	-	4
OA Filter Size 1	-	16x25x2"
Num Final Filter 1	-	8
Final Filter Size 1	-	20x25x2"

Test Data		
	Design	Actual
SF CFM	6150	6063
SF RPM	-	1604
RA CFM	4450	4283
OA CFM	1700	1780
RL Voltage	-	203
RL Amperage	-	19.9
SF Rotation	-	CCW
Min OA Damper Position	-	OPEN
Min OA Damper Type	-	DOAS

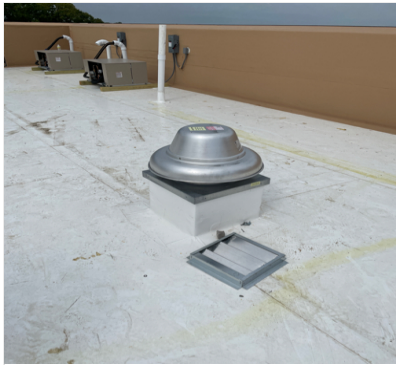
PRV-1

Unit Data		
	Design	Actual
MFG	ACCUREX	CAPTIVEAIRE
Model Num	XRED 090 XG	DR12HFA
Serial Num	-	5375083
Type	DOWNBLAST	DOWNBLAST
Configuration	VERTICAL	VERTICAL

Test Data		
	Design	Actual
CFM	375	368
Fan RPM	1465	877
Fan Rotation	-	CCW
Motor RPM	-	882
System SetPt	-	49P
RL Voltage	-	NA
RL Amperage	-	0.6
Total ESP	0.5"	0.11"
Fan Inlet SP	-	-0.11
Fan Discharge SP	-	ATM

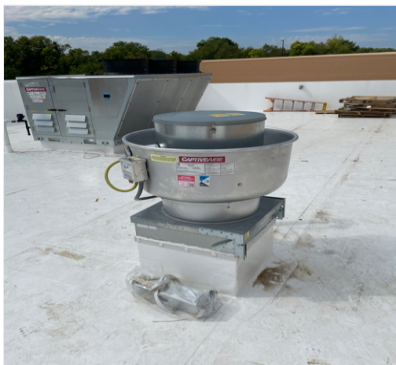
PRV-2

Unit Data		
	Design	Actual
MFG	ACCUREX	CAPTIVEAIRE
Model Num	XRUB 160XP-15	DU85HFA
Serial Num	-	5375083
Type	UPBLAST	UPBLAST
Configuration	VERTICAL	VERTICAL

Test Data		
	Design	Actual
CFM	1500	1522
Fan RPM	1411	1431
Fan Rotation	-	CCW
Motor RPM	-	1431
RL Voltage	-	117
RL Amperage	-	2.1
Suction ESP	-	-0.77
Discharge ESP	-	ATM
Total ESP	2.337"	0.77"

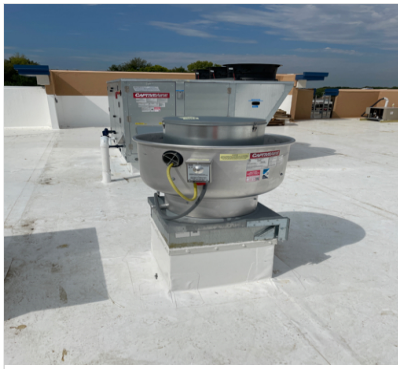
PRV-3

Unit Data		
	Design	Actual
MFG	ACCUREX	CAPTIVEAIRE
Model Num	XRUB 140-7	DU85HFA
Serial Num	-	5375083
Type	UPBLAST	UPBLAST
Configuration	VERTICAL	VERTICAL

Test Data		
	Design	Actual
CFM	1500	1555
Fan RPM	1377	1427
Fan Rotation	-	CCW
Motor RPM	-	1427
RL Voltage	-	117
RL Amperage	-	1.9
Suction ESP	-	-0.53
Discharge ESP	-	ATM
Total ESP	1.0"	0.53"

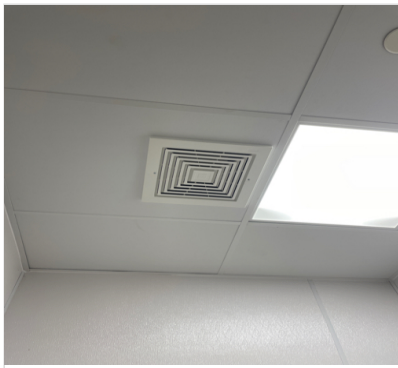
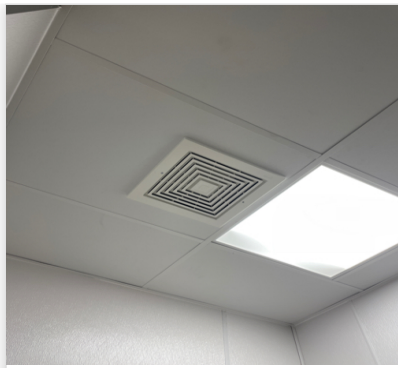
EF-A1

Unit Data		
	Design	Actual
MFG	ACCUREX	NA
Model Num	XCR B80	NA
Serial Num	-	NA
Type	CEILING	NA
Configuration	VERTICAL	NA

Test Data		
	Design	Actual
CFM	75	71
Fan RPM	885	NA
Fan Rotation	-	NA
Motor RPM	-	NA
System SetPt	-	NA
RL Voltage	-	NA
RL Amperage	-	NA
Total ESP	0.125"	NA
Fan Inlet SP	-	NA
Fan Discharge SP	-	ATM

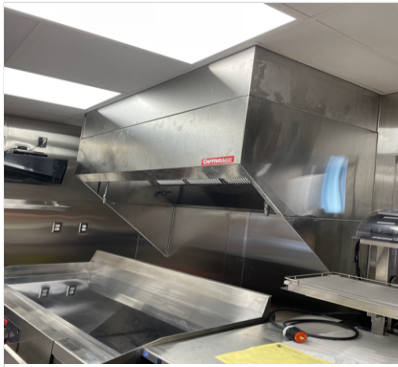
HOOD-1

Unit Data		
	Design	Actual
MFG	ACCUREX	CAPTIVEAIRE
Model Num	XGEP64-S	3347-BD-2
Job / Serial Num	-	5375083
Type	TYPE 1 LOW PROXIMITY	TYPE 1 LOW PROXIMITY
Hood length	64	66
Hood Width	23	33

Test Data Exhaust		
	Design	Actual
Filter Type	GREASE GRABBER	CAPTRATE SOLO GREASE-STOP
Filter Size 1	16X16	16x16"
Filter Qty 1	4	4
Filter AK factor size 1	1.53	1.62
Filter Total AK Area	6.12	6.48
Filter1 FPM	-	225
Filter2 FPM	-	245
Filter3 FPM	-	237
Filter4 FPM	-	234
Filter Ave FPM(corr)	-	235
CFM	1500	1522

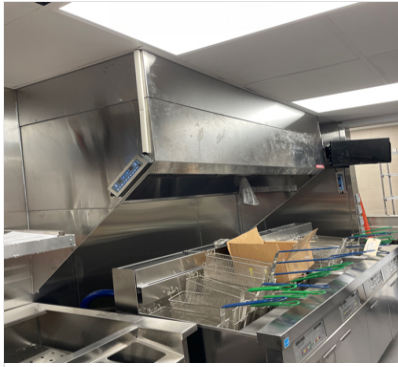
HOOD-2

Unit Data		
	Design	Actual
MFG	ACCUREX	CAPTIVEAIRE
Model Num	XXEP-83-S	3347 BD-2
Job / Serial Num	-	5375083
Type	TYPE 1 LOW PROXIMITY	TYPE I LOW PROXIMITY
Hood length	83	84
Hood Width	23	33

Test Data Exhaust		
	Design	Actual
Filter Type	X-TRACTOR	CAPTRATE SOLO GREASE-STOP
Filter Size 1	16X16	16x16
Filter Qty 1	5	5
Filter AK factor size 1	1.53	1.62
Filter Total AK Area	7.65	8.1
Filter1 FPM	-	204
Filter2 FPM	-	191
Filter3 FPM	-	199
Filter4 FPM	-	187
Filter5 FPM	-	181
Filter Ave FPM(corr)	-	192
CFM	1500	1555
