**Report: FINAL TAB REPORT**  
**Function: Test, Adjust, & Balance**  
**Date: 09/26/2022**

**PROJECT**  
**09-19 CULVERS - LOGANSPOORT, IN**

Client

Captive-Aire Region #60

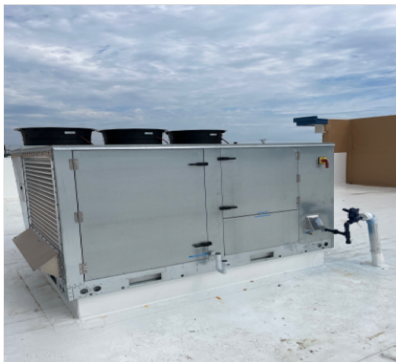
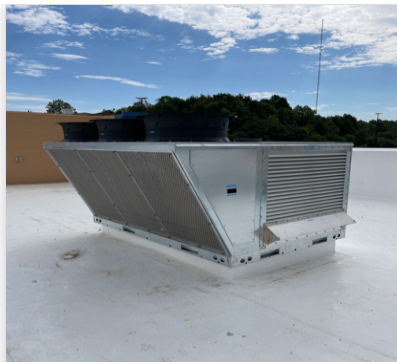
#### RTU-1

Unit Data		
	Design	Actual
MFG	LENNOX	CAPTIVEAIRE
Serial Num	-	5375083
Model Num	LGH 180 H4B	CASRTU3-I.400-24-20T-DOAS
Type	RTU	RTU
Configuration	VERTICAL	VERTICAL
Num OA Filters 1	-	4
OA Filter Size 1	-	16x25x2"
Num Final Filter 1	-	8
Final Filter Size 1	-	20x25x2"

Test Data		
	Design	Actual
SF CFM	6150	5975
SF RPM	-	1553
RA CFM	4400	4217
OA CFM	1750	1758
RL Voltage	-	188
RL Amperage	-	20.4
SF Rotation	-	CCW
Min OA Damper Position	-	OPEN
Min OA Damper Type	-	DOAS
OA Enthalpy Setpt	-	DOAS

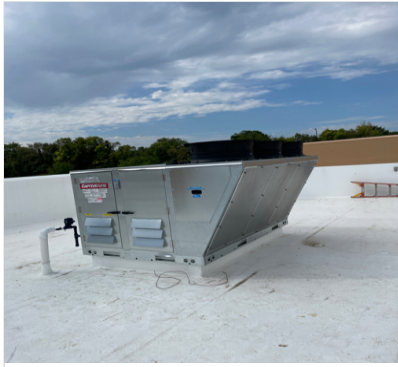
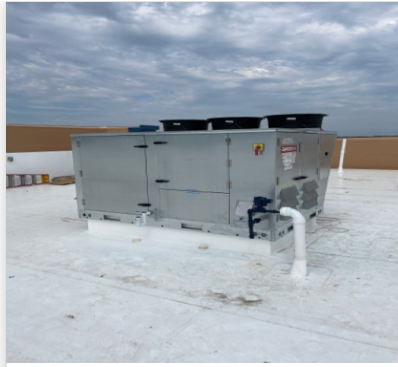
RTU-2

Unit Data		
	Design	Actual
MFG	LENNOX	CAPTIVEAIRE
Serial Num	-	5375083
Model Num	LGH 210 H4B	CASRTU3-I.400-24-20T-DOAS
Type	RTU	RTU
Configuration	VERTICAL	VERTICAL
Num OA Filters 1	-	4
OA Filter Size 1	-	16x25x2"
Num Final Filter 1	-	8
Final Filter Size 1	-	20x25x2"

Test Data		
	Design	Actual
SF CFM	6150	6063
SF RPM	-	1604
RA CFM	4450	4283
OA CFM	1700	1780
RL Voltage	-	203
RL Amperage	-	19.9
SF Rotation	-	CCW
Min OA Damper Position	-	OPEN
Min OA Damper Type	-	DOAS

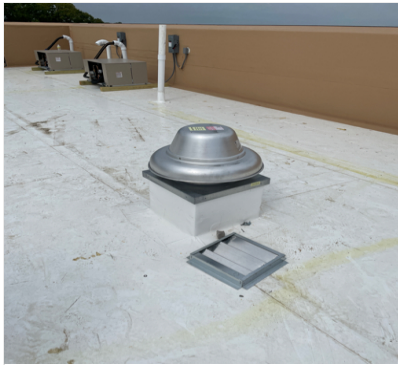
PRV-1

Unit Data		
	Design	Actual
MFG	ACCUREX	CAPTIVEAIRE
Model Num	XRED 090 XG	DR12HFA
Serial Num	-	5375083
Type	DOWNBLAST	DOWNBLAST
Configuration	VERTICAL	VERTICAL

Test Data		
	Design	Actual
CFM	375	368
Fan RPM	1465	877
Fan Rotation	-	CCW
Motor RPM	-	882
System SetPt	-	49P
RL Voltage	-	NA
RL Amperage	-	0.6
Total ESP	0.5"	0.11"
Fan Inlet SP	-	-0.11
Fan Discharge SP	-	ATM

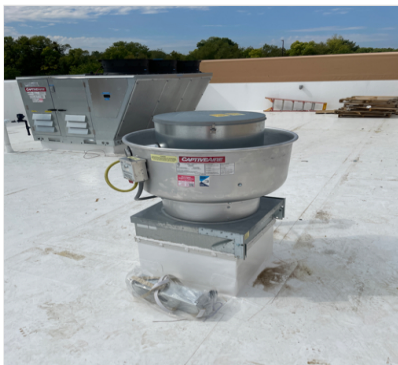
PRV-2

Unit Data		
	Design	Actual
MFG	ACCUREX	CAPTIVEAIRE
Model Num	XRUB 160XP-15	DU85HFA
Serial Num	-	5375083
Type	UPBLAST	UPBLAST
Configuration	VERTICAL	VERTICAL

Test Data		
	Design	Actual
CFM	1500	1522
Fan RPM	1411	1431
Fan Rotation	-	CCW
Motor RPM	-	1431
RL Voltage	-	117
RL Amperage	-	2.1
Suction ESP	-	-0.77
Discharge ESP	-	ATM
Total ESP	2.337"	0.77"

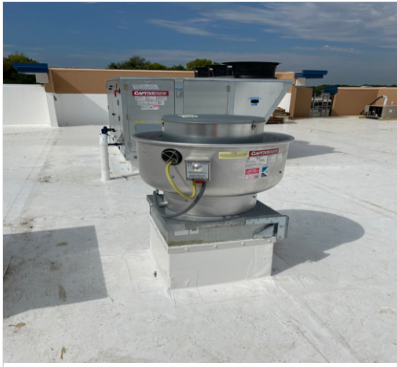
PRV-3

Unit Data		
	Design	Actual
MFG	ACCUREX	CAPTIVEAIRE
Model Num	XRUB 140-7	DU85HFA
Serial Num	-	5375083
Type	UPBLAST	UPBLAST
Configuration	VERTICAL	VERTICAL

Test Data		
	Design	Actual
CFM	1500	1555
Fan RPM	1377	1427
Fan Rotation	-	CCW
Motor RPM	-	1427
RL Voltage	-	117
RL Amperage	-	1.9
Suction ESP	-	-0.53
Discharge ESP	-	ATM
Total ESP	1.0"	0.53"

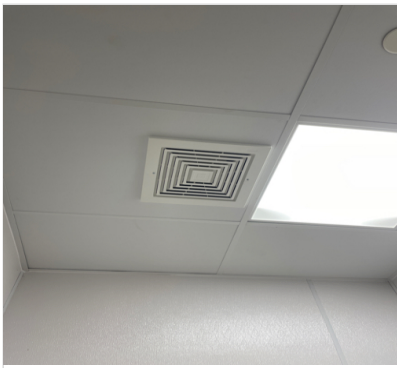
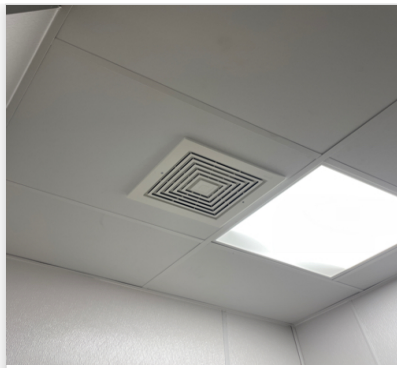
EF-A1

Unit Data		
	Design	Actual
<b>MFG</b>	ACCUREX	NA
<b>Model Num</b>	XCR B80	NA
<b>Serial Num</b>	-	NA
<b>Type</b>	CEILING	NA
<b>Configuration</b>	VERTICAL	NA

Test Data		
	Design	Actual
<b>CFM</b>	75	71
<b>Fan RPM</b>	885	NA
<b>Fan Rotation</b>	-	NA
<b>Motor RPM</b>	-	NA
<b>System SetPt</b>	-	NA
<b>RL Voltage</b>	-	NA
<b>RL Amperage</b>	-	NA
<b>Total ESP</b>	0.125"	NA
<b>Fan Inlet SP</b>	-	NA
<b>Fan Discharge SP</b>	-	ATM

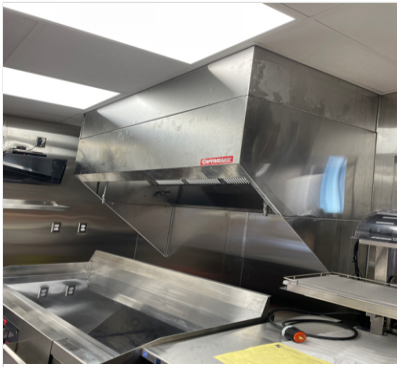
HOOD-1

Unit Data		
	Design	Actual
<b>MFG</b>	ACCUREX	CAPTIVEAIRE
<b>Model Num</b>	XGEP64-S	3347-BD-2
<b>Job / Serial Num</b>	-	5375083
<b>Type</b>	TYPE 1 LOW PROXIMITY	TYPE 1 LOW PROXIMITY
<b>Hood length</b>	64	66
<b>Hood Width</b>	23	33

Test Data Exhaust		
	Design	Actual
<b>Filter Type</b>	GREASE GRABBER	CAPTRATE SOLO GREASE-STOP
<b>Filter Size 1</b>	16X16	16x16"
<b>Filter Qty 1</b>	4	4
<b>Filter AK factor size 1</b>	1.53	1.62
<b>Filter Total AK Area</b>	6.12	6.48
<b>Filter1 FPM</b>	-	225
<b>Filter2 FPM</b>	-	245
<b>Filter3 FPM</b>	-	237
<b>Filter4 FPM</b>	-	234
<b>Filter Ave FPM(corr)</b>	-	235
<b>CFM</b>	1500	1522

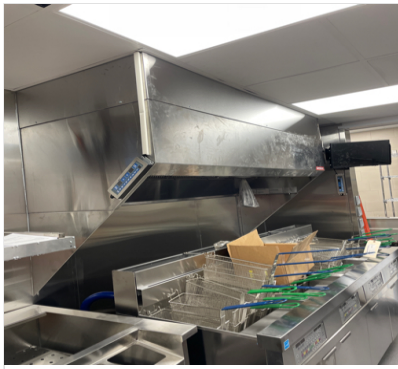
HOOD-2

Unit Data		
	Design	Actual
MFG	ACCUREX	CAPTIVEAIRE
Model Num	XXEP-83-S	3347 BD-2
Job / Serial Num	-	5375083
Type	TYPE 1 LOW PROXIMITY	TYPE I LOW PROXIMITY
Hood length	83	84
Hood Width	23	33

Test Data Exhaust		
	Design	Actual
Filter Type	X-TRACTOR	CAPTRATE SOLO GREASE-STOP
Filter Size 1	16X16	16x16
Filter Qty 1	5	5
Filter AK factor size 1	1.53	1.62
Filter Total AK Area	7.65	8.1
Filter1 FPM	-	204
Filter2 FPM	-	191
Filter3 FPM	-	199
Filter4 FPM	-	187
Filter5 FPM	-	181
Filter Ave FPM(corr)	-	192
CFM	1500	1555
