Report: TAB Report
Function: Test, Adjust, & Balance
Date: 08/15/2025
Completed By: National TAB

07-14-25 WAWA #6623 WINCHESTER, VA

200 CROSSOVER BLVD

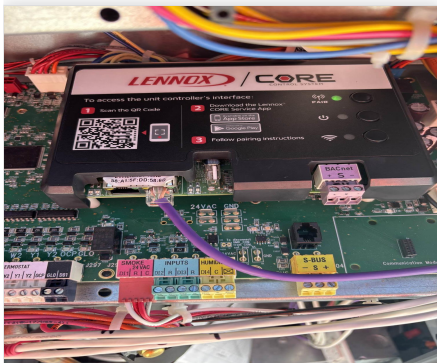
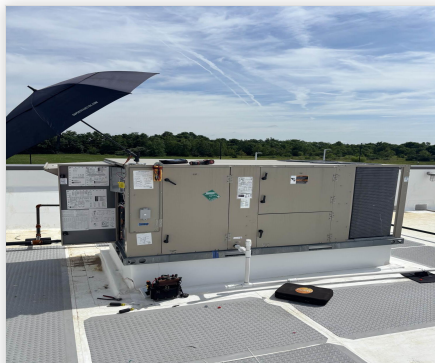
Issue Name : RTU-1: Unable to Connect/Unit not running.
Description : Unable to connect to Service Core board on electrical panel inside of unit. Unable to get unit running. Recommend service from manufacturer.
Created By : National TAB **Assigned To :** National TAB - Kalen Kemp
Status : Open
Priority : Urgent **Asset Tag :** RTU1
Originated Date : 07/17/2025 - Kalen Kemp - National TAB

- **08/15/2025 National TAB - Jordan Best**
 - Lennox core board to be replaced. Unit running.

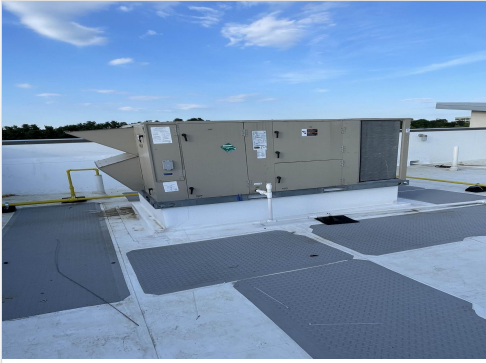
Unit Data - PHOTO LOG

Asset: RTU1

Unit Data		
	Design	Actual
MFG	LENNOX	LENNOX
Serial Num	-	5624H03625
Model Num	LCT150H4E	LCT150H4E
Type	RTU	RTU
Configuration	VERTICAL	VERTICAL
Num OA Filters 1	-	2
OA Filter Size 1	-	14"X23"
Num Final Filter 1	-	4
Final Filter Size 1	-	20"X25"X2"

Test Data		
	Design	Actual
SF CFM	4500	4425
RA CFM	3800	3714
OA CFM	700	711
RL Voltage	-	205.4 / 207.2 / 207.1
RL Amperage	-	4.1 / 4.2 / 4.2
SF System SetPt	-	76%
RA Damper Position	-	80%
OA Damper Position	-	20%
OA Damper Type	-	ECONOMIZER

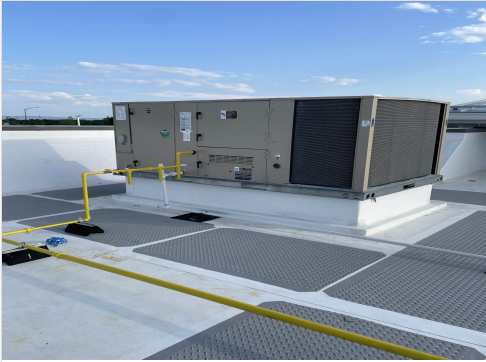
Unit Data - PHOTO LOG

Asset: RTU2

Unit Data		
	Design	Actual
MFG	LENNOX	LENNOX
Serial Num	-	624H03850
Model Num	LGT102H4E	LGT102H4E
Type	RTU	RTU
Configuration	VERTICAL	VERTICAL
Num OA Filters 1	-	2
OA Filter Size 1	-	14"X23"
Num Final Filter 1	-	4
Final Filter Size 1	-	20"X25"X2"

Test Data		
	Design	Actual
SF CFM	3400	3410
RA CFM	3020	3024
OA CFM	380	386
RL Voltage	-	206.3 / 205.4 / 205.4
RL Amperage	-	3.9 / 3.7 / 3.8
SF System SetPt	-	75%
RA Damper Position	-	85%
OA Damper Position	-	15%
OA Damper Type	-	ECONOMIZER

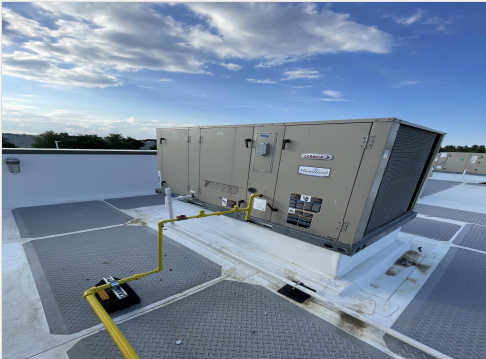
Unit Data - PHOTO LOG

Asset: RTU3

Unit Data		
	Design	Actual
MFG	LENNOX	LENNOX
Serial Num	-	5624H02648
Model Num	LGT072H4E	LGT072H4E
Type	RTU	RTU
Configuration	VERTICAL	VERTICAL
Num OA Filters 1	-	1
OA Filter Size 1	-	32"x15"
Num Final Filter 1	-	4
Final Filter Size 1	-	20X20X2"

Test Data		
	Design	Actual
SF CFM	2400	2370
RA CFM	2200	2181
OA CFM	200	189
RL Voltage	-	208/208/209
RL Amperage	-	0.76/0.79/0.80
SF System SetPt	-	50%
RA Damper Position	-	90%
OA Damper Position	-	10%
OA Damper Type	-	ECON

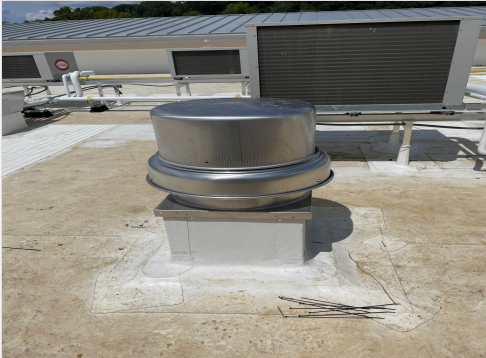
Unit Data - PHOTO LOG

Asset: EF2

Unit Data		
	Design	Actual
MFG	GREENHECK	GREENHECK
Model Num	GB-098-6	GB-098-6
Serial Num	-	26588959
Type	DOWNBLAST	DOWNBLAST
Configuration	VERTICAL	VERTICAL

Test Data		
	Design	Actual
CFM	400	410
Fan Rotation	-	CCW
System SetPt	-	1 TURN OUT
RL Voltage	-	114.5
RL Amperage	-	2.4
Total ESP	.38"	0.17"
Fan Inlet SP	-	-0.17"
Fan Discharge SP	-	ATM

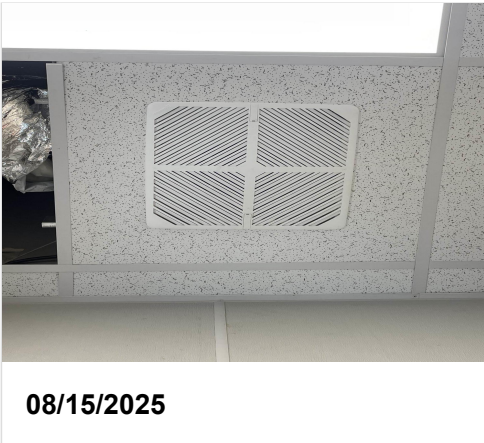
Unit Data - PHOTO LOG

Asset: EF3

Unit Data		
	Design	Actual
MFG	GREENHECK	GREENHECK
Model Num	SP-B200	SP-B200
Serial Num	-	NA
Type	CEILING	CEILING
Configuration	VERTICAL	VERTICAL

Test Data		
	Design	Actual
CFM	200	184
Fan Rotation	-	CCW
System SetPt	-	FIXED SPEED
Fan Discharge SP	-	ATM
