Report: TAB Punchlist
Function: Test, Adjust, & Balance
Date: 01/16/2025
Completed By: National TAB

PROJECT
Wilmington CBOC (Wilmington, OH)

Project: Wilmington CBOC (Wilmington, OH)

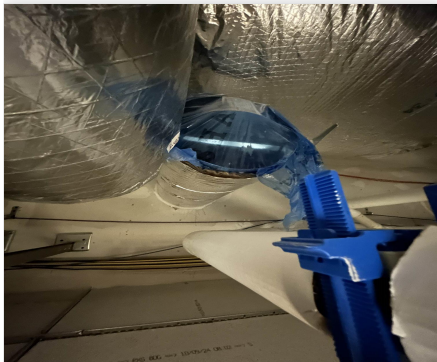
Issue Name : Rtu 3 return grille12
Description : Return grill 12 on Rtu 3 located in the hallway outside reception was not installed. Need flex and grille.
Created By : National TAB **Assigned To :** National TAB - Nick Payne
Status : Open
Priority : Medium **Asset Tag :**
Originated Date : 01/21/2025 - Gabe Merk - National TAB
