Report: TAB REPORT
Function: Test, Adjust, & Balance
Date: 07/19/2023

PROJECT
07-10-23 CULVERS - PLANO, IL

Project Summary

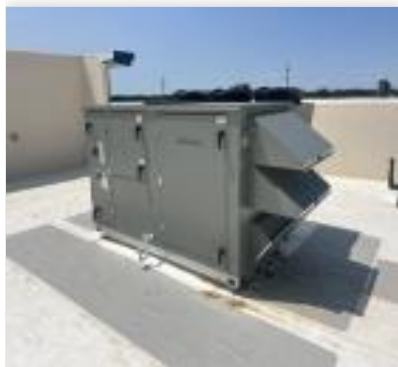
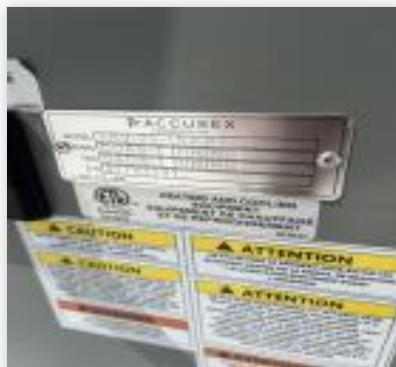
DOAS-1
07/18/2023

Unit Data		
	Design	Actual
MFG	ACCUREX/CAPTIVEAIRE	ACCUREX
Serial Num	-	21747191
Model Num	NA	XRV-25-15J-J-G1
Type	RTU	RTU
Configuration	VERTICAL	VERTICAL
Num OA Filters 1	-	2
OA Filter Size 1	-	18X18
Num Final Filter 1	-	2
Final Filter Size 1	-	20X24X2
Num Final Filter 2	-	2
Final Filter Size 2	-	20X20X2

Test Data		
	Design	Actual
SF CFM	6150	6228
SF RPM	-	DD
RA CFM	4400	4374
OA CFM	1750	1854
RL Voltage	-	152.9/153.2/152.9
RL Amperage	-	16.3 @ VFD
SF Rotation	-	CORRECT
RA Damper Position	-	70%
Min OA Damper Position	-	30%
Min OA Damper Type	-	ECONOMIZER

Performance Data		
	Design	Actual
MA Plenum SP	-	-0.32"
Fan Discharge SP	-	0.73"
Total ESP	0.75"	1.05"

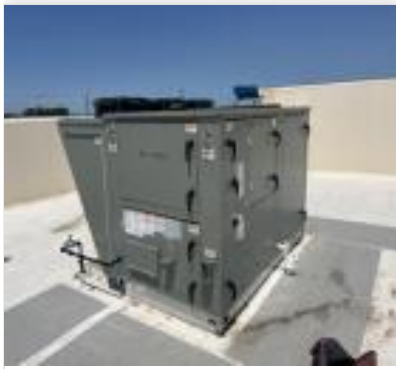
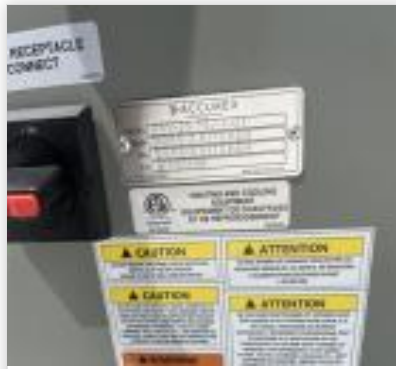
DOAS-2
07/18/2023

Unit Data		
	Design	Actual
MFG	ACCUREX/CAPTIVEAIRE	ACCUREX
Serial Num	-	21747196
Model Num	NA	XRV-25-15J-J-G1
Type	RTU	RTU
Configuration	VERTICAL	VERTICAL
Num OA Filters 1	-	2
OA Filter Size 1	-	18X18
Num Final Filter 1	-	2
Final Filter Size 1	-	20X24X2
Num Final Filter 2	-	2
Final Filter Size 2	-	20X20X2

Test Data		
	Design	Actual
SF CFM	6150	6222
SF RPM	-	DD
RA CFM	4450	4444
OA CFM	1700	1778
RL Voltage	-	153.5/152.9/153.3
RL Amperage	-	16.2 @ VFD
SF Rotation	-	CORRECT
RA Damper Position	-	71%
Min OA Damper Position	-	29%
Min OA Damper Type	-	ECONOMIZER

Performance Data		
	Design	Actual
MA Plenum SP	-	-0.26"
Fan Discharge SP	-	0.81"
Total ESP	0.75"	1.07"

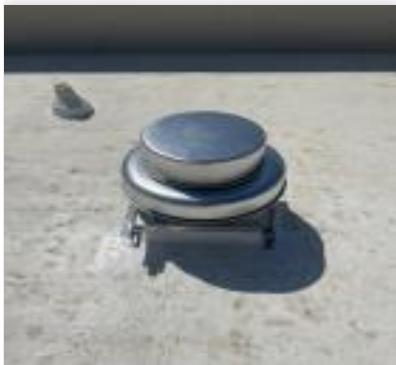
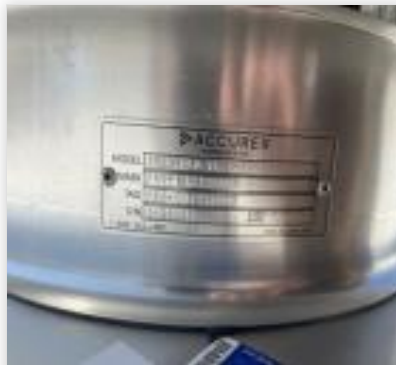
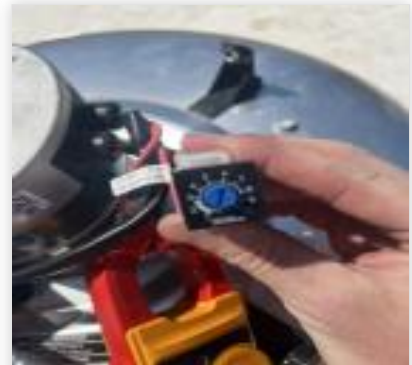
PRV-1
07/18/2023

Unit Data		
	Design	Actual
MFG	ACCUREX	ACCUREX
Model Num	XRED-090-VG	XRED-090-VG-1-17-X
Serial Num	-	21812842
Type	DOWNBLAST	DOWNBLAST
Configuration	VERTICAL	VERTICAL

Test Data		
	Design	Actual
CFM	375	359
Fan RPM	1465	DD
Fan Rotation	-	CCW
Motor RPM	-	DD
System SetPt	-	6@POTENTIOMETER
RL Voltage	-	NA
RL Amperage	-	NA
Total ESP	0.5	0.11"
Fan Inlet SP	-	-0.11"
Fan Discharge SP	-	ATM

Notes:
[1] FAN IS CONTROLLED BY EF-1A LIGHT SWITCH. FANS ARE ON SAME CIRCUIT.

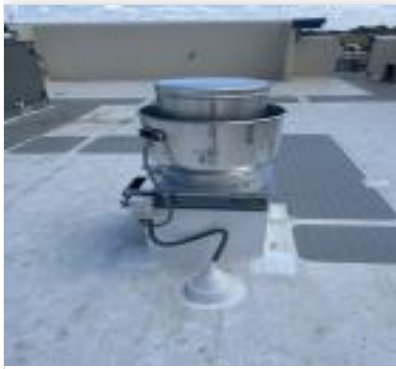
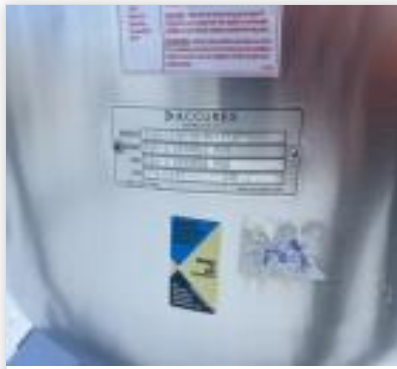
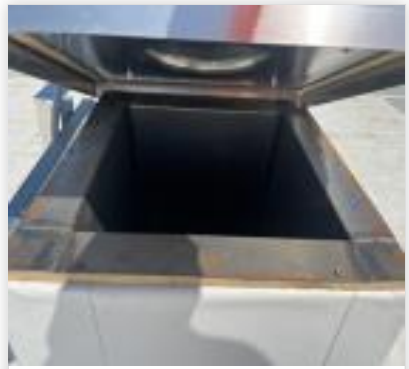
PRV-2
07/18/2023

Hoods were not properly wired on arrival. PRV-2 was not operating and fire system was not wired to DOAS units.

Unit Data		
	Design	Actual
MFG	ACCUREX	ACCUREX
Model Num	XRUB-160XP-15	XCUE-140-10-VG-1-26-G
Serial Num	-	21812392
Type	UPBLAST	UPBLAST
Configuration	VERTICAL	VERTICAL

Test Data		
	Design	Actual
CFM	1500	1516
Fan RPM	-	1295
Fan Rotation	-	CORRECT
Motor RPM	-	1295
RL Voltage	-	121
RL Amperage	-	2.3
Suction ESP	-	-0.81"
Discharge ESP	-	ATM
Total ESP	2.337"	0.81"

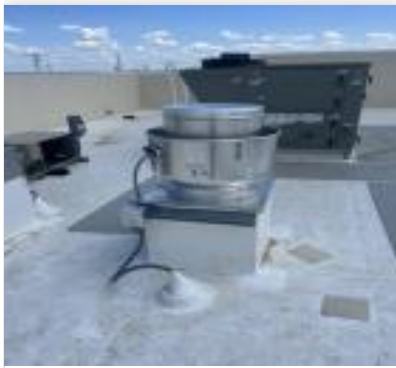
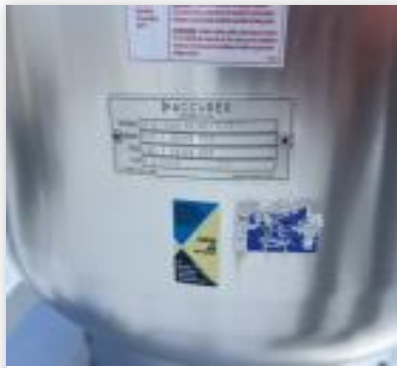
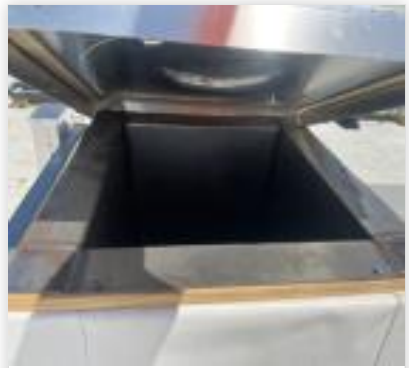
PRV-3
07/18/2023

Unit Data		
	Design	Actual
MFG	ACCUREX	ACCUREX
Model Num	XRUB-140-7	XCUE-140-10-VG-1-26-G
Serial Num	-	21812468
Type	UPBLAST	UPBLAST
Configuration	VERTICAL	VERTICAL

Test Data		
	Design	Actual
CFM	1500	1608
Fan RPM	1377	1068
Fan Rotation	-	CORRECT
Motor RPM	-	1068
RL Voltage	-	121
RL Amperage	-	1.6
Suction ESP	-	-0.43"
Discharge ESP	-	ATM
Total ESP	1.0"	0.43"

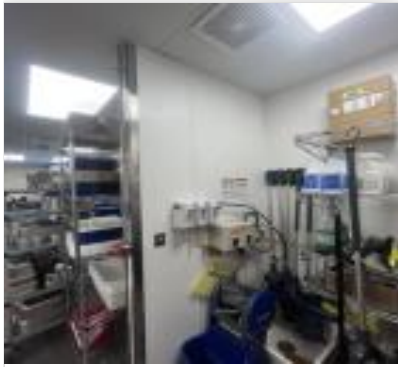
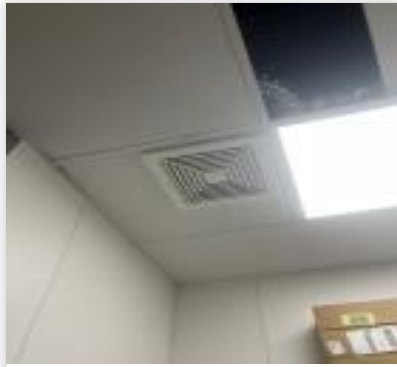
EF-1A
07/18/2023

Test Data		
	Design	Actual
CFM	75	72
Fan RPM	885	900
Fan Rotation	-	CORRECT
Motor RPM	-	900
System SetPt	-	MAX
RL Voltage	-	120
RL Amperage	-	0.7
Total ESP	0.125"	.091"
Fan Inlet SP	-	ATM
Fan Discharge SP	-	0.091"

[1] FAN IS CONTROLLED BY LIGHT SWITCH LOCATED UNDERNEATH FAN. SWITCH ALSO POWERS PRV-1 (RESTROOMS).

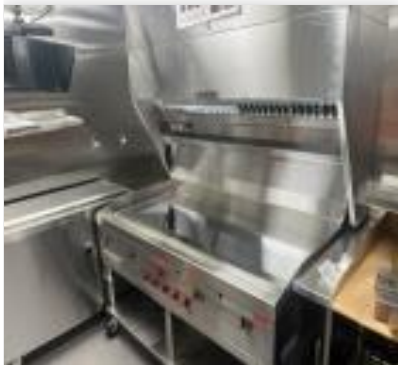
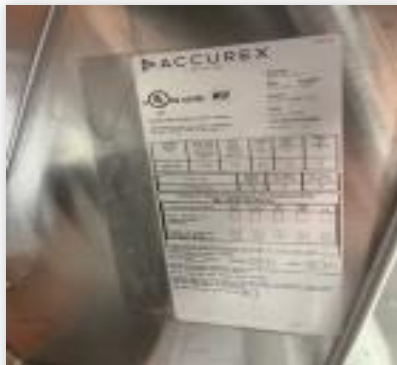
HD-1
07/18/2023

Unit Data		
	Design	Actual
MFG	ACCUREX	ACCUREX
Model Num	XGEP-64-S	XGEP-64-S
Job / Serial Num	-	21816229
Type	TYPE I	TYPE I
Hood length	64"	64"
Hood Width	23"	23"

Test Data Exhaust		
	Design	Actual
Filter Type	GREASE GBRABBER	GREASE GRABBER
Filter Size 1	16X16	16X16
Filter Qty 1	4	4
Filter AK factor size 1	1.53	1.53
Filter Total AK Area	6.12	6.12
Filter1 FPM	-	264
Filter2 FPM	-	226
Filter3 FPM	-	235
Filter4 FPM	-	266
Filter Ave FPM(corr)	-	247.75
CFM	1500	1516

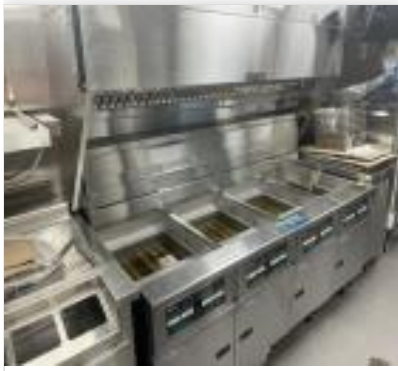
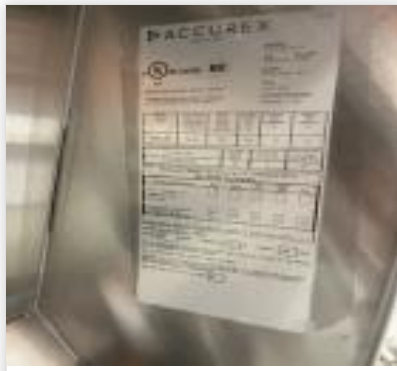
HD-2
07/18/2023

Unit Data		
	Design	Actual
MFG	ACCUREX	ACCUREX
Model Num	XXEP-83-S	XXEP-83-S
Job / Serial Num	-	21816228
Type	TYPE I	TYPE I
Hood length	83"	83"
Hood Width	24"	24"

Test Data Exhaust		
	Design	Actual
Filter Type	XTRACTOR	XTRACTOR
Filter Size 1	16X16	16X16
Filter Qty 1	5	5
Filter AK factor size 1	1.53	1.53
Filter Total AK Area	7.65	7.65
Filter1 FPM	-	206
Filter2 FPM	-	202
Filter3 FPM	-	210
Filter4 FPM	-	211
Filter5 FPM	-	222
Filter Ave FPM(corr)	-	210.2
CFM	1500	1608

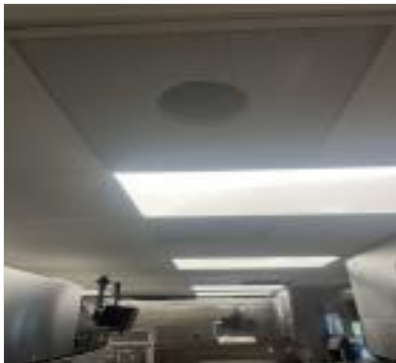
Perforatedcookline.jp..
07/18/2023

Perforated diffusers are installed on the cook line? (4-ways will disrupt hood capture)

Yes
