**Report: TAB Report**  
**Function: Test, Adjust, & Balance**  
**Date: 04/21/2025**  
**Completed By: National TAB**

## 04-14-25 CHIPOTLE #5397 MORGANTON, NC

Project: 04-14-25 CHIPOTLE #5397 MORGANTON, NC

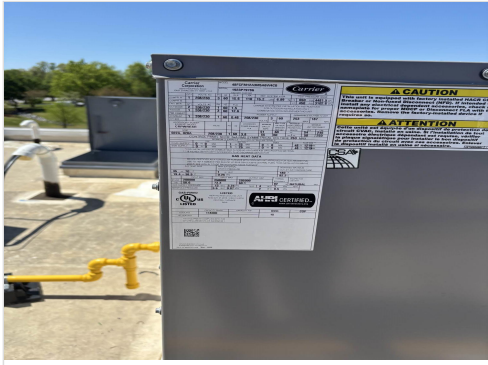
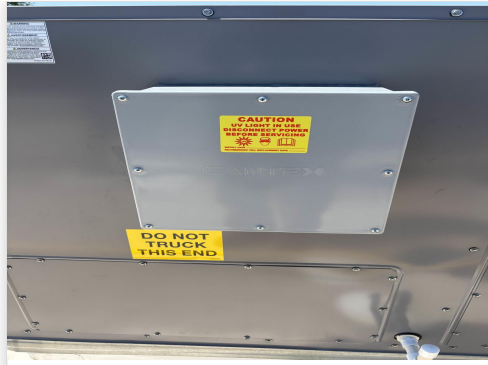
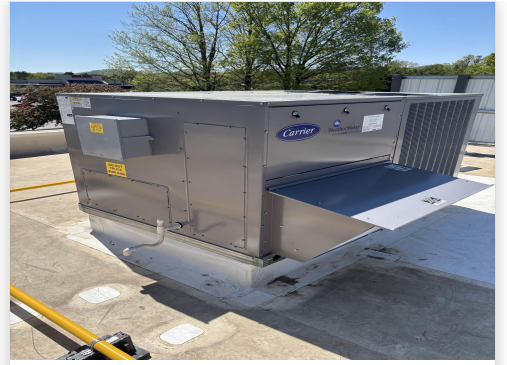
# Unit Data - PHOTO LOG

Asset: RTU1

AREA:KITCHEN

Unit Data		
	Design	Actual
MFG	CARRIER	CARRIER
Serial Num	-	1923P79786
Model Num	48FC_M11	48FCFM12A3M5A6W4C0
Type	RTU	RTU
Configuration	VERTICAL	VERTICAL
Num OA Filters 1	-	1
OA Filter Size 1	-	35X20
Num Final Filter 1	-	4
Final Filter Size 1	-	20X20X2

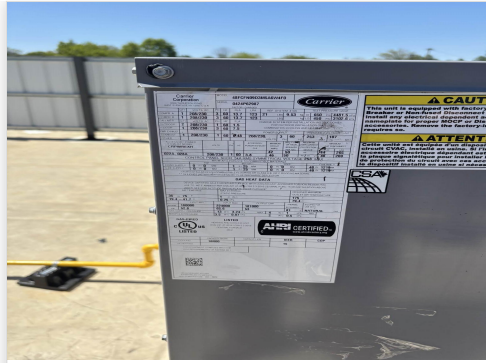
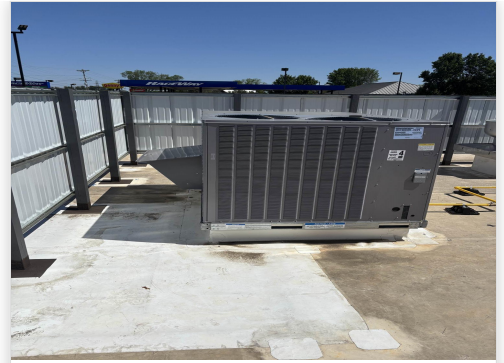
# Unit Data - PHOTO LOG

Asset: RTU2

AREA:DINING

Unit Data		
	Design	Actual
MFG	CARRIER	CARRIER
Serial Num	-	0424P62987
Model Num	48FC_M09	48FCFN09D3M5A6W4F0
Type	RTU	RTU
Configuration	VERTICAL	VERTICAL
Num OA Filters 1	-	1
OA Filter Size 1	-	35X20
Num Final Filter 1	-	4
Final Filter Size 1	-	20X20X2

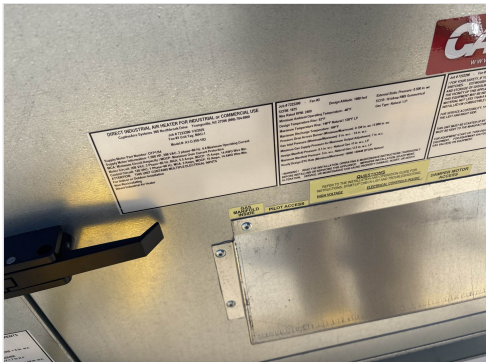
### Unit Data - PHOTO LOG

Asset: MAU1

AREA:HOOD

Unit Data		
	Design	Actual
MFG	CAPTIVEAIRE	CAPTIVEAIRE
Model Num	A1-D.250-15D	A1-D.250-15D
Serial Num	-	7222290
Type	MAU	MAU
Configuration	VERTICAL	VERTCAL

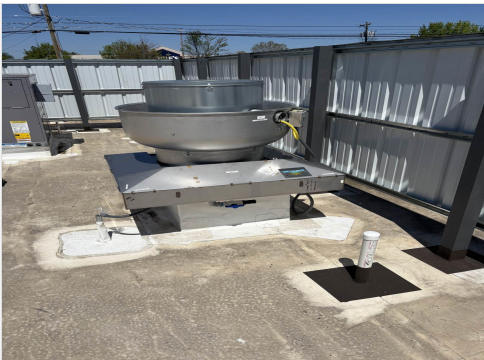
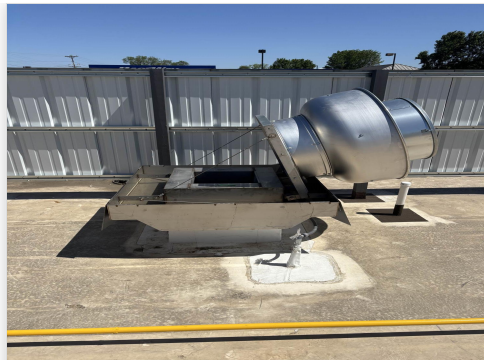
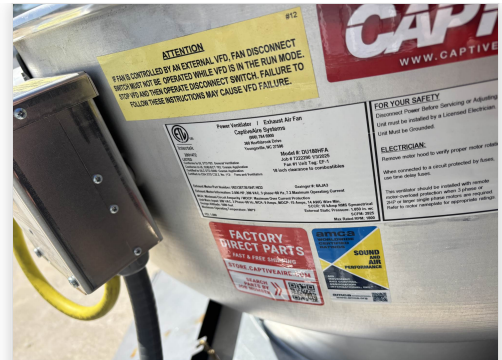
## Unit Data - PHOTO LOG

Asset: EF1

AREA: KITCHEN

Unit Data		
	Design	Actual
MFG	CAPTIVEAIRE	CAPTIVEAIRE
Model Num	DU180HFA	DU180HFA
Serial Num	-	7222290
Type	UPBLAST	UPBLAST
Configuration	VERTICAL	VERTICAL
