Report: TAB Report
Function: Test, Adjust, & Balance
Date: 04/21/2025
Completed By: National TAB

04-14-25 CHIPOTLE #5397 MORGANTON, NC

Project: 04-14-25 CHIPOTLE #5397 MORGANTON, NC

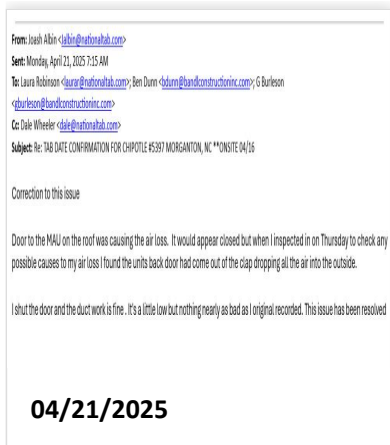
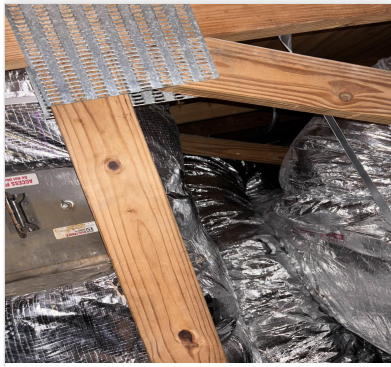
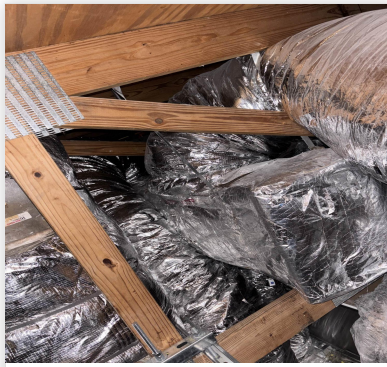
Issue Name : MUA low flow
Description : MAU is not providing adequate air to the hood according to plans. unit calls for 1675 and is pulling 1823 on the roof, however discharge at the hood is 948. technician believes this is due to all of the runs coming off the top of the MAU main, making the duct have to fill with air before its able to attempt to satisfy the diffusers.

- **04/21/2025 National TAB - Will Turnbough**
 - See Ash's email

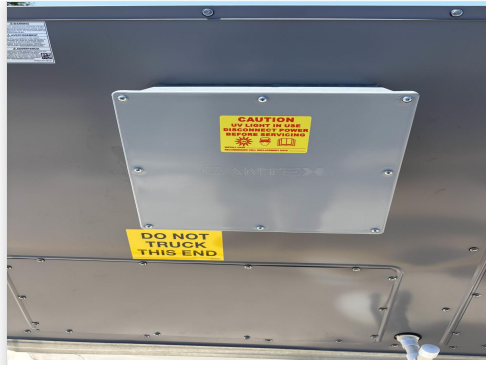
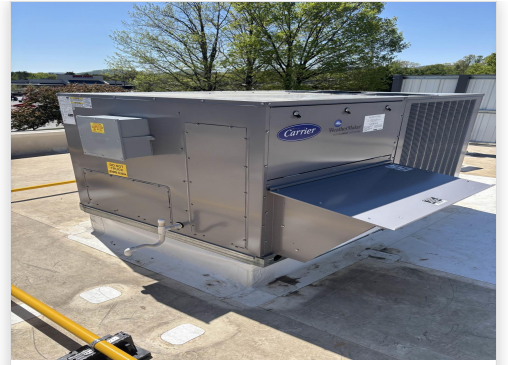
Unit Data - PHOTO LOG

Unit Data		
	Design	Actual
MFG	CARRIER	CARRIER
Serial Num	-	1923P79786
Model Num	48FC_M11	48FCFM12A3M5A6W4C0
Type	RTU	RTU
Configuration	VERTICAL	VERTICAL
Num OA Filters 1	-	1
OA Filter Size 1	-	35X20
Num Final Filter 1	-	4
Final Filter Size 1	-	20X20X2

Test Data		
	Design	Actual
SF CFM	3500	3318
SF RPM	-	DD
RA CFM	3000	2798
OA CFM	500	520
RL Voltage	-	210/211/212
RL Amperage	-	7.2/7.8/7.6
SF Rotation	-	CCW
SF System SetPt	-	80%
RA Damper Position	-	80%
Min OA Damper Position	-	4.35(VDC)
Min OA Damper Type	-	ES5
OA Enthalpy Setpt	-	MIN

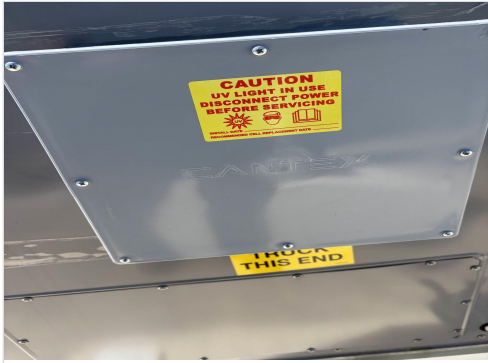
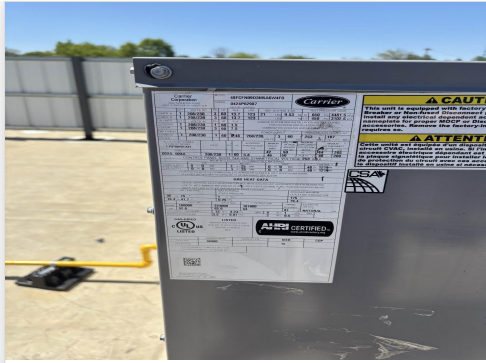
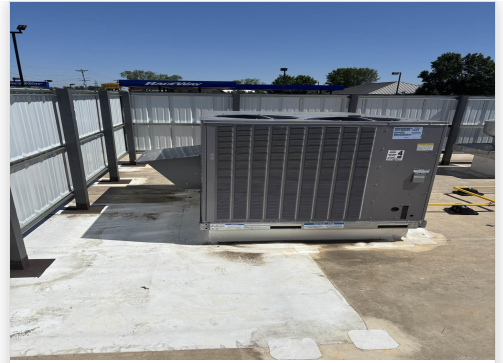
Unit Data - PHOTO LOG

Unit Data		
	Design	Actual
MFG	CARRIER	CARRIER
Serial Num	-	0424P62987
Model Num	48FC_M09	48FCFN09D3M5A6W4F0
Type	RTU	RTU
Configuration	VERTICAL	VERTICAL
Num OA Filters 1	-	1
OA Filter Size 1	-	35X20
Num Final Filter 1	-	4
Final Filter Size 1	-	20X20X2

Test Data		
	Design	Actual
SF CFM	3400	3375
SF RPM	-	DD
RA CFM	2400	2318
OA CFM	1000	1057
RL Voltage	-	210/211/212
RL Amperage	-	7.0/7.1/6.9
SF Rotation	-	CCW
SF System SetPt	-	90%
RA Damper Position	-	70%
Min OA Damper Position	-	30%/5.65(VDC)
Min OA Damper Type	-	ODB
OA Enthalpy Setpt	-	ES5

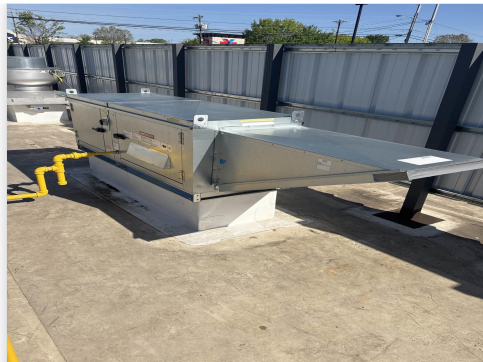
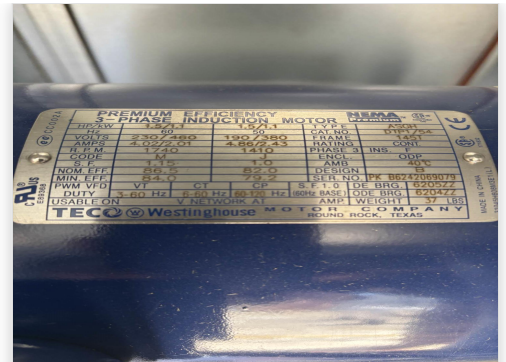
Unit Data - PHOTO LOG

Unit Data		
	Design	Actual
MFG	CAPTIVEAIRE	CAPTIVEAIRE
Model Num	A1-D.250-15D	A1-D.250-15D
Serial Num	-	7222290
Type	MAU	MAU
Configuration	VERTICAL	VERTCAL

Test Data		
	Design	Actual
CFM	1675	1527
SF RPM	-	DD
Motor RPM	-	58Hz
SF System SetPt	-	58Hz
RL Voltage	-	210/211/211
RL Amperage	-	3.5/3.3/3.4

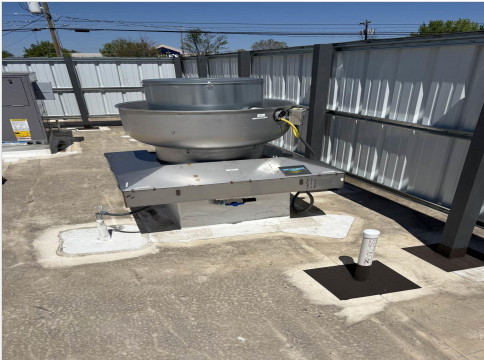
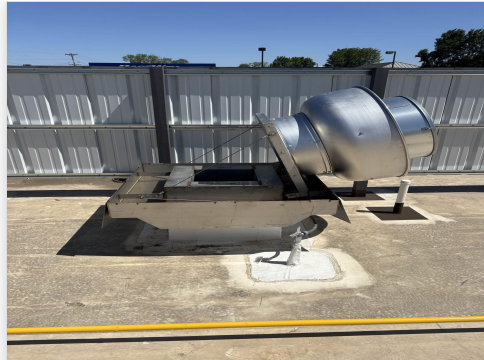
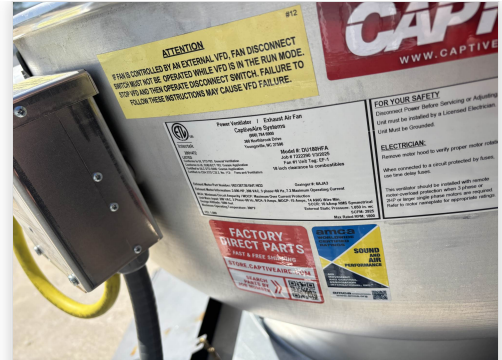
Unit Data - PHOTO LOG

Unit Data		
	Design	Actual
MFG	CAPTIVEAIRE	CAPTIVEAIRE
Model Num	DU180HFA	DU180HFA
Serial Num	-	7222290
Type	UPBLAST	UPBLAST
Configuration	VERTICAL	VERTICAL

Test Data		
	Design	Actual
CFM	2925	2877
Fan RPM	-	DD
Fan Rotation	-	CCW
Motor RPM	-	DD
System SetPt	-	48hZ(VFD)
RL Voltage	-	210/211/211
RL Amperage	-	5.4/5.2/5.2
Total ESP	1.2"	1.12"
Fan Inlet SP	-	-1.12"
Fan Discharge SP	-	ATM

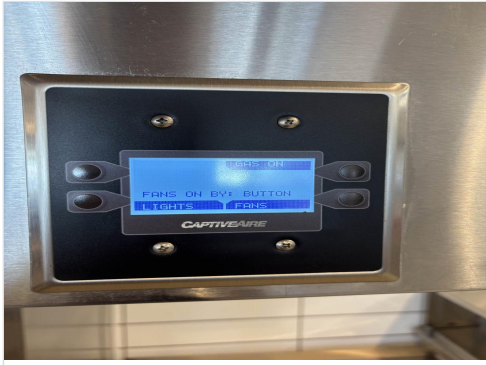
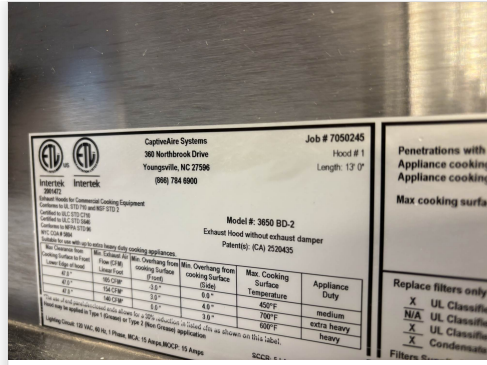
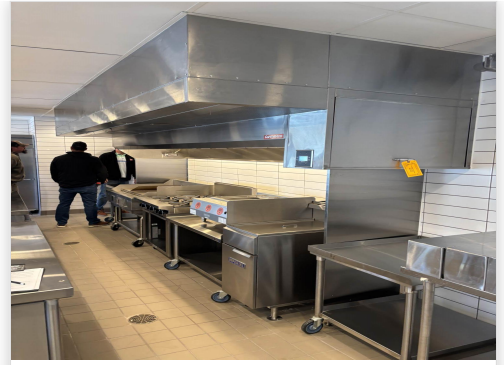
Unit Data - PHOTO LOG

Unit Data		
	Design	Actual
MFG	CAPTIVEAIRE	CAPTIVEAIRE
Model Num	5424 ND-2-ACPSP-F	5424 ND-2-ACPSP-F
Job / Serial Num	-	7050245
Type	TYPE 1 CANOPY	TYPE I
Hood length	153"	156"
Hood Width	54"	61/36
Supply Plenum Type	-	ACPSP
Supply Plenum Width	9"	14"
Supply Plenum Length	165"	166"

Test Data Exhaust		
	Design	Actual
Filter Type	CAPTRATE SOLO	CAPTRATESOLO
Filter Size 1	16X16	16X16
Filter Qty 1	9	9
Filter AK factor size 1	1.62	1.62
Filter Total AK Area	14.58	14.58
Filter1 FPM	-	176
Filter2 FPM	-	213
Filter3 FPM	-	231
Filter4 FPM	-	232
Filter5 FPM	-	204
Filter6 FPM	-	191
Filter7 FPM	-	171
Filter8 FPM	-	166
Filter9 FPM	-	192
Filter10 FPM	-	
Filter11 FPM	-	
Filter12 FPM	-	
Filter Ave FPM(corr)	-	197
CFM	2925	2877
