**National TAB  
1329 E. KEMPER ROAD  
SUITE 4210  
CINCINNATI, OH 45246**

**Report: TAB REPORT  
Function: Test, Adjust, & Balance  
Date: 04/13/2023**

**PROJECT  
04-10-23 CULVERS - WASHINGTON, MI**

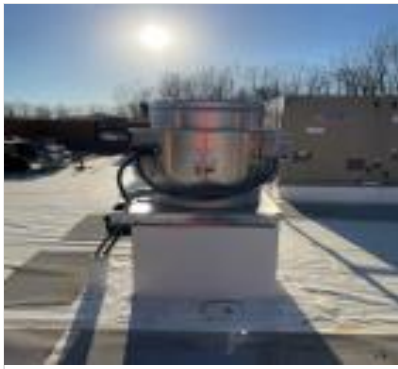
PRV-3

Notes: FAN 2 CFM OUT OF TOLERANCE, SET AT LOWEST POSSIBLE VCD SETTING

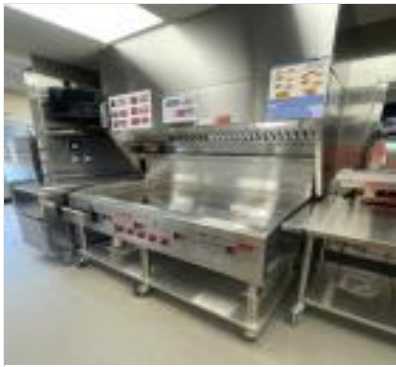
HOOD 1

List equipment turned on for testing	GRIDDLE
List smoke candle type used	S102
Smoke test capture - Perimeter of hood	YES
<ul style="list-style-type: none"> <li><a href="#">Open</a> SmokecaptureHD1.MOV</li> </ul>	
Smoke test capture - Top of cooking surface	YES, VIDEOS UPLOADED TO OTHER CATEGORY

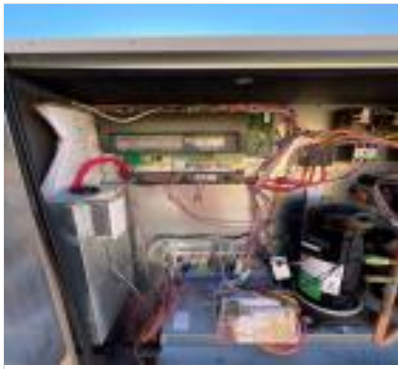
RTU-1BoardWiring.jpeg

PRODIGY BOARD WIRING

Parameter 65 set to 0	YES
Parameter 78 set to 0	YES
Parameter 105 set to 6	YES
Parameter 156 set to 70 (Dining unit only)	YES
Parameter 156 set to 65 (Kitchen Unit Only)	YES
Parameter 170 set to 75 (Dining Unit Only)	YES
Parameter 170 set to 70 (Kitchen Unit Only)	YES
Parameter 131 set to the same % as OA minimum position?	YES
Parameter 117 set to the same % as OA minimum position?	YES
