**Report: Final TAB Report
Function: Test, Adjust, & Balance
Date: 8/24/2022**

**PROJECT
08-08 PENN STATION - SPRINGFIELD, OH**

Project: 08-08 PENN STATION - SPRINGFIELD, OH

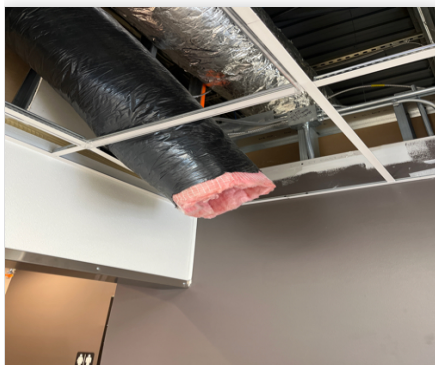
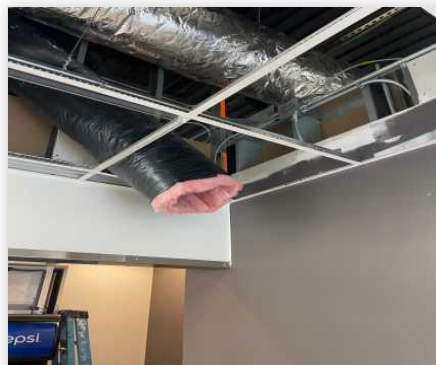
MISSING_DIFFUSER.jpg

Issue Name : Diffuser missing

Description : One air duct is missing a diffuser in the kitchen. (diffuser 1-8)

Review Plan Review Checklist, has it been signed off and meets our standards to start balancing? If not contact processor to ensure job is ready.	YES
All diffusers and grilles are installed and match design?	NO - ISSUES MADE (DIFFUSER 1-8 MISSING AS WELL AS BATHROOM EXHAUST FAN)
All hood filters installed and accounted for?	YES
Hoods are wired and have power?	YES
Hood is free of alarms?	NO B2 LIGHTING ERROR IS STILL PRESENT
Thermostats have power?	YES
Have trades/general contractor been notified about any issues and are they created on FaciliBuild?	YES

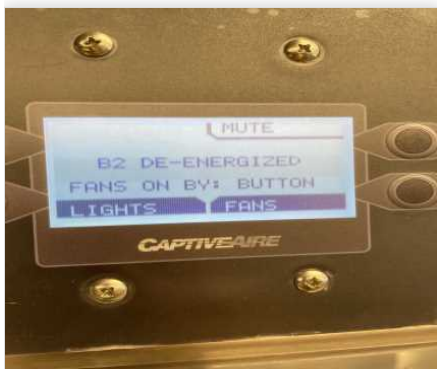
B2_PIC.jpg

Issue Name : LIGHT CONTROLS DAISY CHAINED TOGETHER
Description : GRIDDLE LIGHT CONTROLS ARE CONTROLLED BY FRYER CONTROLS (B2 DE-ENERGIZED ERROR)
Created By : National TAB **Assigned To :** National TAB - Joe Hertenstein
Status : Open
Originated Date : 08/09/2022 - Jack Bain - National TAB

- **08/10/2022 National TAB - Joe Hertenstein**
 - VERIFY IF B2 & W2 ENERGIZE (USING VOLT METER) WITH LIGHT ON / OFF. IF NOT, POWER B2 FROM H1 & W2 FROM N1. THEN POWER GRIDDLE LIGHTS FROM B2 & W2 & B1 & W1 TO GO TO FRYER HOOD. TO BE DONE BY ELECTRICIAN

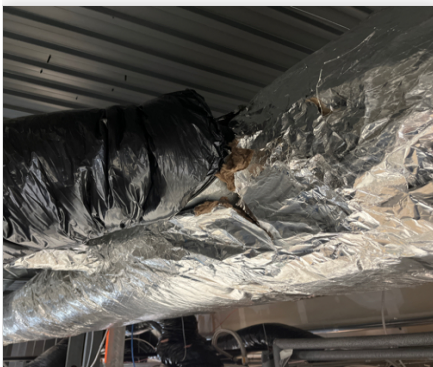
Issue Name : No damper

Description : No damper on diffuser 2-4

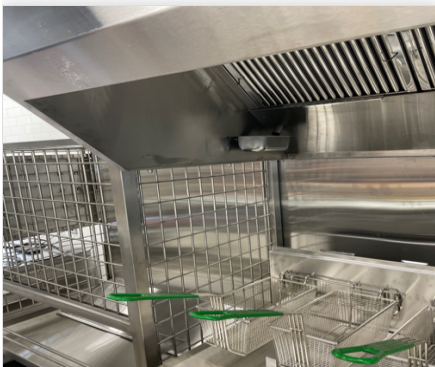
Issue Name : No end panel on hood 3

Description : No end panel on hood 3

Performance Data		
	Design	Actual
Exh-Supply Net CFM	183	150
Smoke Generation Type	-	45 Second
Cooking Equip Heat On	-	No
Hood Capture %	-	99%
End Panels Installed (Y/N)	-	No
Riser Temp F (idle) Riser 1	-	71
Ambient Room Temp	-	72
