**Report: Final TAB Report
Function: Test, Adjust, & Balance
Date: 8/24/2022**

**PROJECT
08-08 PENN STATION - SPRINGFIELD, OH**

Project: 08-08 PENN STATION - SPRINGFIELD, OH

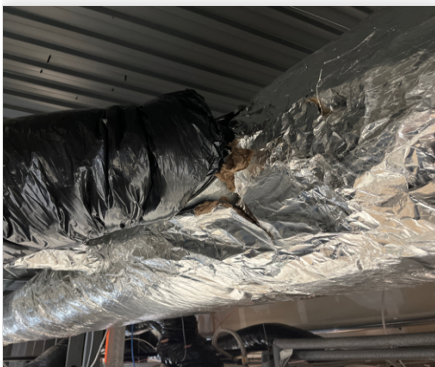
Issue Name : No damper
Description : No damper on diffuser 2-4
Created By : National TAB **Assigned To :** National TAB - Joe Hertenstein
Status : Open
Originated Date : 08/10/2022 - Jack Bain - National TAB

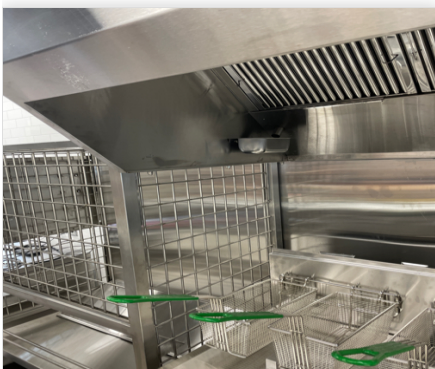
Issue Name : No end panel on hood 3

Description : No end panel on hood 3
