**Report: Final TAB Report
Function: Test, Adjust, & Balance
Date: 08/24/2022**

**PROJECT
08-08 PENN STATION - SPRINGFIELD, OH**

**C&T DESIGN
4025 PORT UNION RD.
FAIRFIELD, OH 45014**

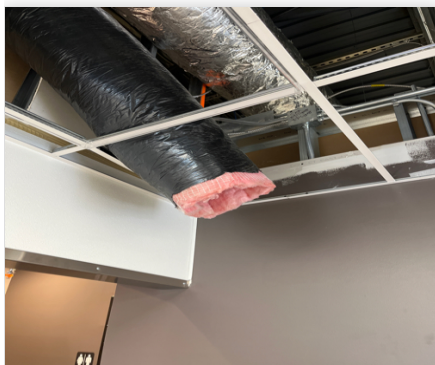
MISSING_DIFFUSER.jpg

Issue Name : Diffuser missing

Description : One air duct is missing a diffuser in the kitchen. (diffuser 1-8)

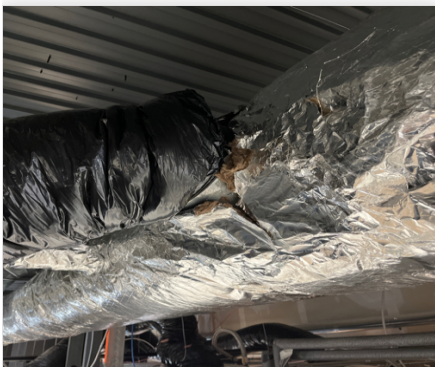
Issue Name : No damper

Description : No damper on diffuser 2-4

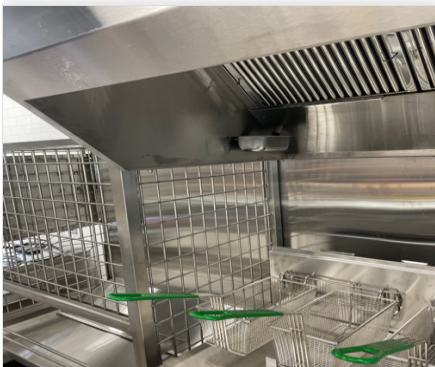
Issue Name : No end panel on hood 3

Description : No end panel on hood 3

Performance Data		
	Design	Actual
Exh-Supply Net CFM	183	150
Smoke Generation Type	-	45 Second
Cooking Equip Heat On	-	No
Hood Capture %	-	99%
End Panels Installed (Y/N)	-	No
Riser Temp F (idle) Riser 1	-	71
Ambient Room Temp	-	72

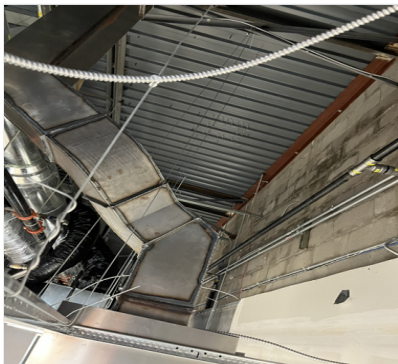
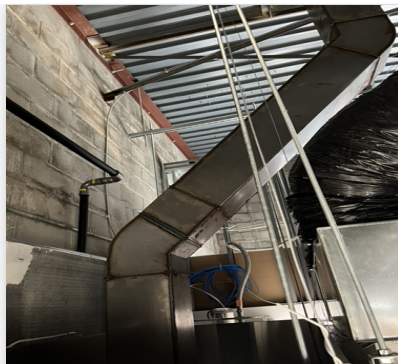
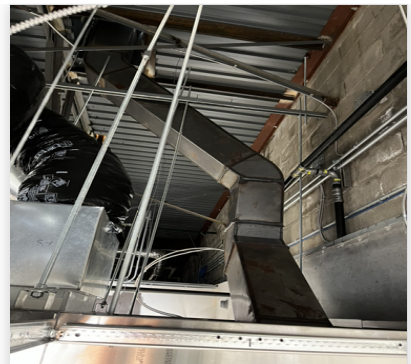
Grease Duct

Rotation is correct?	YES
Belts are tight?	N/A
Grease cup installed on hood fan?	Yes
Hinge kit installed installed on hood fan?	Yes
Lean fan back. Is grease duct installation adequate and is duct ran all the way to the base of the fan?	Yes
