**Report: Final TAB Report  
Function: Test, Adjust, & Balance  
Date: 8/24/2022**

**PROJECT  
08-08 PENN STATION - SPRINGFIELD, OH**

Project: 08-08 PENN STATION - SPRINGFIELD, OH

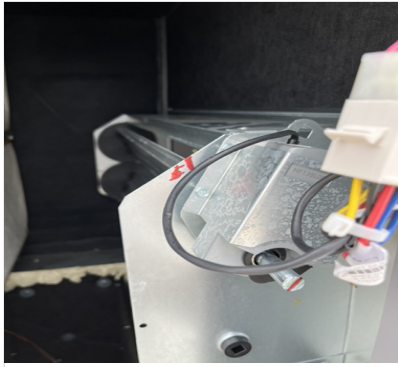
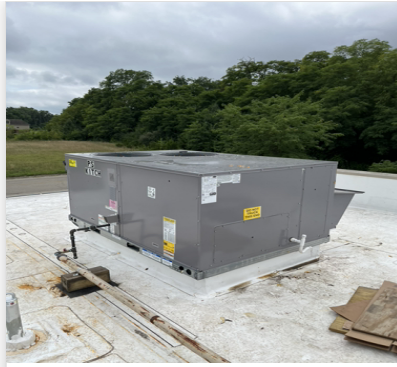
RTU-2

Test Data		
	Design	Actual
SF CFM	3000	2937
SF RPM (Initial)	-	758
SF RPM	-	758
RA CFM	2250	2139
OA CFM	750	798
RL Voltage	-	208-206-208
RL Amperage	-	5.9-5.6-4.9
SF Rotation	-	Counterclockwise
RA Damper Position	-	Open
OA Damper Position	-	7/8"
OA Damper Type	-	Motorized outside air damper
Min OA Damper Position	-	7/8"

Performance Data		
	Design	Actual
MA Plenum SP	-	-0.266
Fan Suction SP	-	-0.467
Fan Discharge SP	-	0.795
Total ESP	-	1.061
Fan Total SP	-	1.262

General		
	Design	Actual
Unit free of Damage	-	Yes
Unit Completely Assembled	-	Yes
Unit Leveled	-	Yes
Curb & Unit Installed Air Tight	-	Yes
Controls Complete	-	No
Unit Filters Clean	-	Yes
Evap Coil Clean	-	Yes
Condensor Coil Clean	-	Yes
Condensor Fins Straight	-	Yes
Condensate Drain Installed	-	Yes
