TAB PUNCHLIST - Sep 19, 2024

L04358_Roseville FSU (MI)

32061 Gratiot Avenue, Roseville, Michigan

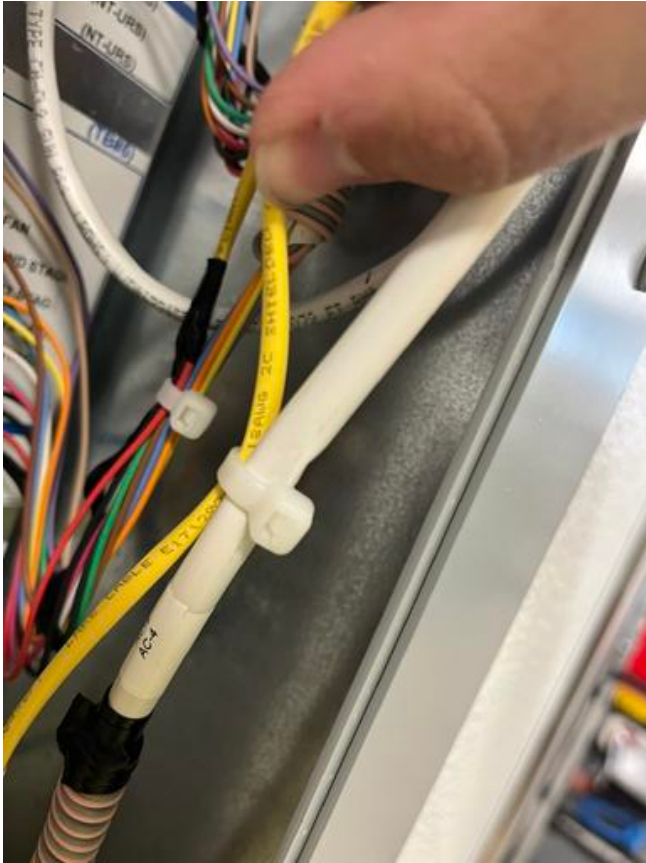
IMG_9137

Description
Thermostat cabling is I not 18awg 12 conductor ConnectAir W1812C-2148 and / or sensor cable is not ConnectAir W221P-2003NT cable. Full spec and ordering at: NetworkThermostat.com/CFA

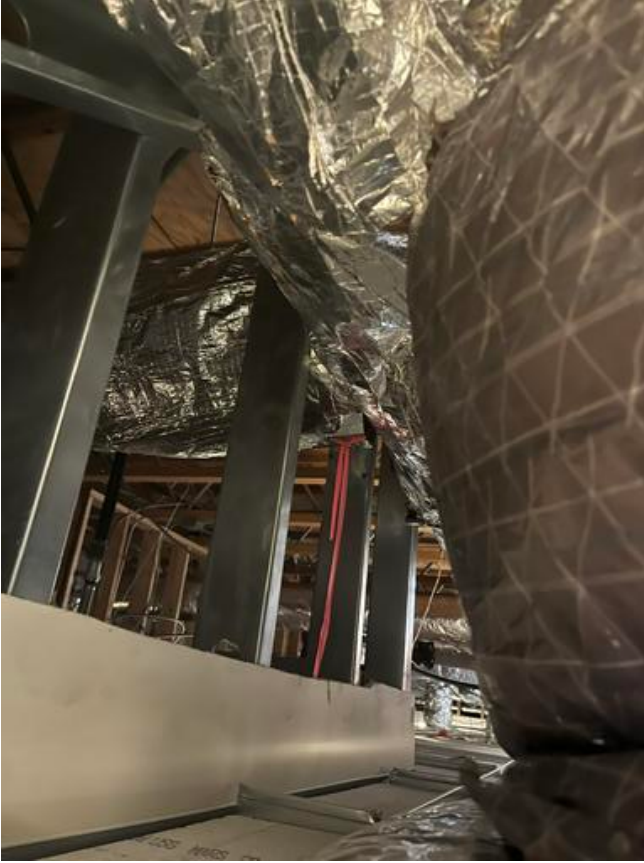
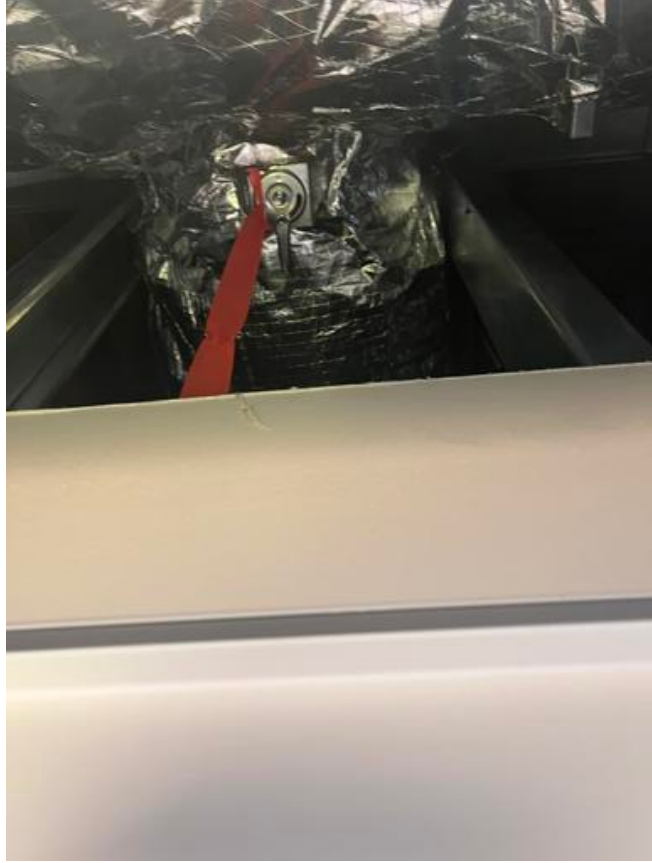
Dampers to be installed parallel to airflow. In horizontal runs, position damper on left or right at 9 or 3 o'clock. On vertical ducts position damper on bottom only (6 o'clock). Only found on one branch and branch is between two metal studs.

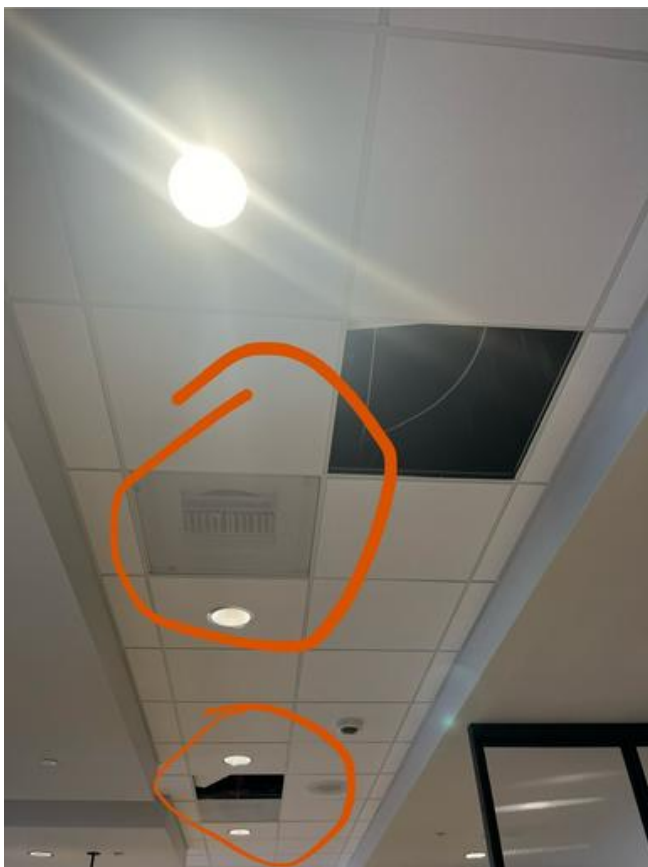
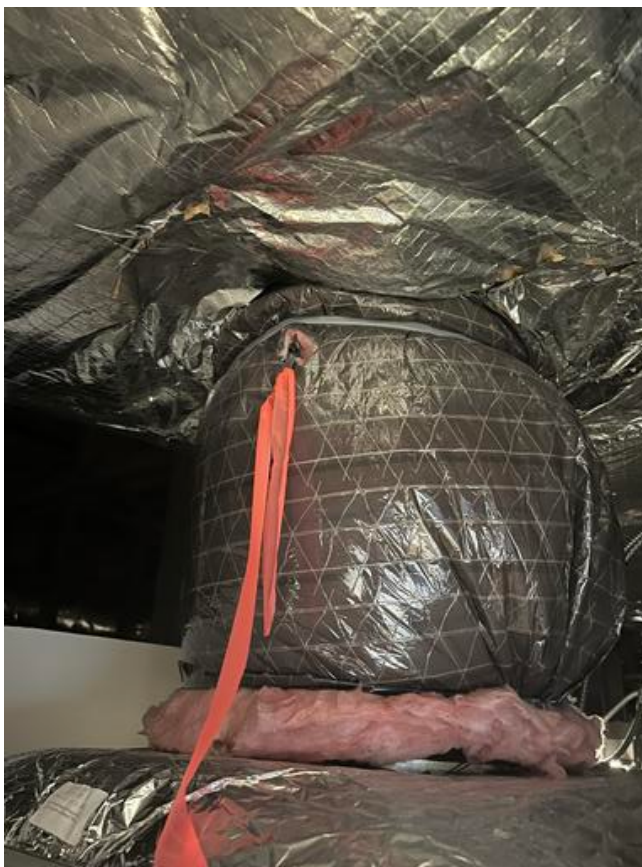
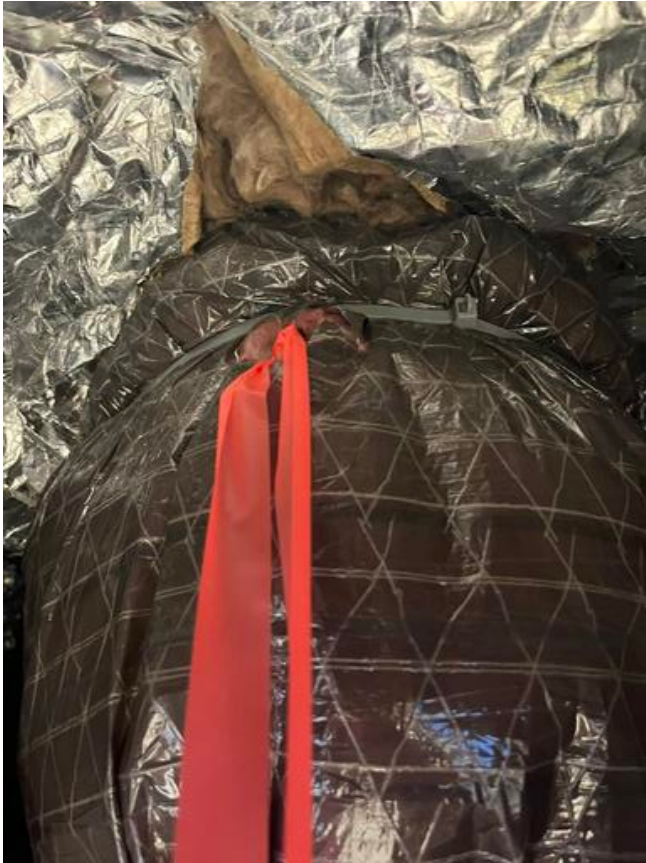
Dampers observed of wrong type with incorrect standoff. Contact national account provider for replacements.

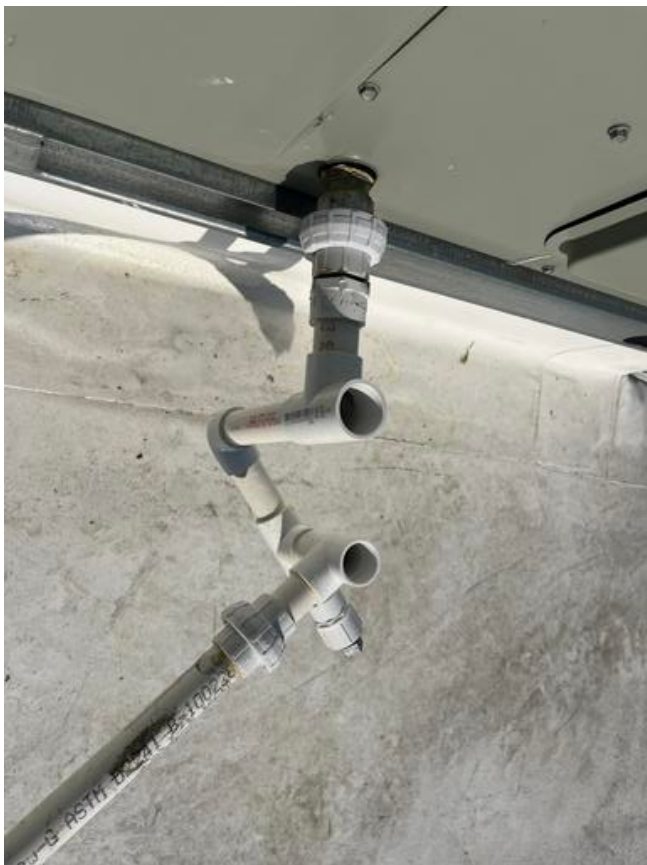
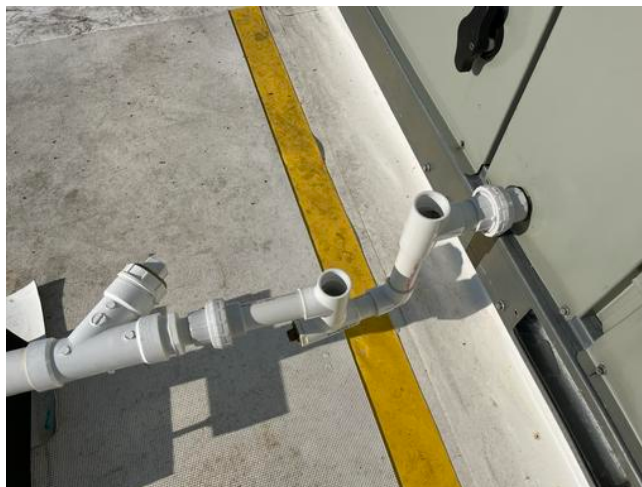
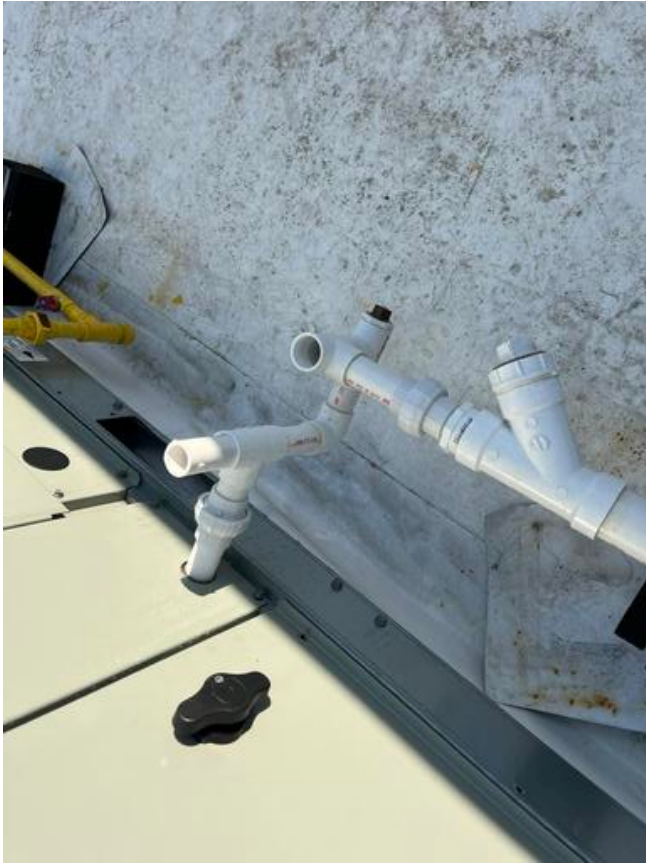
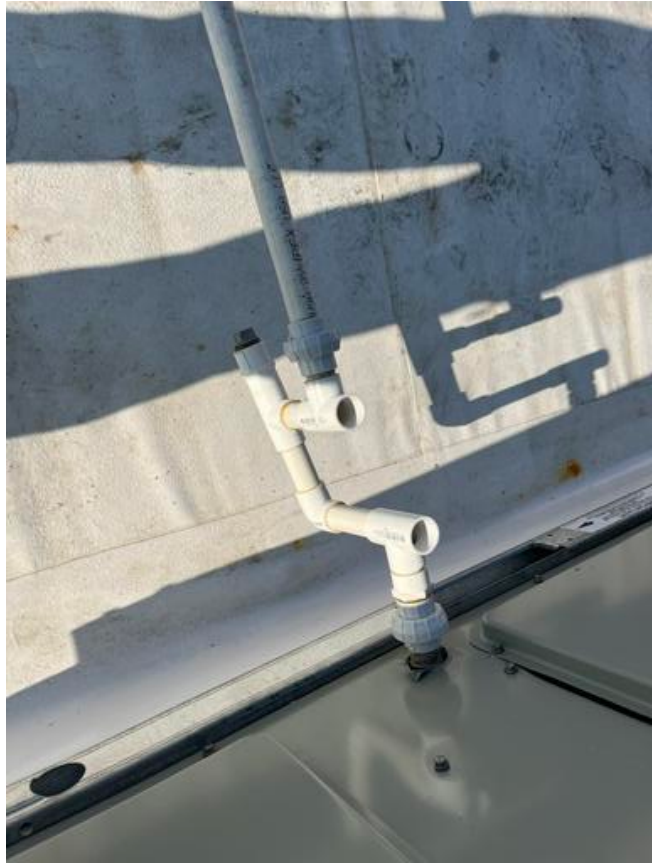
Equipment condensate piping or p-trap is not constructed per normal CFA specifications. It is causing excess condensation on the units.

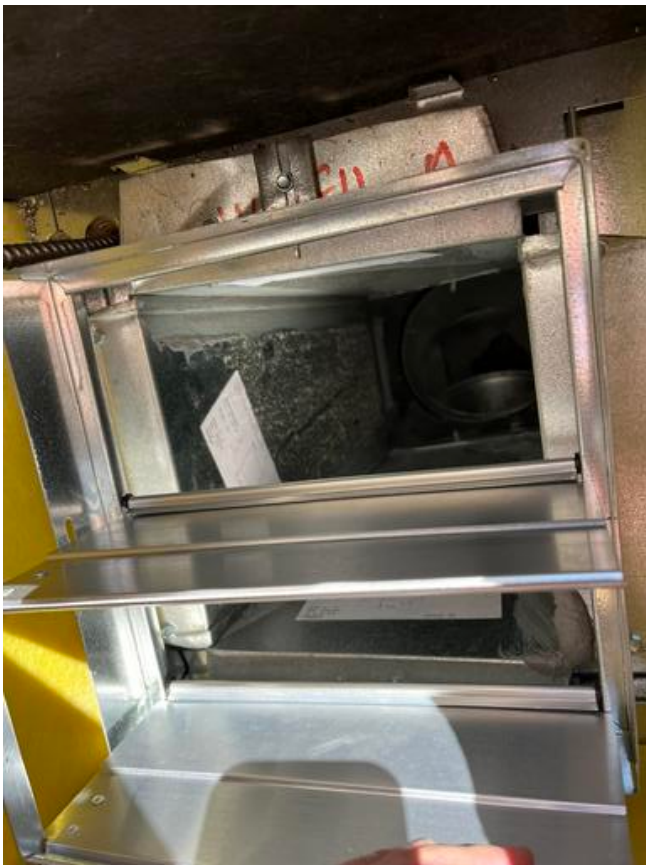
IMG_9103

Restroom exhaust rectangular duct riser not correctly lined per specification and/or is missing backdraft damper.

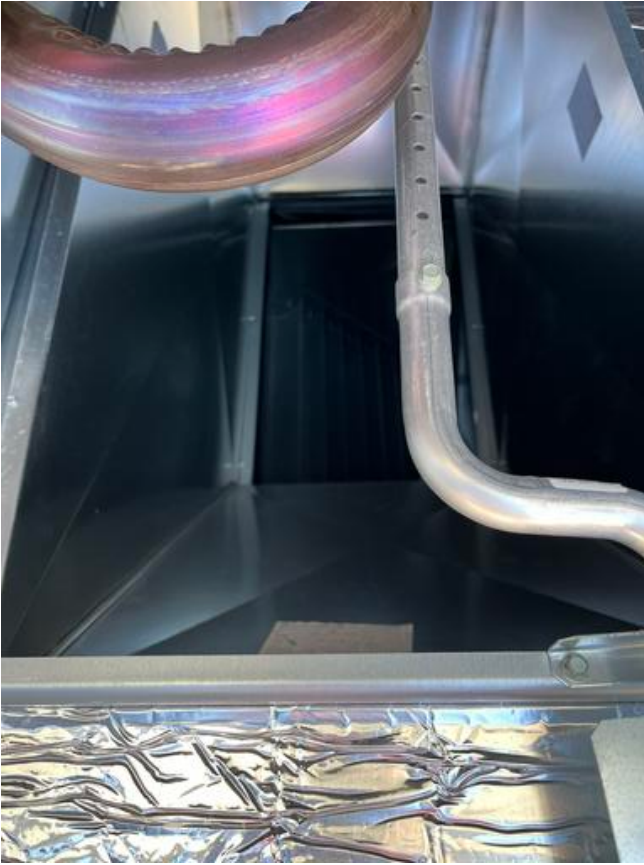
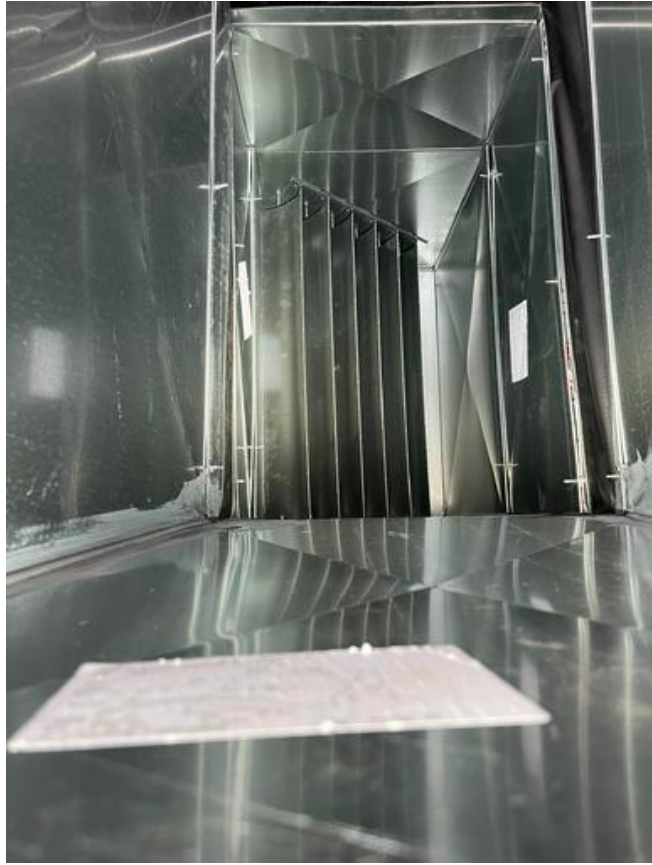
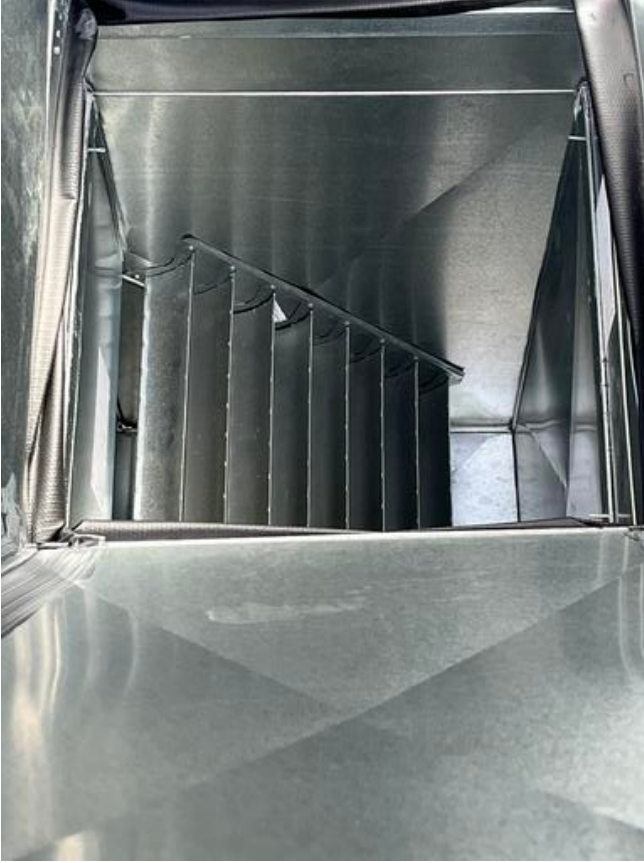
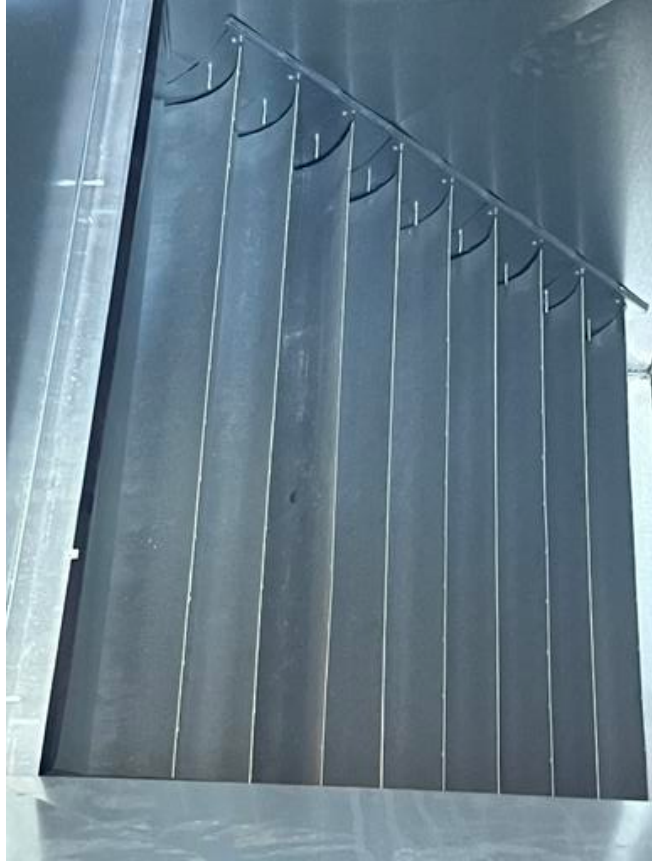
Double thickness turning vanes are present in the system. Per specification only single thickness are to be installed in 90 degree turns where any dimension is greater than 12". Duct is not designed to accommodate the static drop across double thickness vanes. Remove and replace. Unable to balance system until corrected.

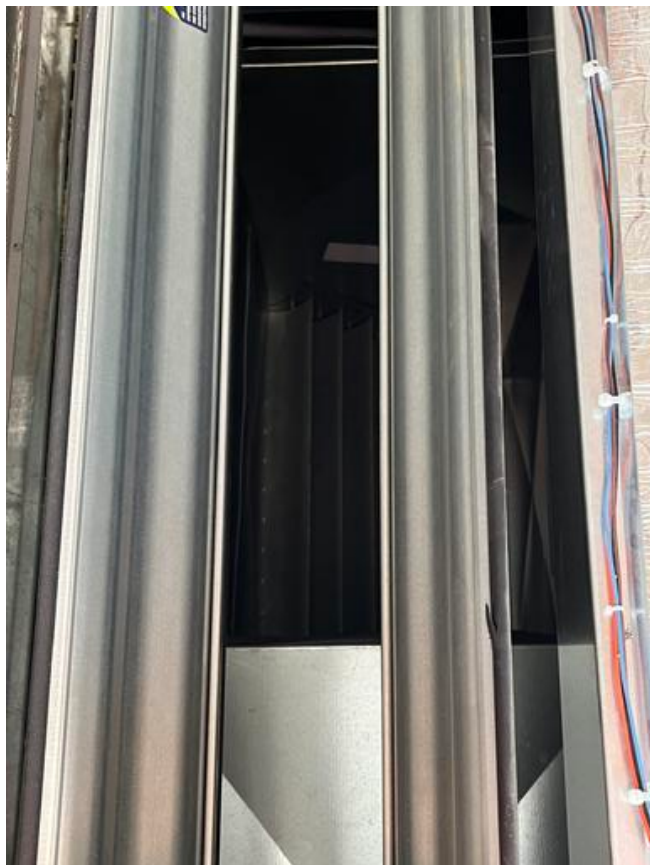
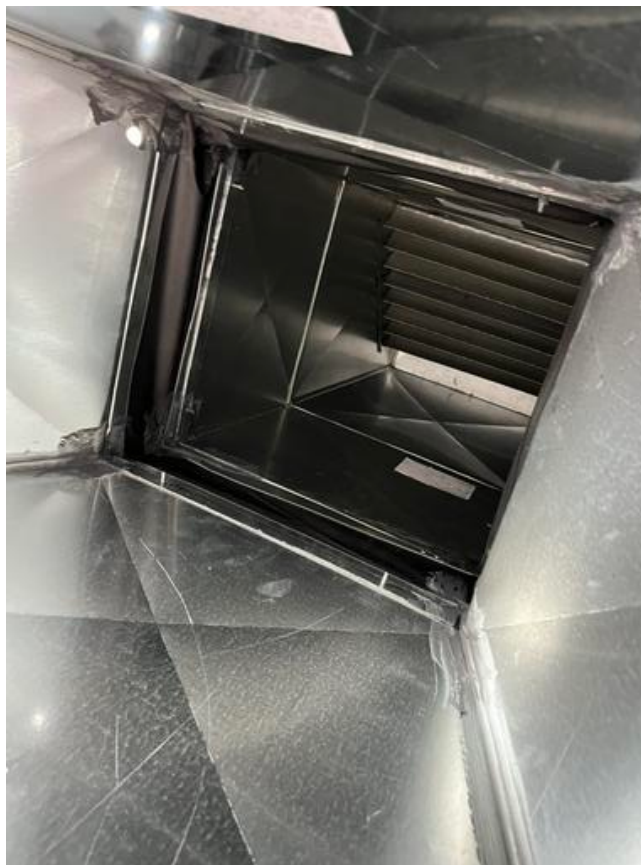
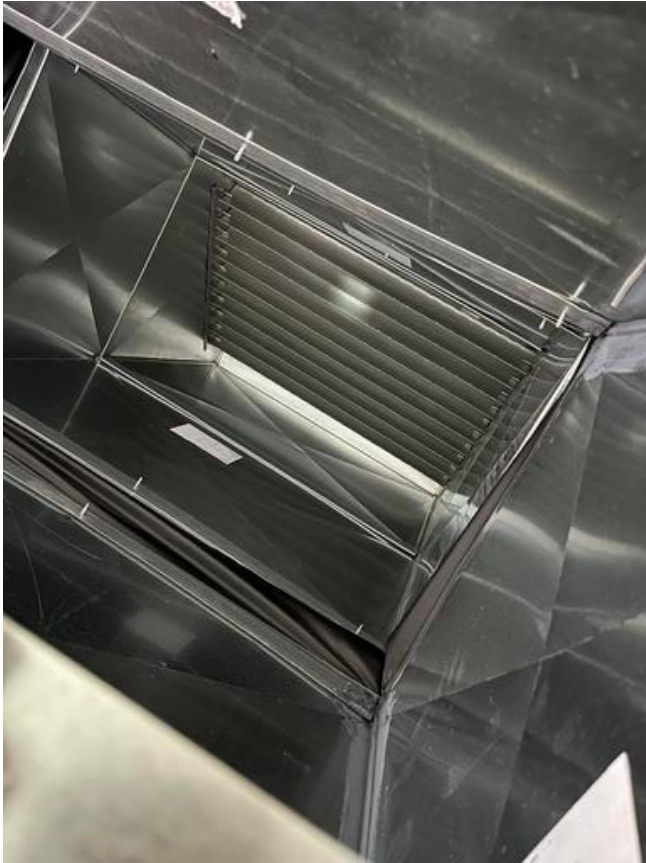
Description
Turning vanes are present in the return duct and need to be removed per specification. Only present in returns for AC2, AC3, and AC4

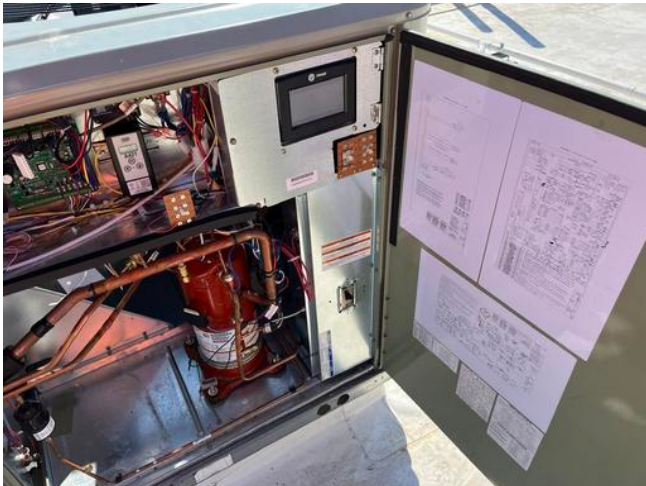
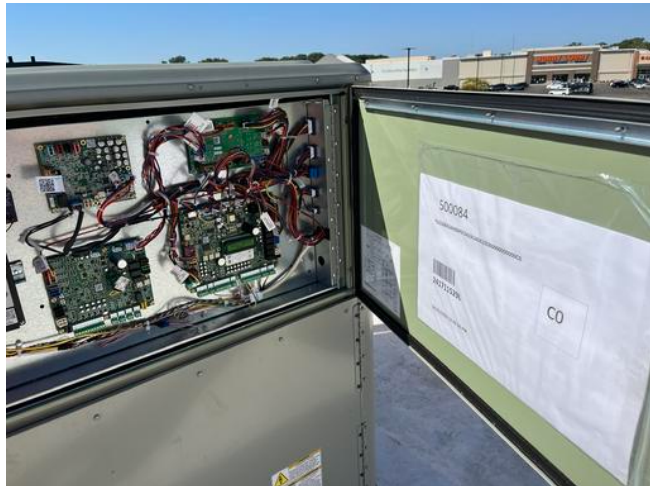
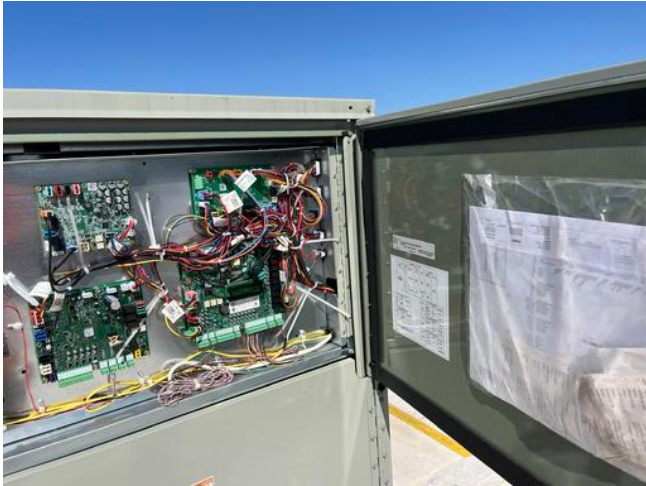
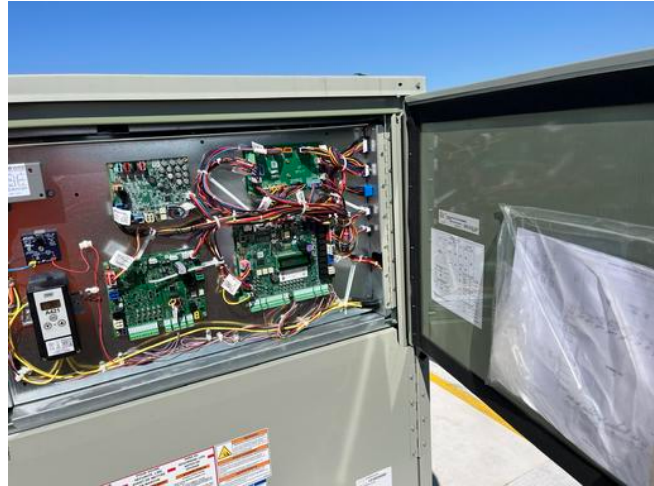
Equipment missing
laminated copy of controls
detail low voltage wiring
diagrams.

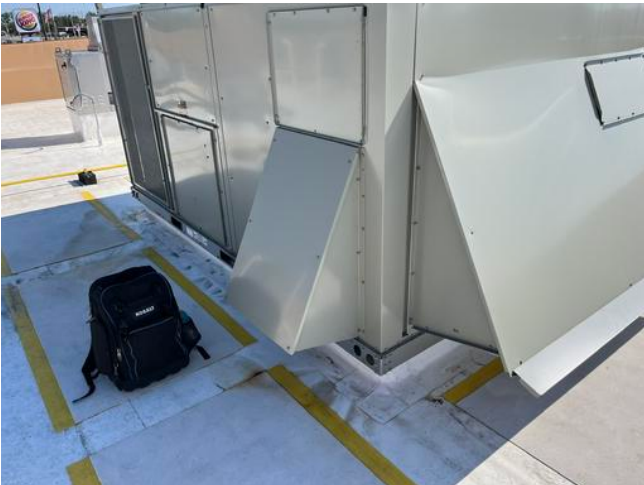
IMG_9086

Equipment is missing options from schedule design (power exhaust, barometric relief, correct economizer enthalpy type) or accessories of said options (additional hood assemblies). AC1 is supposed to have powered exhaust that is not installed.

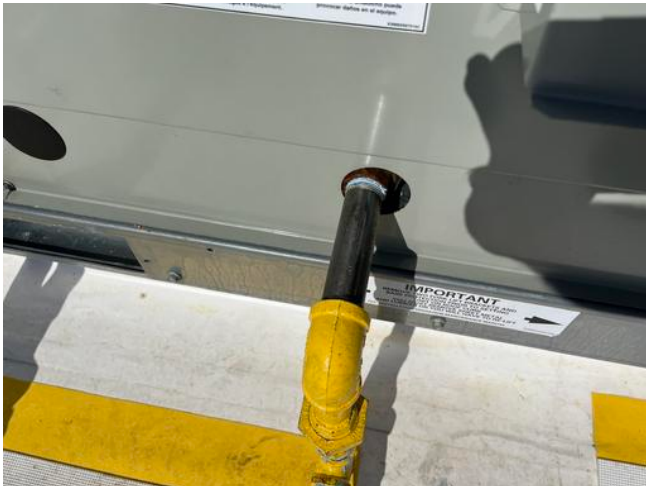
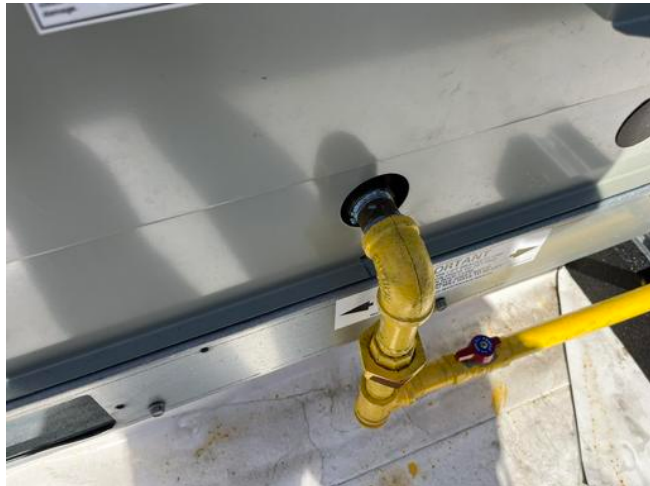
Description
AC gas inlet grommet is missing at the gas line/RTU penetration point. Only missing on AC1 and AC3

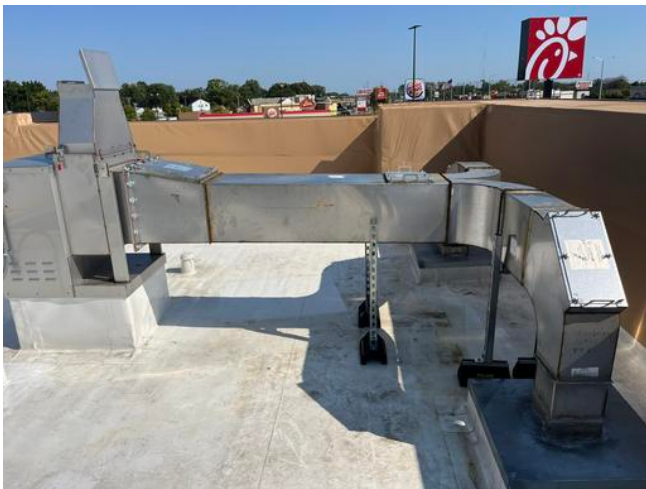
IMG_9074

Exhaust fan G2 Drip Guard is not installed correctly or is missing.

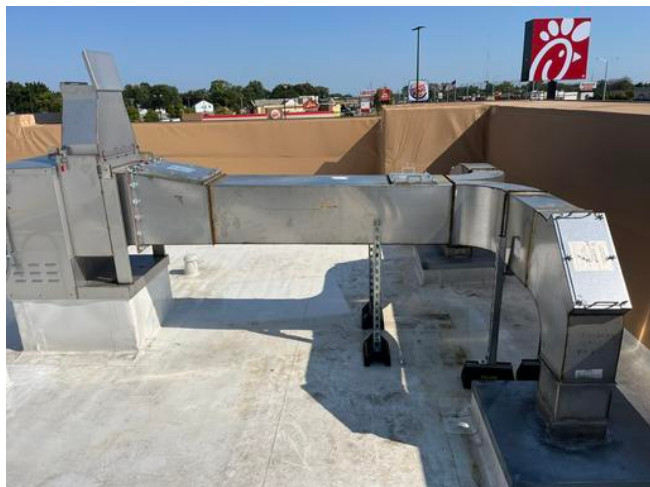
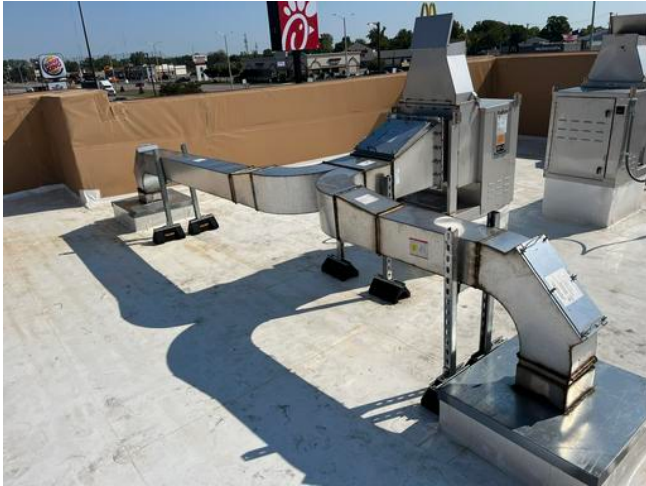
Exposed grease exhaust duct is to be painted per specification on kitchen hood exhaust fan detail.

Currently the exhaust is stainless steel not requiring painting

According to M-001, Stainless steel does not get painted and the exhaust ductwork is stainless.

According to Bryan from Cushman, duct should still be painted as it is galvanized and not stainless.

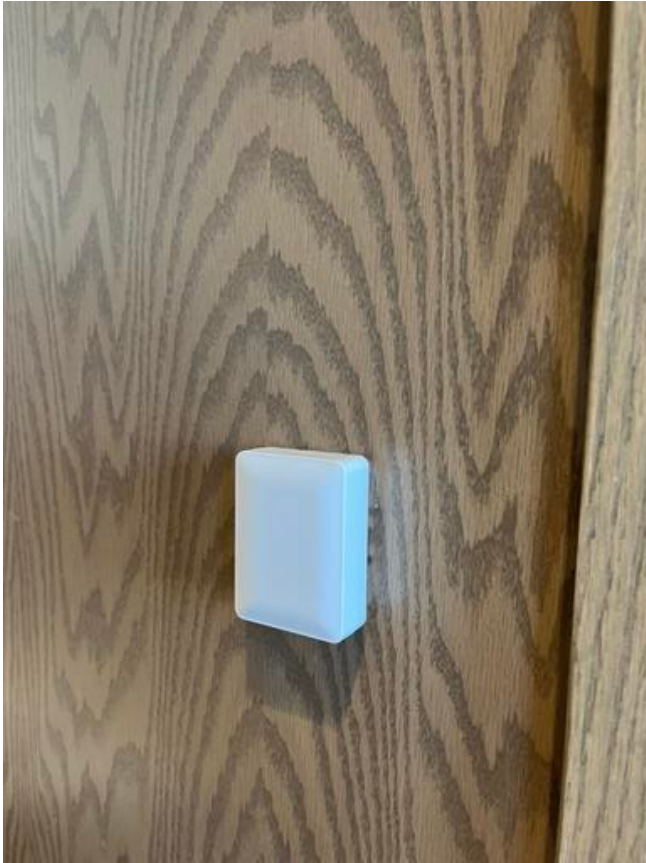
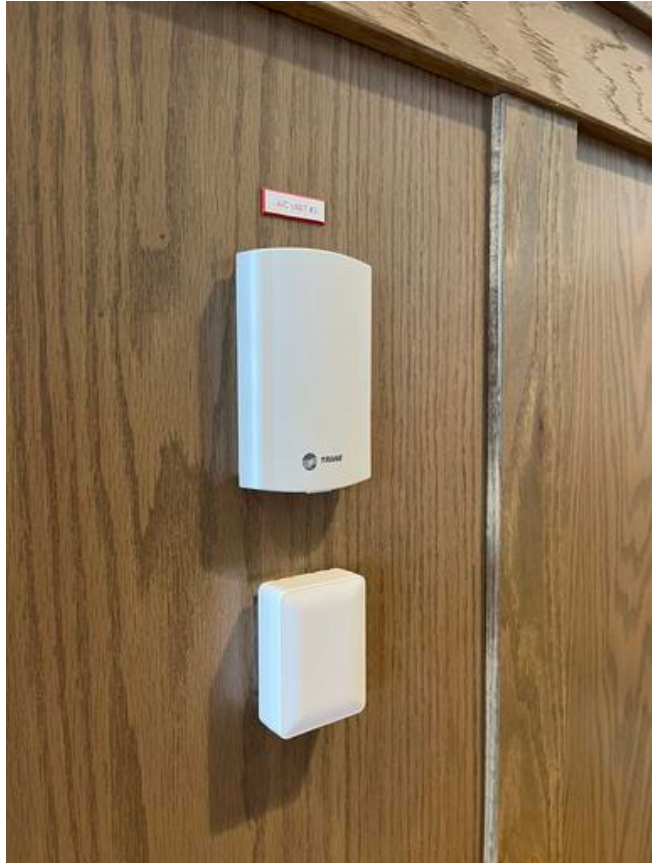
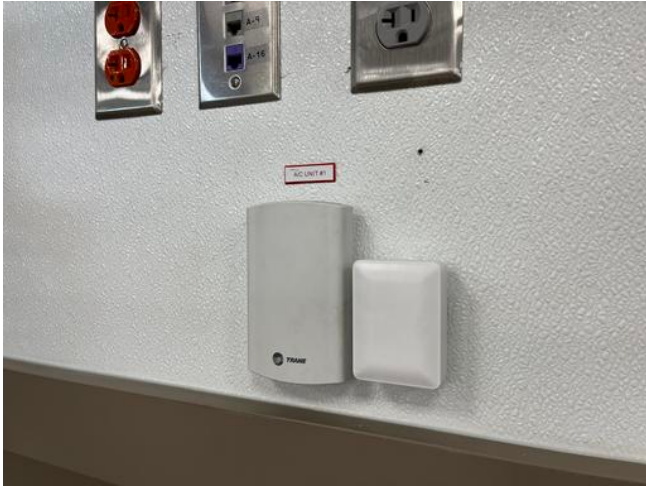
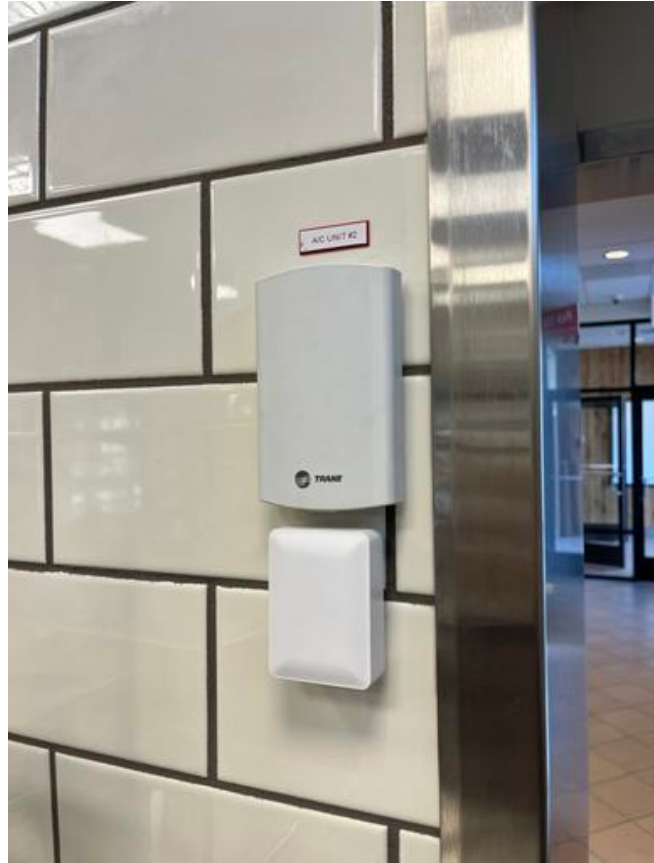
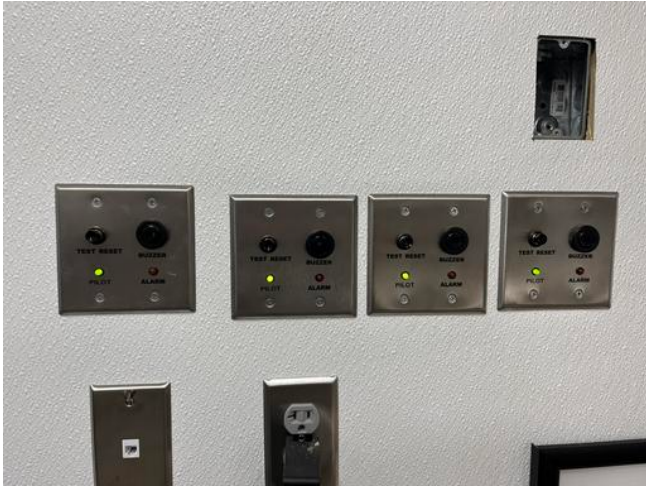
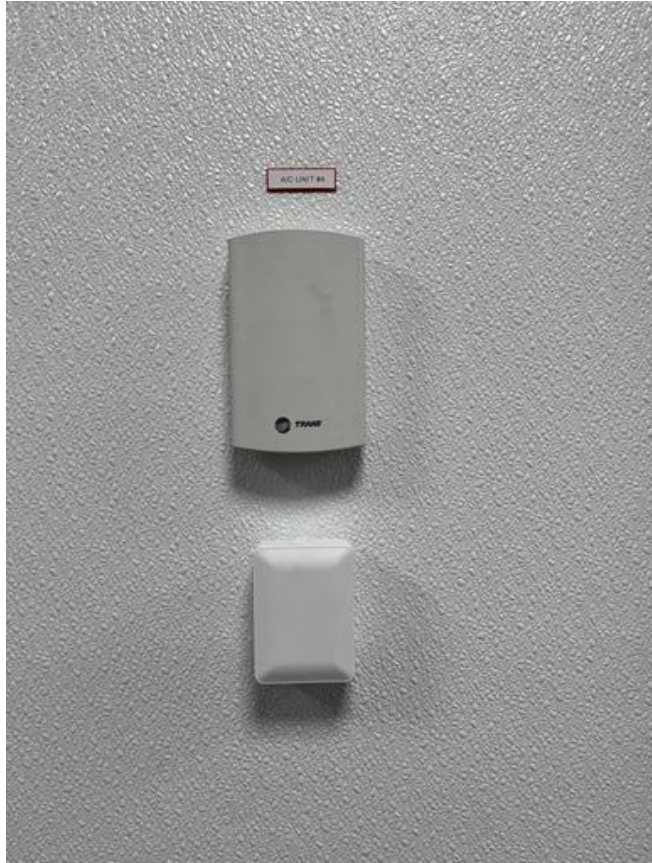
Label all sensors, humidistats, thermostats, smoke annunciators and remote space mounted OADs, MODs, VFD's for which piece of equipment they serve. Currently they are labeled with labelmaker labels and need to be engraved.
