**Report: Deweys Evaluation Phase 1**

**Function: Test, Adjust, & Balance**

**Date: 02/18/2026**

## **Deweys Evaluation (Covington, KY)**

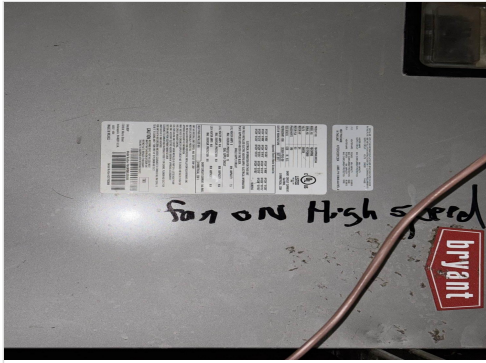
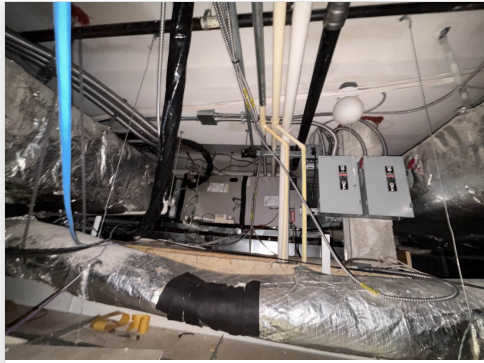
Asset: FCU-1

- FCU-1 (Kitchen) Total Flow: Total=1370 CFM in high cooling mode. OA= 24 cfm. Possible closed damper.
  - FCU-2 (Dining) Total Flow: Verified power to unit, sent commands through stat, blower does not operate.

FCU-1 Inlet temperature:55wb/ 74db Outlet Temperature: 56wb/ 72db Thermostat programming or wiring may be an issue. When in auto, and changing temp setpoints, the unit does not shift modes on its own. Stat taken out of auto then forced into heat, fan speed slowed and observed temp shoot up to 105+. When placed back into cooling, airflow sped up as it should in cooling mode, but temp slowly dropped to settle at 73.

FCU-1 bringing insufficient amount of airflow. Duct is slightly crushed near unit and may contribute to issue. See pictures in report.

AREA:KITCHEN

Unit Data	
	Actual
MFG	BRYANT
Model Num	F84CNPOS0
Serial Num	4317F03669

Test Data		
	Design	Actual
SFAN CFM	2000	1370
OA CFM	350	24

FCU-1 and 3 will run but not able to cool. Both in high speed are 20-30% out of design airflow.

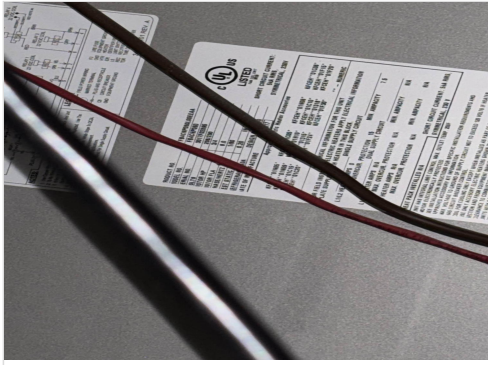
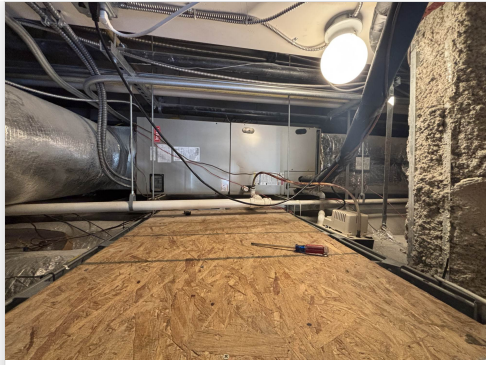
Asset: FCU-2

FCU-2 see above – N/a - Not functioning so could not test cooling. We confirmed power at line/load to compressing units on roof but no operation. it could be the control wiring.

AREA:DINING AREA

Unit Data	
	Actual
MFG	BRYANT
Model Num	FB4CNP060
Serial Num	3017F02895

Test Data		
	Design	Actual
SFAN CFM	2000	0
OA CFM	350	0

FCU-2 isn't working at all- needs repair to run and verify cooling.

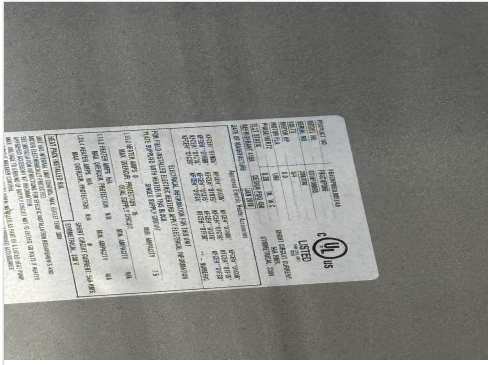
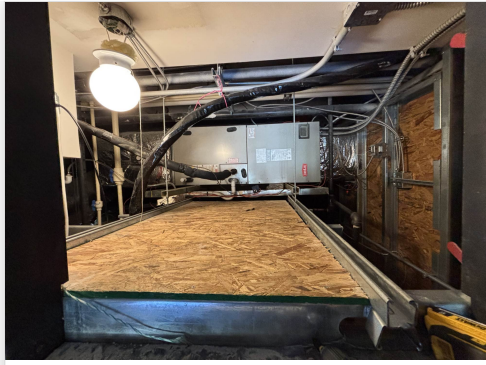
Asset: FCU-3

FCU-3 Inlet temperature: 55wb / 71db, Outlet Temperature: 56wb/73dw. Fcu-3 is experiencing the same issue as fcu-1 regarding thermostat and compressor operation.

AREA:DINING AREA

Unit Data	
	Actual
MFG	BRYANT
Model Num	FB4CNP060
Serial Num	0818F08803

Test Data		
	Design	Actual
SFAN CFM	2000	1612
OA CFM	350	375

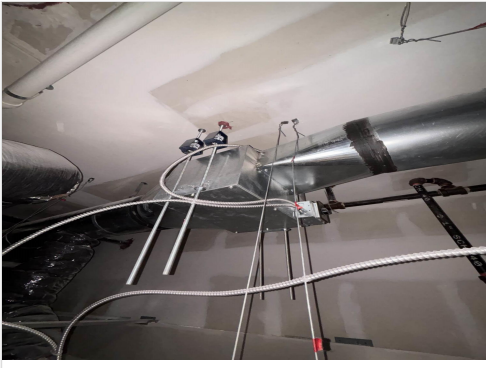
Asset: EF-1

AREA: BATHROOMS

Unit Data		
	Design	Actual
MFG	NA	[1]
Model Num	NA	[1]
Type	INLINE	INLINE

Test Data		
	Design	Actual
CFM	450	126

[1] Unable to locate fan- not in area drawings show. Possibly relocated.

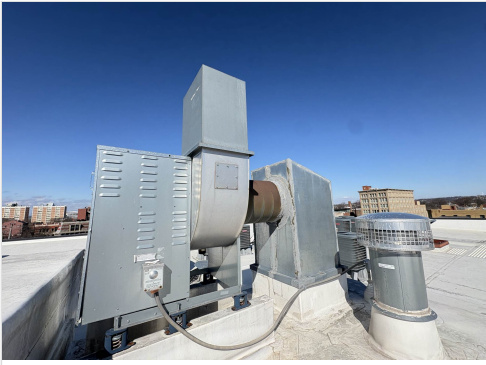
Asset: KEF-1

Unit Data		
	Design	Actual
MFG	NA	CAPTIVEAIRE
Model Num	NA	USBI18DD-RM
Serial Num	-	3405768
Type	KEF	UTILITY

Test Data		
	Design	Actual
CFM	2800	2479

Motor Data		
	Design	Actual
Horsepower	-	2.0
Phase	-	3
Voltage (rated)	-	208
Amperage (rated)	-	8.3

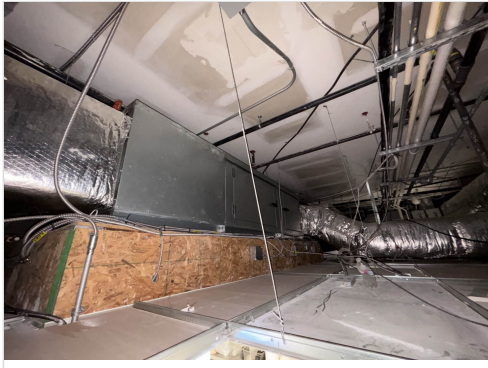
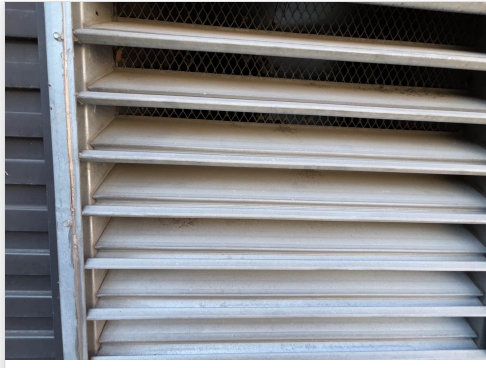
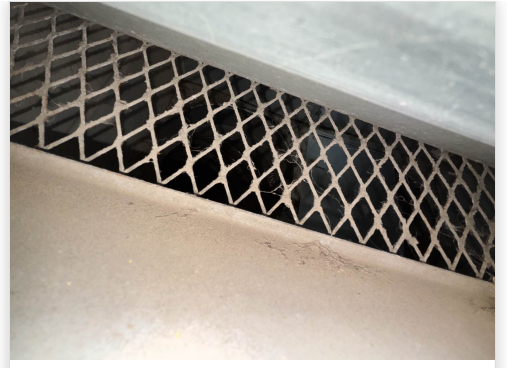
Asset: KMAU-1

AREA: KITCHEN

Unit Data	
	Actual
MFG	CAPTIVEAIRE
Model Num	A1-D.250-G10
Serial Num	3405768

Test Data		
	Design	Actual
CFM	2300	1851

Unable to reach or locate unit data due to install above cooking surfaces and walls.

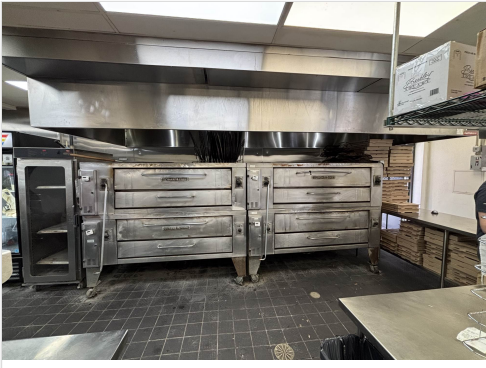
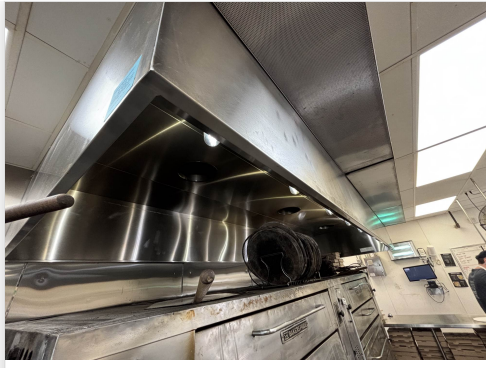
Asset: KHD-1

AREA:KITCHEN

Unit Data		
	Design	Actual
MFG	NA	CAPTIVEAIRE
Model Num	NA	7224VHB
Job / Serial Num	-	3405768
Type	I	TYPE II
Hood length	16'0"	192"
Hood Width	-	14"
Supply Plenum Type	-	PSP
Supply Plenum Width	192"	192"
Supply Plenum Length	14"	14"

Test Data Exhaust		
	Design	Actual
Filter Type	-	NO FILTERS
Filter Total AK Area	(3) 12" holes	2.36
Filter1 FPM	-	1365
Filter2 FPM	-	998
Filter3 FPM	-	789
Filter Ave FPM(corr)	-	1051
CFM	-	2479

Test Data Supply		
	Design	Actual
Total Area	-	18.67
Kv factor (Vel)	-	0.91
Num of Readings	-	12
Reading1 FPM	-	121
Reading2 FPM	-	104
Reading3 FPM	-	90
Reading4 FPM	-	90
Reading5 FPM	-	112
Reading6 FPM	-	89
Reading7 FPM	-	135
Reading8 FPM	-	148
Reading9 FPM	-	156
Reading10 FPM	-	107
Reading11 FPM	-	124
Reading12 FPM	-	161
Ave FPM(corr)	-	109
CFM	2800	1851

Hood is capturing adequately, but end panels would help performance and after Fan Coils are fixed, we may be able to reduce supply air a bit.
