Report: TAB Report
Function: Test, Adjust, & Balance
Date: 03/03/2026
Completed By: National TAB

PROJECT
03-02-26 QT #1410 PHOENIX, AZ

Project: 03-02-26 QT #1410 PHOENIX, AZ

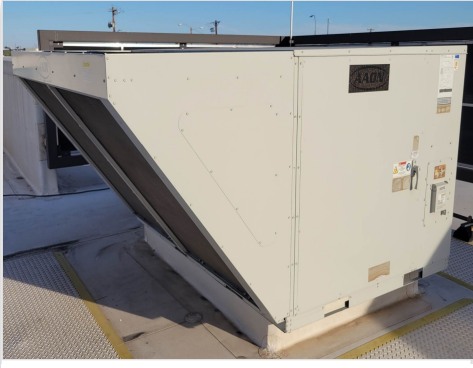
Unit Data - PHOTO LOG

Asset: RT-1

Test Data		
	Design	Actual
SF CFM	5000	4467
SF RPM	-	49.98 HZ
OA CFM (Hoods On)	865	894
OA CFM (Hoods Off)	415	426
RL Voltage	-	174.5
RL Amperage	-	9.92
VFD Max SetPt	-	83.3
VFD Min SetPt	-	24.0
OA Damper Position (Hoods On)	-	0.5"
OA Damper Position (Hoods Off)	-	3.0 GAP@BOTTOM

General	
	Actual
Fan Rotation Correct	YES
Unit Filters Clean	NO
Condensate Drain Installed	YES

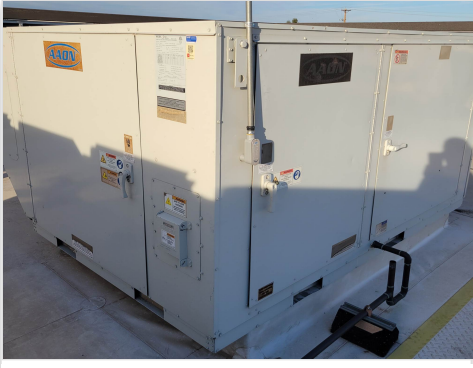
Unit Data - PHOTO LOG

Asset: RT-2

Test Data		
	Design	Actual
SF CFM	5000	4949
SF RPM	-	49.98 HZ
OA CFM (Hoods On)	865	894
OA CFM (Hoods Off)	415	413
RL Voltage	-	174.4
RL Amperage	-	9.76
VFD Max SetPt	-	83.3
VFD Min SetPt	-	24.0
OA Damper Position (Hoods On)	-	0.5"
OA Damper Position (Hoods Off)	-	3.0 GAP@BOTTOM

General	
	Actual
Fan Rotation Correct	YES
Unit Filters Clean	NO
Condensate Drain Installed	YES

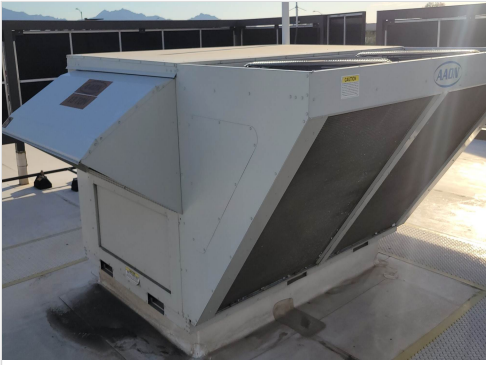
Unit Data - PHOTO LOG

Asset: RT-3

Test Data		
	Design	Actual
SF CFM	-	4455
SF RPM	-	49.2 HZ
OA CFM (Hoods On)	865	896
OA CFM (Hoods Off)	415	413
RL Voltage	-	177.7
RL Amperage	-	8.45
VFD Max SetPt	-	82.0
VFD Min SetPt	-	24.0
OA Damper Position (Hoods On)	-	0.5"
OA Damper Position (Hoods Off)	-	3.0 GAP@BOTTOM

Notes:
[1] UNIT NOT OPERATING; UNABLE TO TAB, SEE ISSUE

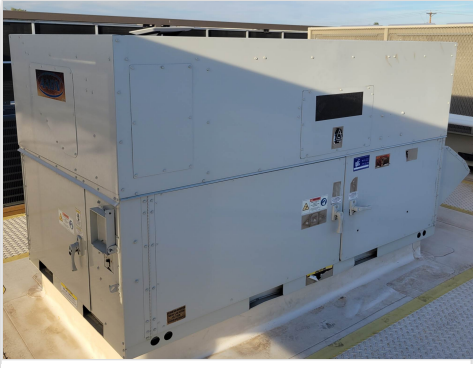
Unit Data - PHOTO LOG

Asset: RT-4

Test Data		
	Design	Actual
SF CFM	1800	1743
SF RPM	-	48 HZ
OA CFM (Hoods On)	160	161
OA CFM (Hoods Off)	160	161
RL Voltage	-	165.2
RL Amperage	-	4.19
VFD Max SetPt	-	80.0
VFD Min SetPt	-	24.0
OA Damper Position (Hoods On)	-	0.125"
OA Damper Position (Hoods Off)	-	0.125"

Notes:
Dampers 4-6 and 4-7 are inaccessible.

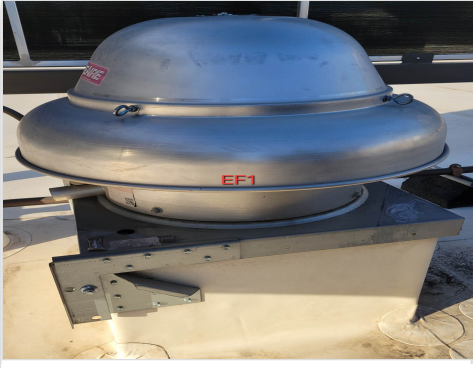
Unit Data - PHOTO LOG

Asset: EF1

Test Data		
	Design	Actual
CFM	500	526
Fan RPM	-	1228
Fan Rotation	-	CCW
Motor RPM	-	1228
System SetPt	-	65P
RL Voltage	-	N/A
RL Amperage	-	1.17
Total ESP	-	0.29"
Fan Inlet SP	-	-0.29"
Fan Discharge SP	-	ATMS

Notes:
[1] COULD NOT INCREASE AIRFLOW.

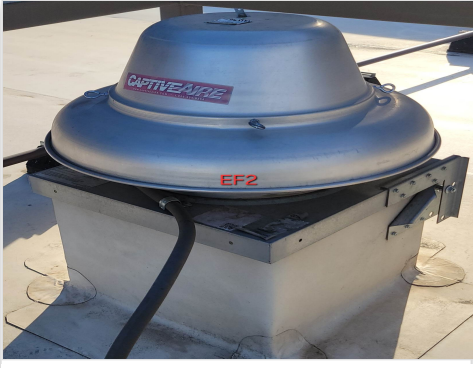
Unit Data - PHOTO LOG

Asset: EF2

Test Data		
	Design	Actual
CFM	350	335
Fan RPM	-	825
Fan Rotation	-	CCW
Motor RPM	-	825
System SetPt	-	56P
RL Voltage	-	N/A
RL Amperage	-	0.69
Total ESP	-	0.16"
Fan Inlet SP	-	-0.16"
Fan Discharge SP	-	ATMS

[1] FAN NOT OPERATIONAL, NO POWER, AT TIME OF TAB

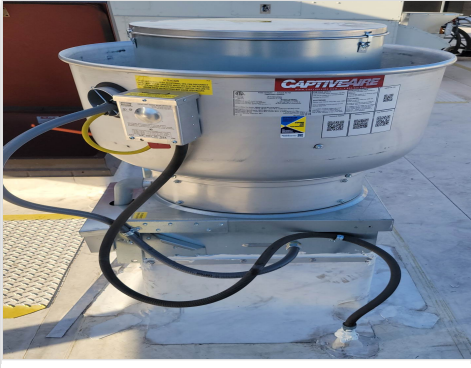
Unit Data - PHOTO LOG

Asset: EF3

Test Data		
	Design	Actual
CFM	1350	1410
Fan RPM	-	1195
Fan Rotation	-	CCW
Motor RPM	-	1195
System SetPt	-	52.8 HZ
RL Voltage	-	218.0
RL Amperage	-	1.3
Total ESP	0.75"	0.63"
Fan Inlet SP	-	-0.63"
Fan Discharge SP	-	ATMS

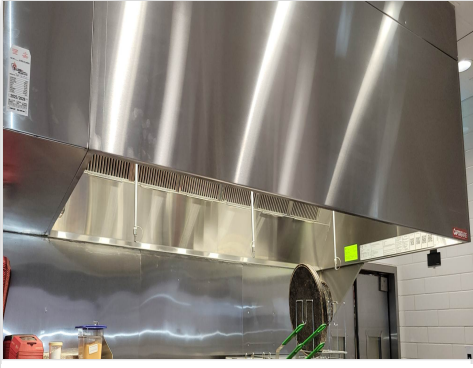
Unit Data - PHOTO LOG

Asset: HD1

Test Data Exhaust		
	Design	Actual
Filter Type	CAPTRATE SOLO FILTER	CAPTRATE SOLO
Filter Size 1	20X16	16X20
Filter Qty 1	6	6
Filter AK factor size 1	2.08	2.08
Filter Total AK Area	12.48	12.48
Filter1 FPM	-	116
Filter2 FPM	-	115
Filter3 FPM	-	116
Filter4 FPM	-	113
Filter5 FPM	-	110
Filter6 FPM	-	108
Filter Ave FPM(corr)	-	113
CFM	1350	1410
