Report: TAB REPORT
Function: Test, Adjust, & Balance
Date: 07/10/2025
Completed By: National TAB

PROJECT
07-07-25 CULVERS EVANSVILLE, WI

Project: 07-07-25 CULVERS EVANSVILLE, WI

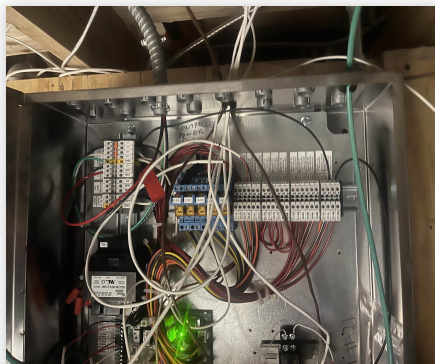
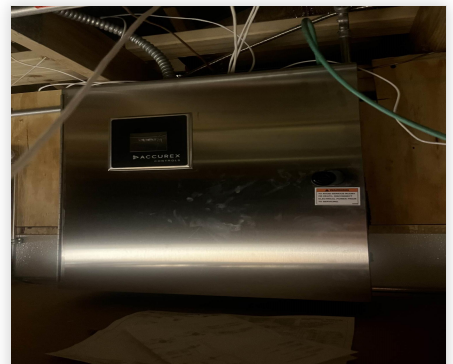
Issue Name : INFO ONLY: Accurex Hood Control Panel
Description : Accurex Hood control Panel does not appear intended for this job. The Wiring Diagram indicates "TOWNE DELI." The control panel is set up for additional exhaust fans and an MUA. Panel has all the components necessary for this store and is operating properly. Information only.
Created By : National TAB **Assigned To :** National TAB - Michael McDonnell
Status : Open
Priority : InfoOnly **Asset Tag :**
Originated Date : 07/09/2025 - Michael McDonnell - National TAB

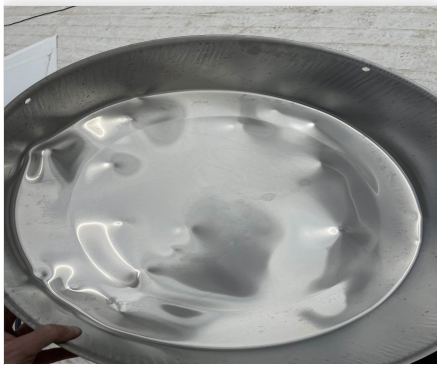
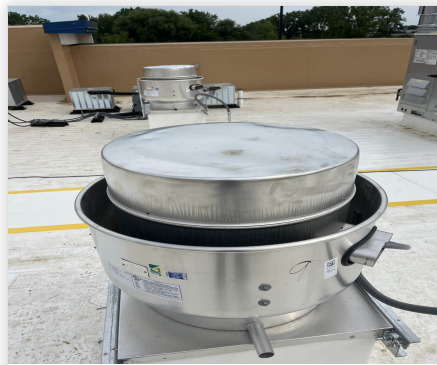
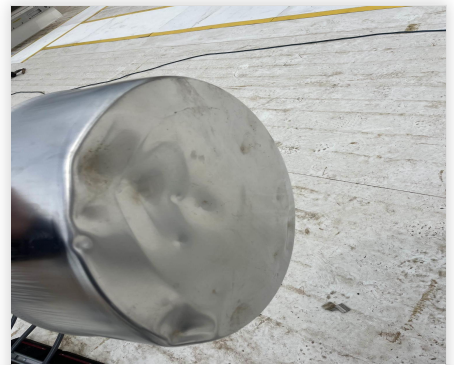
Issue Name : PRV-2 & PRV-3: Fan Lids Damaged and Need Replacement.
Description : Fan lids have several dents in them. Unsure how this could have occurred. Recommend lids are replaced; these are brand new fans.
Created By : National TAB **Assigned To :** National TAB - Michael McDonnell
Status : Open
Priority : Low **Asset Tag :**
Originated Date : 07/10/2025 - Michael McDonnell - National TAB

RTUS have bolts installed around blower door. This is not typical and requires them to be removed with tool instead of quick release handles. Exhaust Fans have damage to their lids, as if someone could not get the lid back on. Recommend they are replaced.

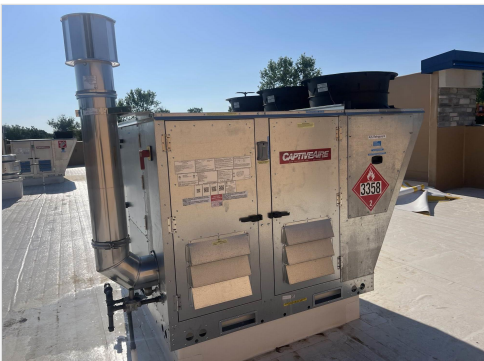
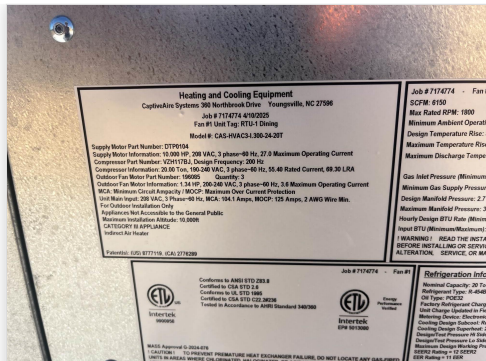
Asset: RTU1

Unit Data		
	Design	Actual
MFG	LENNOX	CAPTIVE AIRE
Serial Num	-	7174774
Model Num	ENLIGHT LGT	CAS-HVAC3-1.300-24-20T
Type	RTU	RTU
Configuration	VERTICAL	VERTICAL
Num OA Filters 1	-	4
OA Filter Size 1	-	16X25X2
Num Final Filter 1	-	8
Final Filter Size 1	-	20X25X2

Test Data		
	Design	Actual
SF CFM	6150	6093
SF RPM	-	1667
RA CFM	4450	4253
OA CFM	1700	1840
RL Voltage	-	188 @ VFD
RL Amperage	-	23.2 @ VFD
SF Rotation	-	CCW, CORRECT
SF System SetPt	-	57.0 HZ
RA Damper Position	-	MECHANICALLY LINKED
Min OA Damper Position	-	4.5 V
Min OA Damper Type	-	ECONOMIZER

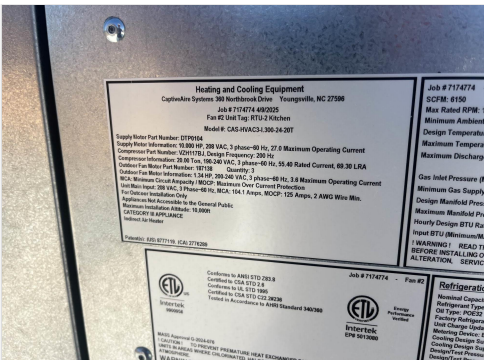
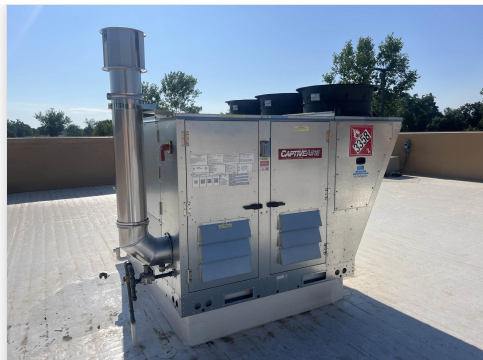
Asset: RTU2

Unit Data		
	Design	Actual
MFG	LENNOX	CAPTIVE AIRE
Serial Num	-	7174774
Model Num	ENLIGHT LGT	CAS-HVAC3-1.300-24-20T
Type	RTU	RTU
Configuration	VERTICAL	VERTICAL
Num OA Filters 1	-	4
OA Filter Size 1	-	16X25X2
Num Final Filter 1	-	8
Final Filter Size 1	-	20X25X2

Test Data		
	Design	Actual
SF CFM	6150	5830
SF RPM	-	1740
RA CFM	4475	4040
OA CFM	1675	1790
RL Voltage	-	202 @ VFD
RL Amperage	-	24.0 @ VFD
SF Rotation	-	CCW, CORRECT
SF System SetPt	-	59.5 HZ
RA Damper Position	-	MECHANICALLY LINKED
Min OA Damper Position	-	4.3 VDC
Min OA Damper Type	-	ECONOMIZER

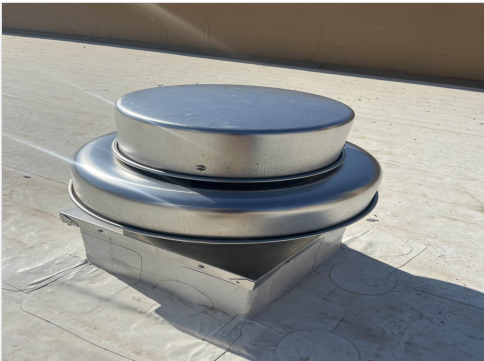
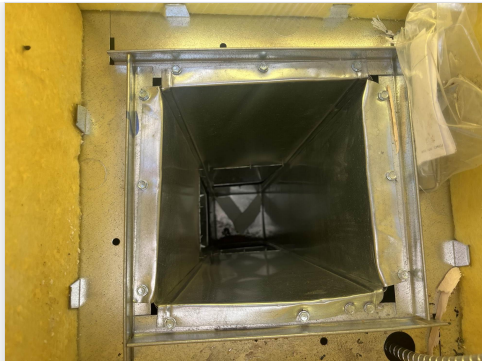
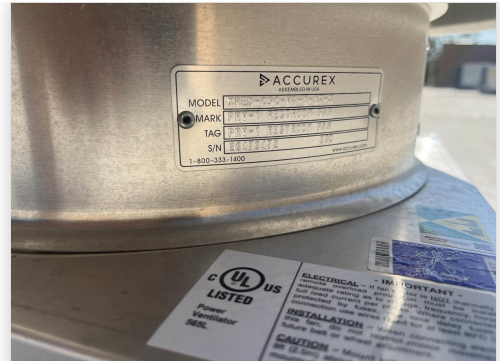
Asset: PRV1

Unit Data		
	Design	Actual
MFG	ACCUREX	ACCUREX
Model Num	XRED-090-VG	XRED-090-VG
Serial Num	-	26473472
Type	DOWNBLAST	DOWNBLAST
Configuration	VERTICAL	VERTICAL

Test Data		
	Design	Actual
CFM	375	380
Fan RPM	1466	DD
Fan Rotation	-	CW, CORRECT
Motor RPM	-	DD
System SetPt	-	5 ON SPEED CONTROLLER
RL Voltage	-	119
RL Amperage	-	0.40
Total ESP	0.50"	0.10"
Fan Inlet SP	-	-0.10"
Fan Discharge SP	-	ATM

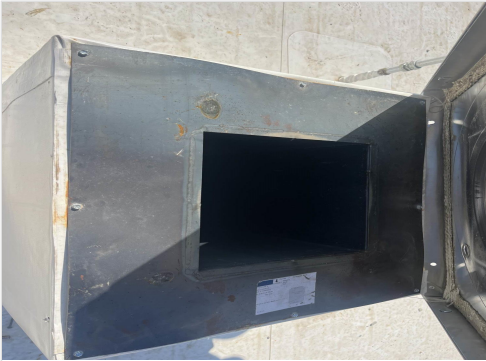
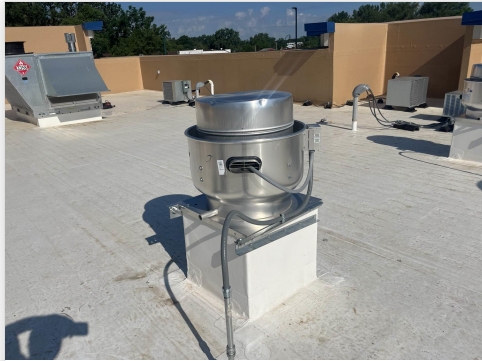
Asset: PRV2

Unit Data		
	Design	Actual
MFG	ACCUREX	ACCUREX
Model Num	XCUE-140-VG	XCUE-140-VG
Serial Num	-	26473473
Type	UPBLAST	CRE UPBLAST
Configuration	VERTICAL	VERTICAL

Test Data		
	Design	Actual
CFM	1500	1622
Fan RPM	-	1242
Fan Rotation	-	CW, CORRECT
Motor RPM	-	1242
System SetPt	-	7.1 VDC
RL Voltage	115	119
RL Amperage	-	4.7
Total ESP	1.801"	1.08"
Fan Inlet SP	-	-1.08"
Fan Discharge SP	-	ATM

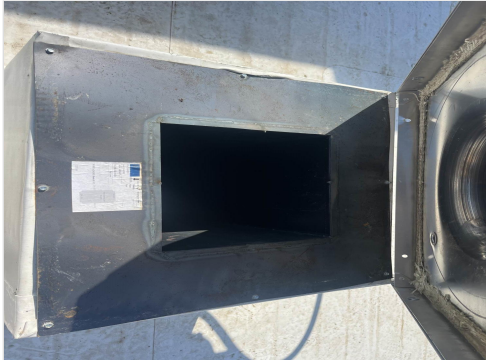
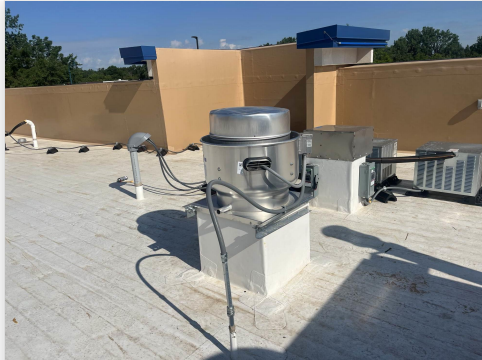
Asset: PRV3

Unit Data		
	Design	Actual
MFG	ACCUREX	ACCUREX
Model Num	XCUE-140-VG	XCUE-140-VG
Serial Num	-	26473474
Type	UPBLAST	CRE UPBLAST
Configuration	VERTICAL	VERTICAL

Test Data		
	Design	Actual
CFM	1500	1593
Fan RPM	-	1155
Fan Rotation	-	CW, CORRECT
Motor RPM	-	1155
System SetPt	-	6.6 VDC
RL Voltage	115	119
RL Amperage	-	3.6
Total ESP	1.00"	0.99"
Fan Inlet SP	-	-0.99"
Fan Discharge SP	-	ATM

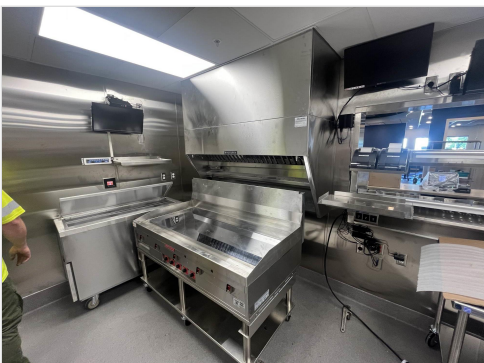
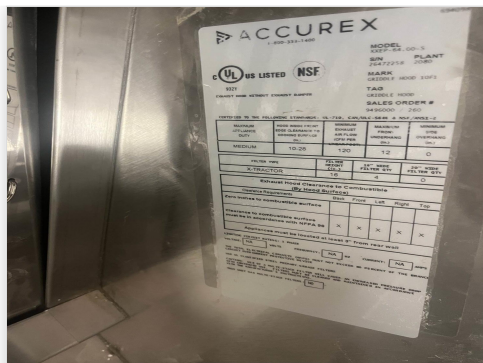
Asset: HD1

Unit Data		
	Design	Actual
MFG	ACCUREX	ACCUREX
Model Num	XGEP-64-S	XGEP-64-S
Job / Serial Num	-	26472258
Type	TYPE - LOW PROXIMITY	TYPE I- LOW PROFILE
Hood length	64"	64"
Hood Width	23"	23"

Test Data Exhaust		
	Design	Actual
Filter Type	XTRACTOR	XTRACTOR
Filter Size 1	16X16	16X16
Filter Qty 1	4	4
Filter AK factor size 1	1.53	1.53
Filter Total AK Area	6.12	6.12
Filter1 FPM	-	273
Filter2 FPM	-	253
Filter3 FPM	-	254
Filter4 FPM	-	280
Filter Ave FPM(corr)	-	265
CFM	1500	1622

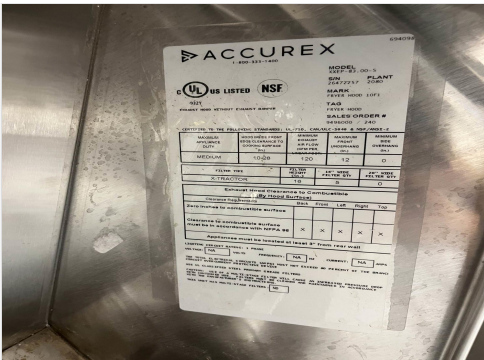
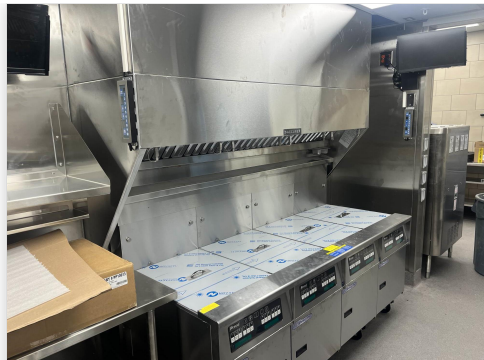
Asset: HD2

Unit Data		
	Design	Actual
MFG	ACCUREX	ACCUREX
Model Num	XXEP-83-S	XXEP-83-S
Job / Serial Num	-	26472257
Type	TYPE - LOW PROXIMITY	TYPE I - LOW PROFILE
Hood length	83"	83"
Hood Width	23"	23"

Test Data Exhaust		
	Design	Actual
Filter Type	XTRACTOR	XTRACTOR
Filter Size 1	16X16	16X16
Filter Qty 1	5	5
Filter AK factor size 1	1.53	1.53
Filter Total AK Area	7.65	7.65
Filter1 FPM	-	215
Filter2 FPM	-	207
Filter3 FPM	-	201
Filter4 FPM	-	197
Filter5 FPM	-	221
Filter Ave FPM(corr)	-	208.20
CFM	1500	1593
