Report: ISSUE LIST
Function: Test, Adjust, & Balance
Date: 07/09/2025
Completed By: National TAB

PROJECT
07-07-25 CULVERS EVANSVILLE, WI

Project: 07-07-25 CULVERS EVANSVILLE, WI

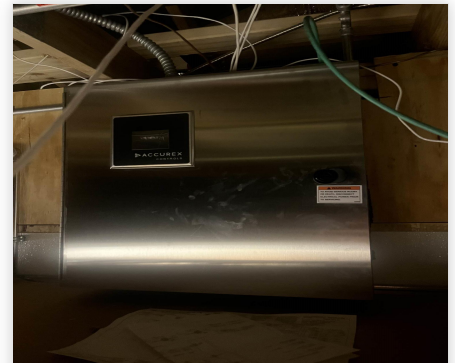
Issue Name : INFO ONLY: Accurex Hood Control Panel
Description : Accurex Hood control Panel does not appear intended for this job. The control panel is set up for additional exhaust fans and an MUA. Still has all the components necessary for this store and is operating properly.
Created By : National TAB **Assigned To :** National TAB - Michael McDonnell
Status : Open
Priority : InfoOnly **Asset Tag :**
Originated Date : 07/09/2025 - Michael McDonnell - National TAB

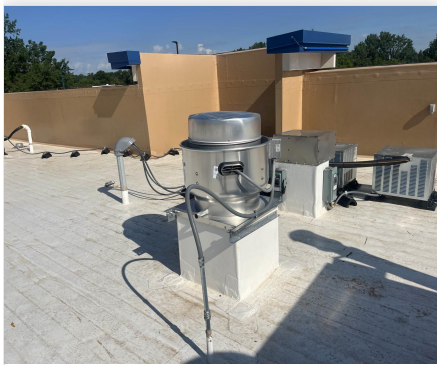
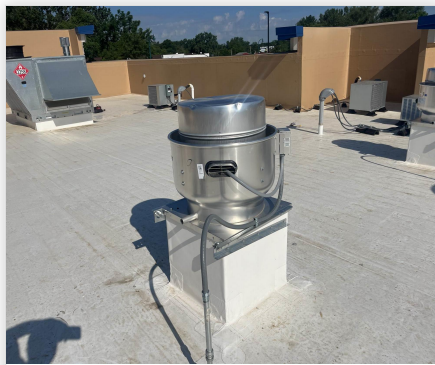
Issue Name : PRV-1 & PRV-2: Grease Cups Not Installed
Description : Hood exhaust fans do not have their grease cups installed on the roof. Could not locate cups. Recommend they are located and installed.
Created By : National TAB **Assigned To :** National TAB - Michael McDonnell
Status : Open
Priority : Medium **Asset Tag :**
Originated Date : 07/09/2025 - Michael McDonnell - National TAB

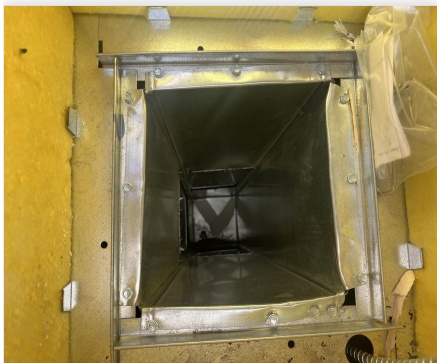
Issue Name : PRV-1 (RR): No Backdraft Damper Installed.
Description : Plans call for damper, none installed. Recommend it is located and installed low enough in the duct so it can fully open and does not impede airflow.
Created By : National TAB **Assigned To :** National TAB - Michael McDonnell
Status : Open
Priority : Medium **Asset Tag :**
Originated Date : 07/09/2025 - Michael McDonnell - National TAB

- **07/09/2025 National TAB - Michael McDonnell**
 - Duct is also not fully sealed at connection to fan. Fan is pulling from ceiling space.

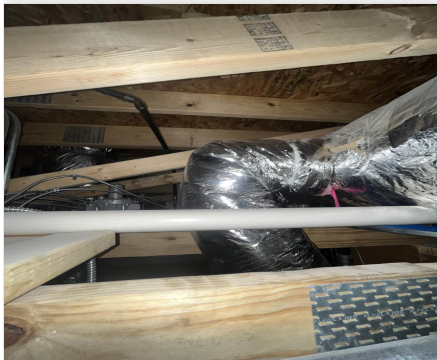
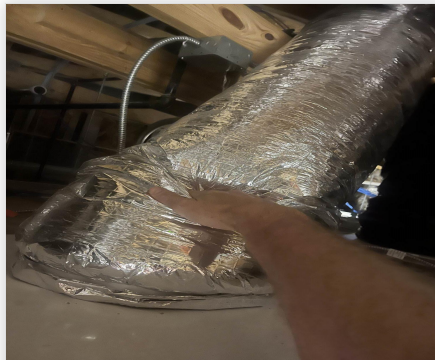
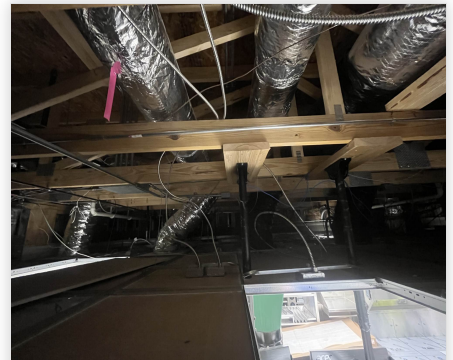
Issue Name : RTU Ductwork: Rigid Elbows
Description : Diffusers are to have rigid 90s installed to vertical rigid duct at connection to diffuser. This is especially important on the Kitchen Cookline Diffusers for proper hood capture. See Detail C6 on M201. Rigid 90s and rigid duct is NOT installed per plan; flex is used for the entirety of most all diffuser runs.
Created By : National TAB **Assigned To :** National TAB - Michael McDonnell
Status : Open
Priority : High **Asset Tag :**
Originated Date : 07/09/2025 - Michael McDonnell - National TAB

- **07/09/2025 National TAB - Michael McDonnell**
 - RTUs are achieving design airflow.

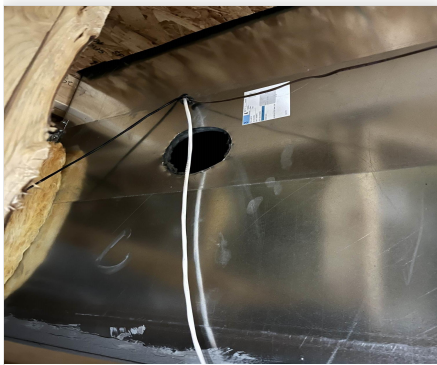
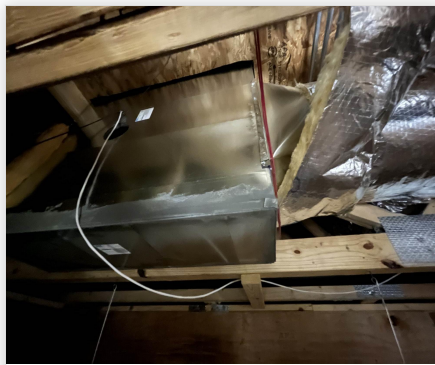
Issue Name : RTU-2 (Kitchen): Return Drop Has Hole
Description : The return Drop has a hole cut out. Recommend hole is patched so all return is drawn from the space. Insulation is also hanging from return drop.
Created By : National TAB **Assigned To :** National TAB - Michael McDonnell
Status : Open
Priority : **Medium** **Asset Tag :**
Originated Date : 07/09/2025 - Michael McDonnell - National TAB
