**Report: TAB Report**  
**Function: Test, Adjust, & Balance**  
**Date: 02/25/2026**  
**Completed By: National TAB**

**03-02-26 QT #0739 TUCKER, GA**

4330 CHAMBLEE TUCKER RD

QUIKTRIP  
4705 SOUTH 129TH EAST AVENUE  
TULSA, OK 74134

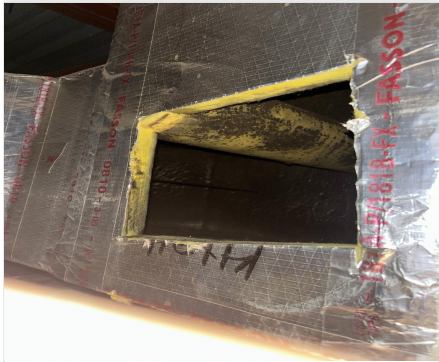
Project Issue File Details

**Issue Name :** RTU-1 Duct Leakage  
**Description :** At the supply drop of RTU-1 there is a duct leakage causing the unit to be unable to be balanced.  
**Created By :** National TAB                      **Assigned To :** National TAB - Dan Hertenstein  
**Status :** Open  
**Priority :** Urgent                                      **Asset Tag :**  
**Originated Date :** 03/04/2026 - Anthony Taylor - National TAB

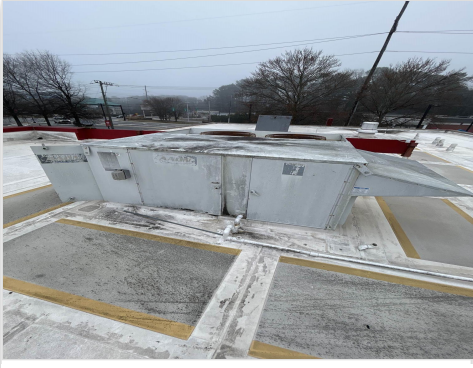
**Unit Data - PHOTO LOG**

Asset: RT-1

AREA:RESTROOM

Unit Data	
	Actual
MFG	AAON
Serial Num	200503-AMEF04120
Model Num	RN-006-B-AA01-132
Num OA Filters 1	1
OA Filter Size 1	12X35
Num Final Filter 1	4
Final Filter Size 1	16X20X2

**Issue Name :** Faded RTU Label  
**Description :** RTU-1 label is faded and is not readable. All data inputted is directly from the motor.  
**Created By :** National TAB                      **Assigned To :** National TAB - Dan Hertenstein  
**Status :** Open  
**Priority :** InfoOnly                                      **Asset Tag :**  
**Originated Date :** 03/04/2026 - Anthony Taylor - National TAB

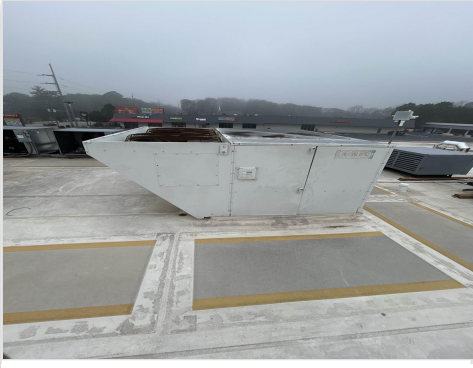
**Unit Data - PHOTO LOG**

Asset: RT-2

AREA:SALES

Unit Data	
	Actual
MFG	AAON
Serial Num	200503-AMEK041102
Model Num	RN-013-8-0-AB02-162
Num OA Filters 1	1
OA Filter Size 1	18X40
Num Final Filter 1	6
Final Filter Size 1	16X20X2

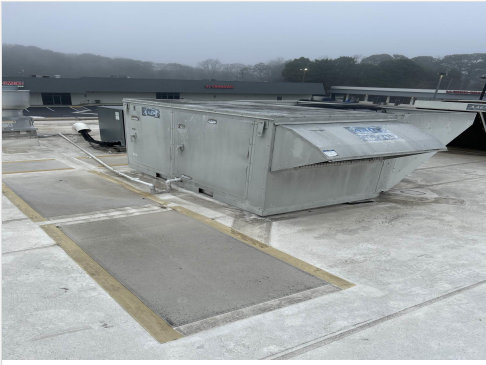
## Unit Data - PHOTO LOG

Asset: RT-3

AREA:KITCHEN

Unit Data	
	Actual
MFG	AAON
Serial Num	201405-ANEJI0433
Model Num	RN-010-8-0-FB09-16A
Num OA Filters 1	1
OA Filter Size 1	18X28
Num Final Filter 1	4
Final Filter Size 1	16X20X2

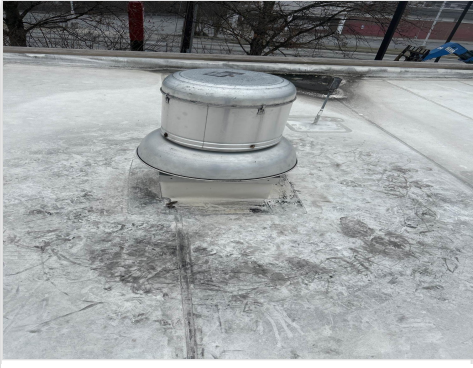
**Unit Data - PHOTO LOG**

Asset: EF-1

AREA:RESTROOM

Unit Data		
	Design	Actual
MFG	NA	LOREN COOK
Model Num	NA	120 ACE 120C3B
Serial Num	-	050S826529- 00/0000710
Type	-	DOWNBLAST
Configuration	-	VERTICAL

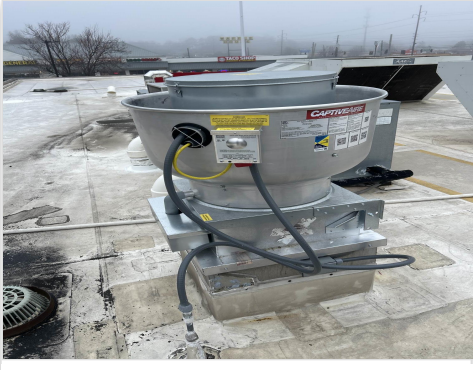
## Unit Data - PHOTO LOG

Asset: EF-3

AREA: KITCHEN HOOD

Unit Data		
	Design	Actual
MFG	NA	CAPTIVEAIRE
Model Num	NA	DU50HFA
Serial Num	-	8469131
Type	UPBLAST	UPBLAST
Configuration	VERTICAL	VERTICAL

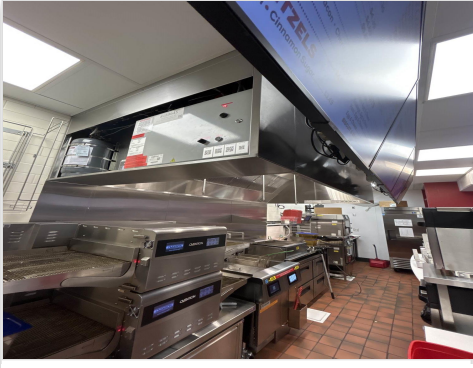
**Unit Data - PHOTO LOG**

Asset: HD-1

AREA:GRIDDLE

Unit Data		
	Design	Actual
MFG	CAPTIVEAIRE	CAPTIVEAIRE
Model Num	6030ND-2-F	6030ND-2-F
Job / Serial Num	-	8189645
Type	TYPE I CANOPY	TYPE I CANOPY
Hood length	108"	108"
Hood Width	60"	60"
