Report: TAB Report
Function: Test, Adjust, & Balance
Date: 10/23/2025
Completed By: National TAB

PROJECT
01-19-26 QT #1431 TOLLESON, AZ

Project: 01-19-26 QT #1431 TOLLESON, AZ

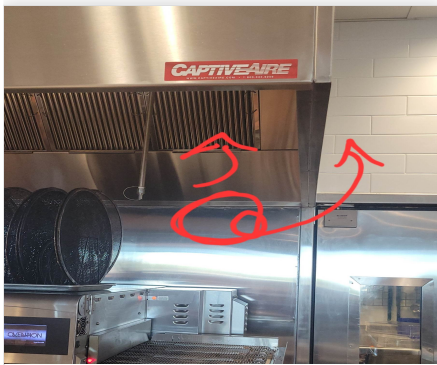
Issue Name : OVEN FAN PUSHES SMOKE OUT OF HOOD
Description : Picture shows surface smoke air flow. About half is exhausted while the other half is swirled and pushed out of the hood. The fan on the side of the pizza oven is what is pushing it out.
Created By : National TAB **Assigned To :** National TAB - Dan Hertenstein
Status : Open
Priority : Low **Asset Tag :** HD1
Originated Date : 02/14/2026 - Christine Weale - National TAB
