Report: TAB REPORT
Function: Test, Adjust, & Balance
Date: 05/30/2024

**06-03-24 CAVA HOUSTON, TX
(GREENHOUSE RD)**

Project: 06-03-24 CAVA HOUSTON, TX (GREENHOUSE RD)

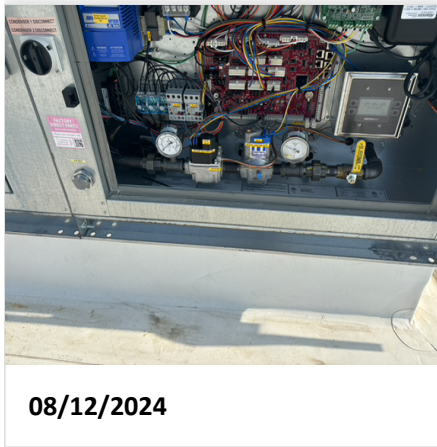
Issue Name : MUA Gas Line
Description : MUA gas line is not connected. Recommend connecting and testing unit for gas heat functionality.
Created By : National TAB **Assigned To :** National TAB - Will Turnbough
Status : Open
Priority : **Asset Tag :**
Originated Date : 08/12/2024 - Wesley John - National TAB

GAS LINE NOT INSTALLED. SEE ISSUES.

HEATER NOT TESTED. UNIT NOT CONNECTED TO GAS.
