Report: TAB REPORT
Function: Test, Adjust, & Balance
Date: 05/30/2024

**06-03-24 CAVA HOUSTON, TX
(GREENHOUSE RD)**

Project Summary

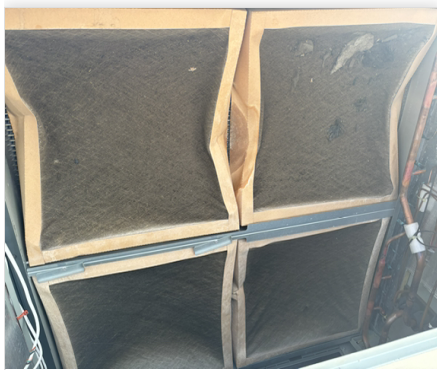
Issue Name : Dirty Evaporator filters on RTUs
Description : Both RTUs have dirty construction filters. Filters were removed for testing. Recommend replacing with appropriate size pleated MERV rated filters.
Created By : National TAB **Assigned To :** National TAB - Will Turnbough
Status : Open
Priority : **Asset Tag :**
Originated Date : 08/12/2024 - Wesley John - National TAB

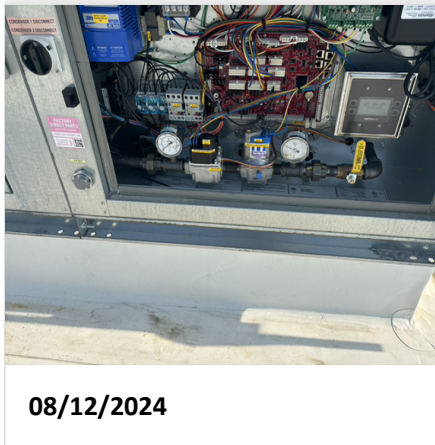
Issue Name : MUA Gas Line
Description : MUA gas line is not connected. Recommend connecting and testing unit for gas heat functionality.
Created By : National TAB **Assigned To :** National TAB - Will Turnbough
Status : Open
Priority : **Asset Tag :**
Originated Date : 08/12/2024 - Wesley John - National TAB

GAS LINE NOT INSTALLED. SEE ISSUES.

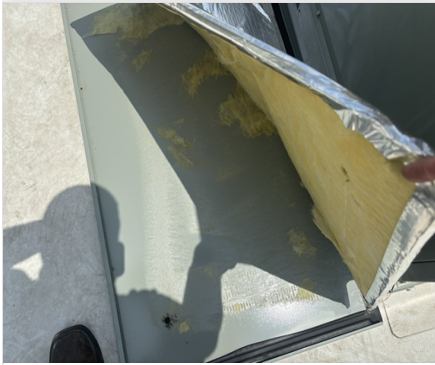
Issue Name : RTU-2 Insulation
Description : RTU-2 suction door insulation peeled off. Recommend securing with stick pins. Tech placed it in compressor compartment.
Created By : National TAB **Assigned To :** National TAB - Will Turnbough
Status : Open
Priority : **Asset Tag :**
Originated Date : 08/12/2024 - Wesley John - National TAB

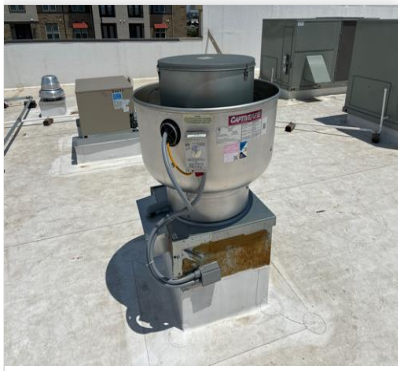
KEF-1

KITCHEN EXHAUST FAN SET TO 100% AND MEASURED AT 87% OF DESIGN AIR FLOW.

KITCHEN EXHAUST FAN MEASURED SLIGHTLY ABOVE FULL LOAD AMP RATING (11.9 OUT OF 11.6 AMPS). FAN KEPT AT THIS SETTING TO AID IN HOOD PERFORMANCE.

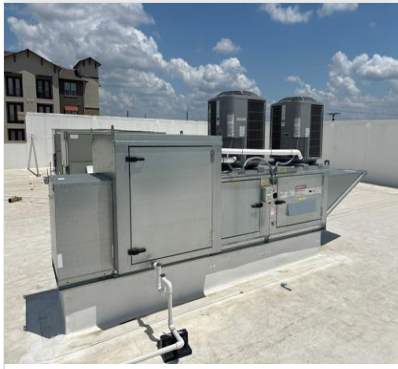
MUA-1

MUA KEPT TO NEAR 90% OF DESIGN AIR FLOW TO COMPENSATE FOR LOW EXHAUST AIR FLOW.
