Report: TAB Report
Function: Test, Adjust, & Balance
Date: 10/23/2025
Completed By: National TAB

PROJECT
10-27-25 QT #1180 COLUMBIA, SC

Project: 10-27-25 QT #1180 COLUMBIA, SC

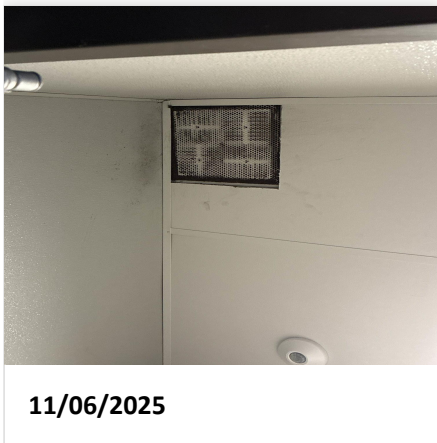
Issue Name : EF1-2 Incorrect Diffuser
Description : The diffuser for EF1-2 in the janitor's closet is the incorrect type.
Created By : National TAB **Assigned To :** National TAB - Dan Hertenstein
Status : Open
Priority : Low **Asset Tag :** EGRD2
Originated Date : 11/06/2025 - Alex Bauer - National TAB

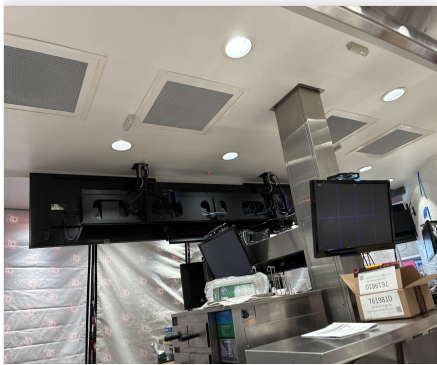
Issue Name : Incorrect Kitchen Diffusers
Description : The kitchen diffusers 3-1 through 3-4 are not the correct type. They should be the Titus S1 diffuser. The contractor is aware and they will be replaced in the near future.
Created By : National TAB **Assigned To :** National TAB - Dan Hertenstein
Status : Open
Priority : InfoOnly **Asset Tag :** RT-3
Originated Date : 11/06/2025 - Alex Bauer - National TAB

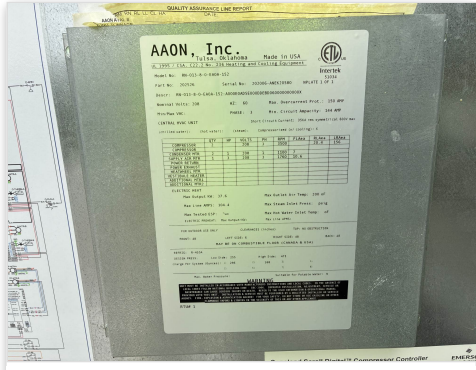
Unit Data - PHOTO LOG

Unit Data	
	Actual
MFG	AAON
Serial Num	202006-ANEK20581
Model Num	RN-013-8-0-EA0A-152
Num OA Filters 1	1
OA Filter Size 1	44.5 X 22.5

Test Data		
	Design	Actual
SF CFM	4200	4499
SF RPM	-	DD/53 Hz
OA CFM (Hoods On)	800	813
OA CFM (Hoods Off)	350	362
RL Voltage	-	202 VFD
RL Amperage	-	11.1 VFD
VFD Max SetPt	-	53 Hz
OA Damper Position (Hoods On)	-	46%
OA Damper Position (Hoods Off)	-	34%

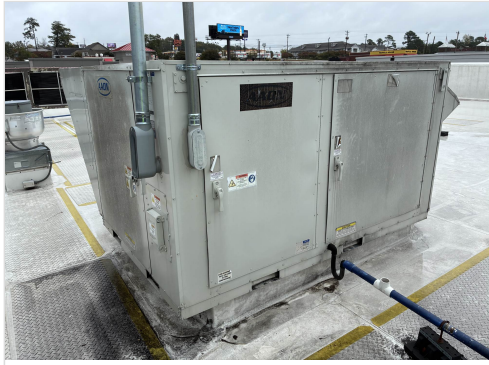
Unit Data - PHOTO LOG

Unit Data	
	Actual
MFG	AAON
Serial Num	202006-ANEK20580
Model Num	RN-013-8-0-EA0A-152
Num OA Filters 1	1
OA Filter Size 1	44.5X22.5

Test Data		
	Design	Actual
SF CFM	4200	4033
SF RPM	-	DD/37 Hz
OA CFM (Hoods On)	800	820
OA CFM (Hoods Off)	350	322
RL Voltage	-	101 VFD
RL Amperage	-	6.84 VFD
VFD Max SetPt	-	37 Hz
OA Damper Position (Hoods On)	-	46%
OA Damper Position (Hoods Off)	-	26%
