Report: TAB Report
Function: Test, Adjust, & Balance
Date: 10/23/2025
Completed By: National TAB

PROJECT
10-27-25 QT #1180 COLUMBIA, SC

8205 TWO NOTCH ROAD

Project: 10-27-25 QT #1180 COLUMBIA, SC

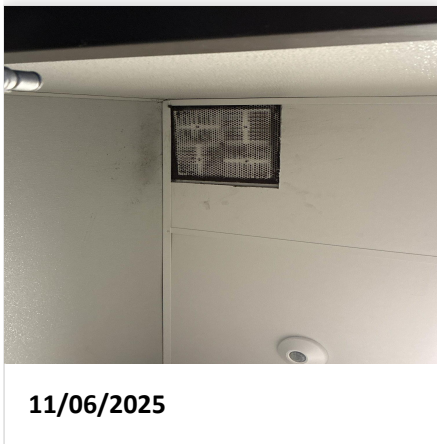
Issue Name : EF1-2 Incorrect Diffuser
Description : The diffuser for EF1-2 in the janitor's closet is the incorrect type. This is a supply diffuser, should be exhaust.
Created By : National TAB **Assigned To :** National TAB - Dan Hertenstein
Status : Open
Priority : Low **Asset Tag :** EGRD2
Originated Date : 11/06/2025 - Alex Bauer - National TAB

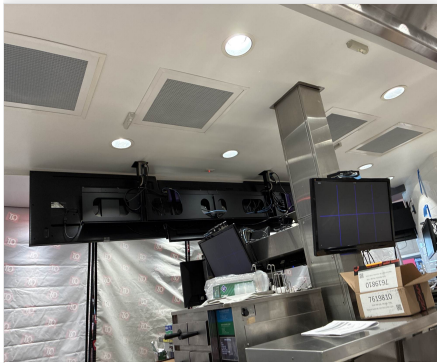
Issue Name : Incorrect Kitchen Diffusers
Description : The kitchen diffusers 3-1 through 3-4 are not the correct type. They should be the Titus S1 diffuser. The contractor is aware and they will be replaced in the near future. Pictured on the right is the correct style diffuser.

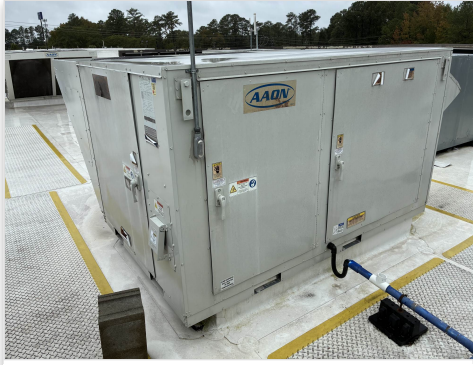
Asset: RT-1

Unit Data	
	Actual
MFG	AAON
Serial Num	202006-ANEK20579
Model Num	RN-013-8-0-EA0A-152
Num OA Filters 1	1
OA Filter Size 1	44.5 X 22.5

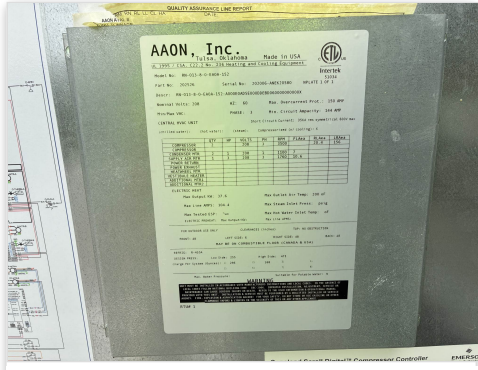
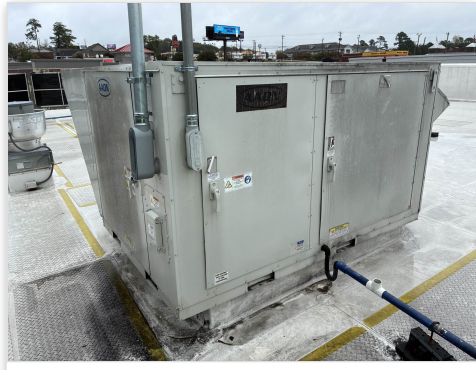
Asset: RT-2

Unit Data	
	Actual
MFG	AAON
Serial Num	202006-ANEK20581
Model Num	RN-013-8-0-EA0A-152
Num OA Filters 1	1
OA Filter Size 1	44.5 X 22.5

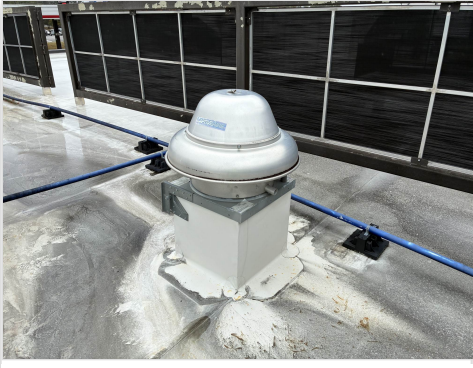
Asset: EF1

[1] NO DAMPER FOUND ON COMBI-OVEN EXHAUST GRILLE OR ON OTHER EF INTLET TO PULL MORE AIR FROM COMBI-OVEN GRILLE. DAMPERS MAY BE INSTALLED BUT ARE INACCESSIBLE IF SO.

Issue Name : Combi-oven Grille below Design
Description : No dampers were accessible or found on the EF-1 ductwork. Fan total exhaust is within design, but we cannot dampen to exhaust more air from combi-oven grille. Recommend installing accessible dampers so grille can be balanced to design.
Created By : National TAB **Assigned To :** National TAB - Dan Hertenstein
Status : Open
Priority : Medium **Asset Tag :**
Originated Date : 01/14/2026 - Michael McDonnell - National TAB

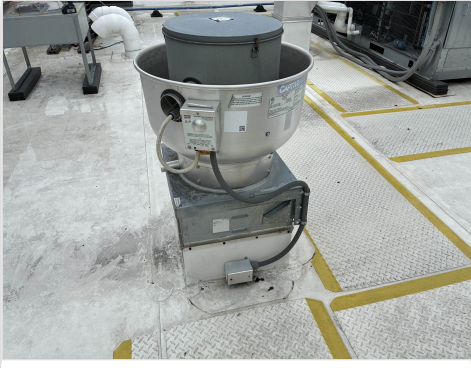
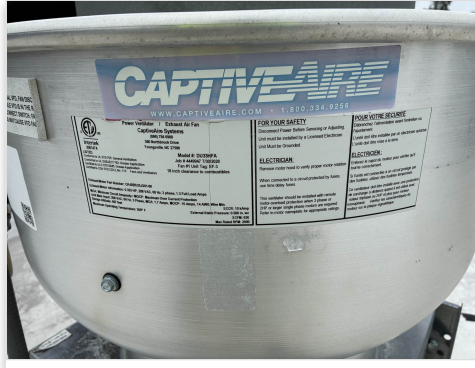
Asset: EF3

Unit Data		
	Design	Actual
MFG	NA	CAPTIVEAIRE
Model Num	NA	DU50HFA
Serial Num	-	4449947
Type	UPBLAST	UPBLAST
Configuration	VERTICAL	VERTICAL

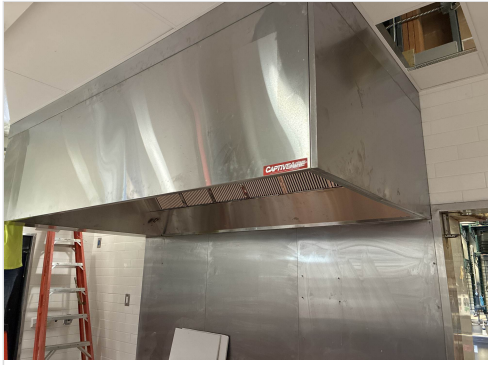
Asset: HD1

Unit Data		
	Design	Actual
MFG	CAPTIVEAIRE	CAPTIVEAIRE
Model Num	6030ND-2-F	6030 ND-2
Job / Serial Num	-	7619810
Type	TYPE I CANOPY	TYPE I CANOPY
Hood length	-	108"
Hood Width	-	60"
