Report: TAB Report
Function: Test, Adjust, & Balance
Date: 10/23/2025
Completed By: National TAB

PROJECT
10-27-25 QT #1180 COLUMBIA, SC

8205 TWO NOTCH ROAD

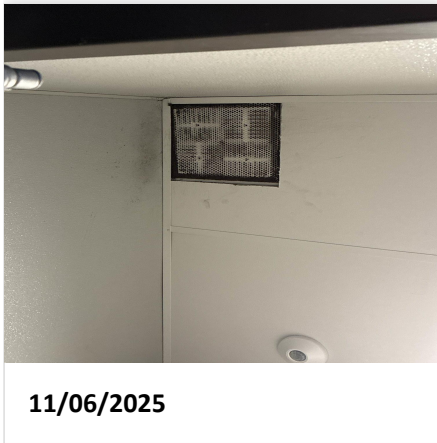
Issue Name : EF1-2 Incorrect Diffuser
Description : The diffuser for EF1-2 in the janitor's closet is the incorrect type. This is a supply diffuser, should be exhaust.
Created By : National TAB **Assigned To :** National TAB - Dan Hertenstein
Status : Open
Priority : Low **Asset Tag :** EGRD2
Originated Date : 11/06/2025 - Alex Bauer - National TAB

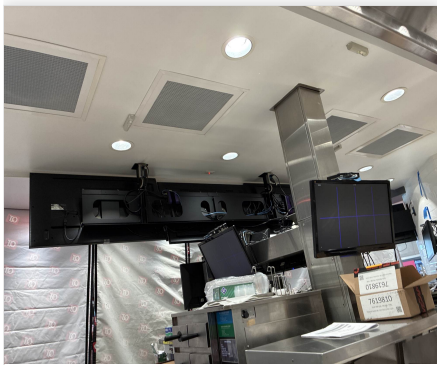
Issue Name : Incorrect Kitchen Diffusers
Description : The kitchen diffusers 3-1 through 3-4 are not the correct type. They should be the Titus S1 diffuser. The contractor is aware and they will be replaced in the near future. Pictured on the right is the correct style diffuser.

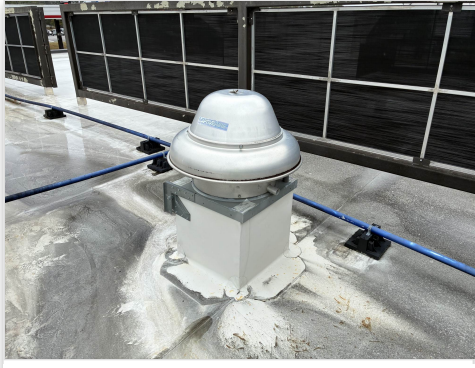
Unit Data - PHOTO LOG

Unit Data		
	Design	Actual
MFG	NA	CAPTIVE AIRE
Model Num	NA	DR50HFA
Serial Num	-	4449947
Type	-	UPBLAST
Configuration	VERTICAL	VERTICAL

[1] NO DAMPER FOUND ON COMBI-OVEN EXHAUST GRILLE OR ON OTHER EF INTLET TO PULL MORE AIR FROM COMBI-OVEN GRILLE. DAMPERS MAY BE INSTALLED BUT ARE INACCESSIBLE IF SO.

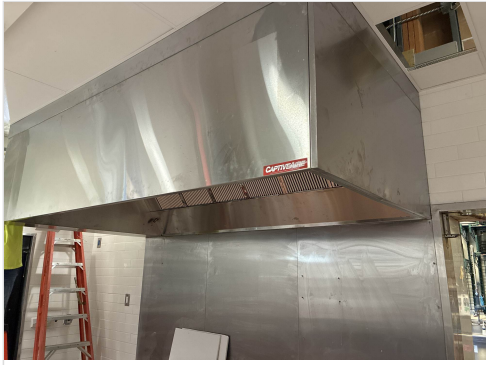
Unit Data - PHOTO LOG

Unit Data		
	Design	Actual
MFG	CAPTIVEAIRE	CAPTIVEAIRE
Model Num	6030ND-2-F	6030 ND-2
Job / Serial Num	-	7619810
Type	TYPE I CANOPY	TYPE I CANOPY
Hood length	-	108"
Hood Width	-	60"

Test Data Exhaust		
	Design	Actual
Filter Type	-	BAFFLE FILTERS
Filter Size 1	-	16X20
Filter Qty 1	-	6
Filter AK factor size 1	-	2.08
Filter Total AK Area	-	12.48
Filter1 FPM	-	98
Filter2 FPM	-	114
Filter3 FPM	-	109
Filter4 FPM	-	129
Filter5 FPM	-	106
Filter6 FPM	-	109
Filter Ave FPM(corr)	-	111
CFM	1350	1385
