**Report: TAB Report**  
**Function: Test, Adjust, & Balance**  
**Date: 10/23/2025**  
**Completed By: National TAB**

**PROJECT**  
**10-27-25 QT #1180 COLUMBIA, SC**

QUIKTRIP  
4705 SOUTH 129TH EAST AVENUE  
TULSA, OK 74134

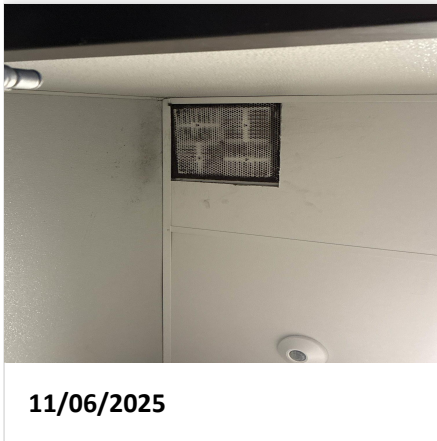
**Issue Name :** EF1-2 Incorrect Diffuser  
**Description :** The diffuser for EF1-2 in the janitor's closet is the incorrect type.  
**Created By :** National TAB                      **Assigned To :** National TAB - Dan Hertenstein  
**Status :** Open  
**Priority :** Low                                      **Asset Tag :** EGRD2  
**Originated Date :** 11/06/2025 - Alex Bauer - National TAB

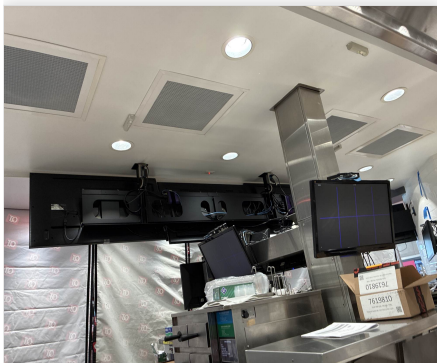
**Issue Name :** Incorrect Kitchen Diffusers  
**Description :** The kitchen diffusers 3-1 through 3-4 are not the correct type. They should be the Titus S1 diffuser. The contractor is aware and they will be replaced in the near future.  
**Created By :** National TAB                      **Assigned To :** National TAB - Dan Hertenstein  
**Status :** Open  
**Priority :** InfoOnly                                      **Asset Tag :** RT-3  
**Originated Date :** 11/06/2025 - Alex Bauer - National TAB

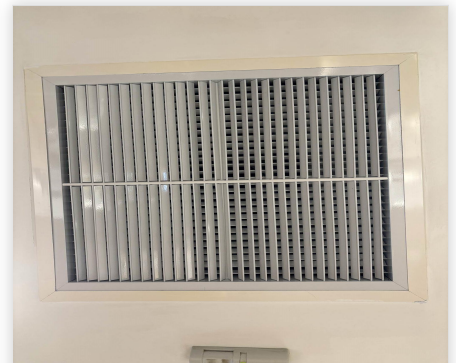
**GRILLE, REGISTER, & DIFFUSER SCHEDULE**

QTY	MANUFACTURER	MODEL	SERVICE	FACE SIZE	BOX SIZE	DESCRIPTION	NOTES
10	TTES	350L	24043	18" X 18"	SEE PLAN	34" DEEP BLADE TOWER GRILLE AL. W/TE	12
5	TTES	3075	5071	22" X 22"	SEE PLAN	20" DEEP TOWER GRILLE AL. W/TE	13

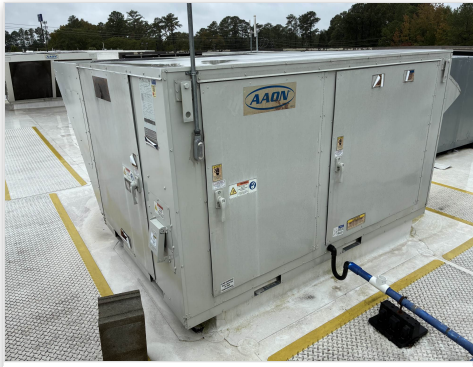
# Unit Data - PHOTO LOG

Unit Data	
	Actual
MFG	AAON
Serial Num	202006-ANEK20579
Model Num	RN-013-8-0-EA0A-152
Num OA Filters 1	1
OA Filter Size 1	44.5 X 22.5

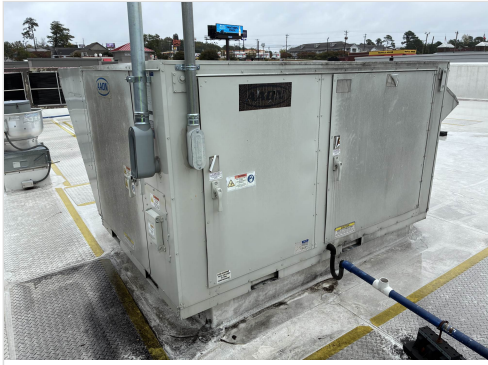
# Unit Data - PHOTO LOG

Unit Data	
	Actual
MFG	AAON
Serial Num	202006-ANEK20580
Model Num	RN-013-8-0-EA0A-152
Num OA Filters 1	1
OA Filter Size 1	44.5X22.5

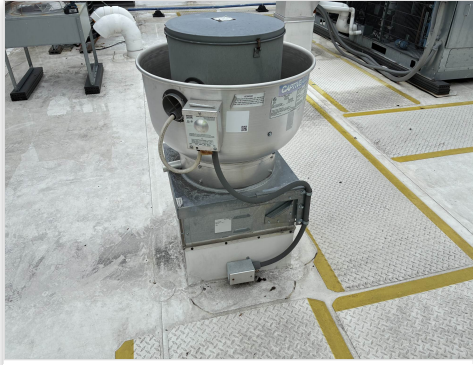
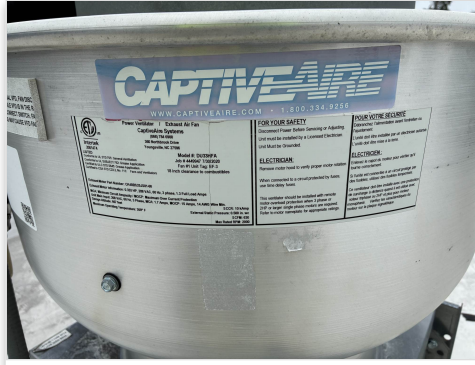
# Unit Data - PHOTO LOG

Unit Data		
	Design	Actual
MFG	NA	CAPTIVEAIRE
Model Num	NA	DU50HFA
Serial Num	-	4449947
Type	UPBLAST	UPBLAST
Configuration	VERTICAL	VERTICAL
