**Report: TAB Report**  
**Function: Test, Adjust, & Balance**  
**Date: 10/23/2025**  
**Completed By: National TAB**

**PROJECT**  
**10-27-25 QT #1180 COLUMBIA, SC**

QUIKTRIP  
4705 SOUTH 129TH EAST AVENUE  
TULSA, OK 74134

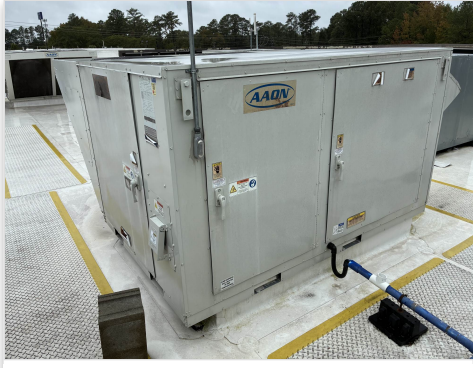
# Unit Data - PHOTO LOG

Unit Data	
	Actual
MFG	AAON
Serial Num	202006-ANEK20579
Model Num	RN-013-8-0-EA0A-152
Num OA Filters 1	1
OA Filter Size 1	44.5 X 22.5
