Report: PRELIM TAB REPORT
Function: Test, Adjust, & Balance
Date: 11/12/2024
Completed By: National TAB

PROJECT
Warby Parker (Liberty Twp, OH)

Project: Warby Parker (Liberty Twp, OH)

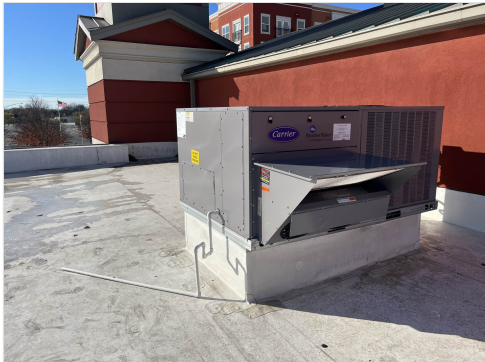
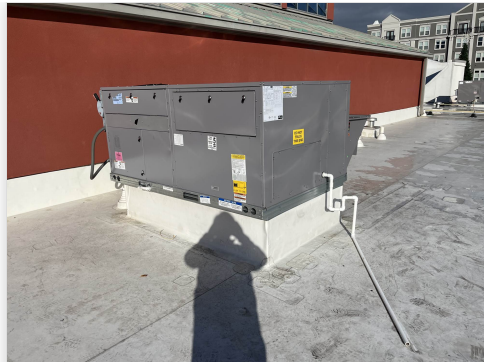
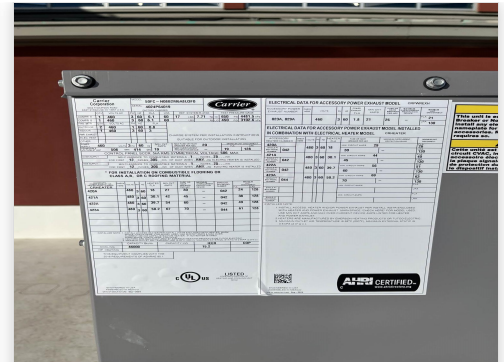
Unit Data - PHOTO LOG

Unit Data		
	Design	Actual
MFG	NA	Carrier
Serial Num	-	4024P64019
Model Num	NA	50FC - N08B2M6A8U3F0
Configuration	VERTICAL	Vertical
Num OA Filters 1	-	1
OA Filter Size 1	-	35"x20"
Num PreFilter 1	-	4
PreFilter Size 1	-	20"x16"

Test Data		
	Design	Actual
SF CFM	2600	2651
RA CFM	2280	2281
OA CFM	320	343
RL Voltage	460	491/492/488
RL Amperage	-	2.3
OA Damper Position	-	2%

Notes:
Final BP -0.03"
BP with equipment off -0.04
Building is not a stand alone building and there are multiple KEF's serving other spaces.

Unit total flows are in design; diffusers were unable to be balanced due to a large amount of nonfunctional dampers.

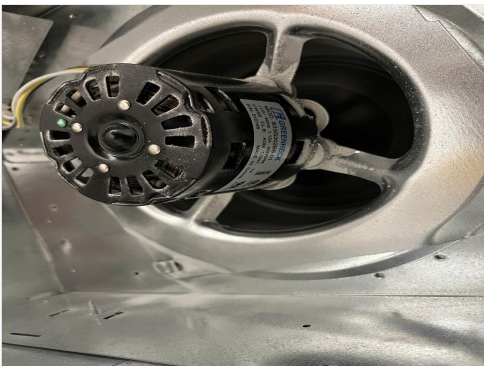
Motor Data - PHOTO LOG

Unit Data		
	Design	Actual
MFG	NA	NA
Model Num	NA	NA
Serial Num	-	NL
Type	CEILING	CEILING

Test Data		
	Design	Actual
CFM	75	95
RL Voltage	-	120
RL Amperage	-	1.2
Total ESP	0.30	NA

Motor Data		
	Design	Actual
Motor MFG	-	GREENHECK
Frame	-	NL
Horsepower	-	NL
Motor Rpm	950	950
Phase	1	1
Voltage (rated)	115	115
Amperage (rated)	-	1.15
Service Factor	-	NL

Notes:
Single speed fan; unable to reduce CFM.

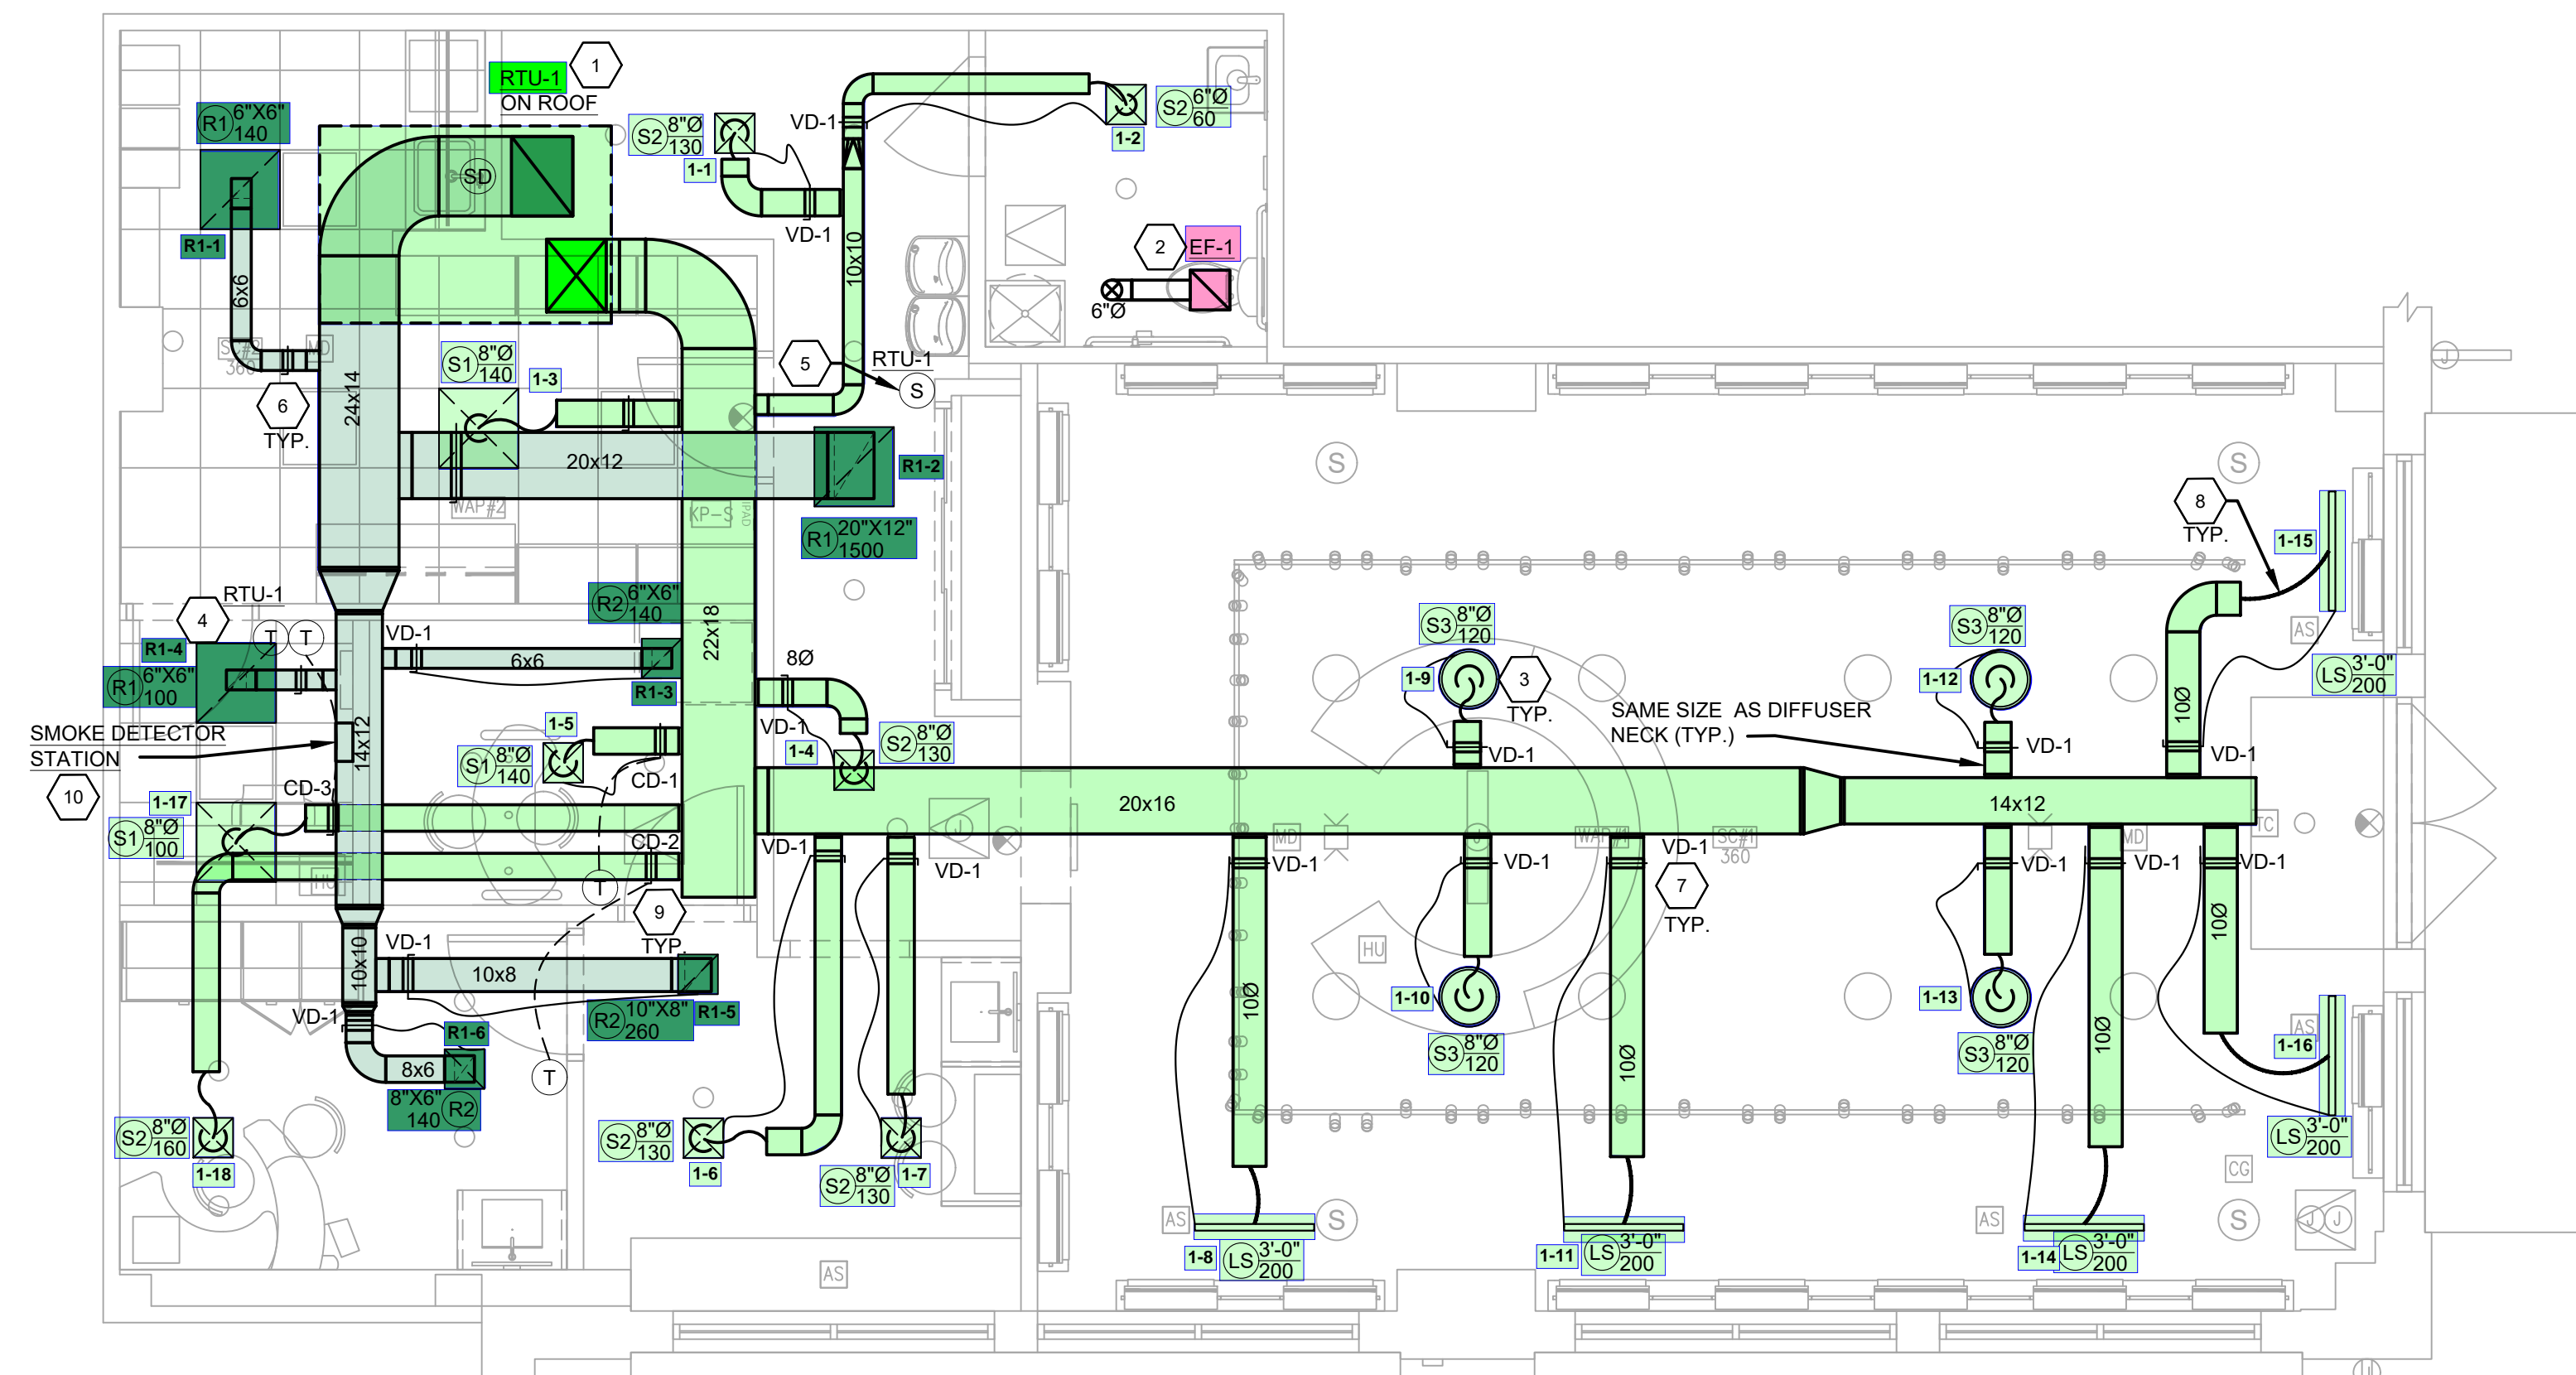
1 MECHANICAL PLAN
SCALE: 1/4" = 1'-0"

- 1. INSTALL NEW RTU PER MANUFACTURER'S IOM AND MAINTAIN CLEARANCES. TRANSITION DUCT TO FULL SIZE CONNECTION AT UNIT AS REQUIRED. REFER TO DETAIL 9/M-103.

- 2. PROVIDE NEW TOILET EXHAUST FAN PER SCHEDULE ON M-101. INTERLOCK FAN WITH LIGHT SWITCH. NEW 6" EXHAUST DUCT UP TO ROOF AND TERMINATE INTO A ROOF CAP, EQUIVALENT TO GREENHECK MODEL GRSR SIZE 8. PROVIDE WITH INTEGRAL BIRDSCREEN, PREFABRICATED ROOF CURB AND GRAVITY BACKDRAFT DAMPER. FIELD VERIFY LOCATION AND DISTANCE IN FIELD TO MAINTAIN A MINIMUM DISTANCE OF 10" FROM AIR INTAKE.

- 3. 1-SLOT ROUND DIFFUSER. COORDINATE DIFFUSER LOCATION WITH TRACK LIGHTS, SPEAKERS AND EXISTING STRUCTURE. TRACK LIGHTS AND SPEAKER LOCATIONS SHALL NOT HAVE TO BE RELOCATED WITHOUT PRIOR APPROVAL FROM ARCHITECT AND/OR WARBY PARKER PM. MECHANICAL CONTRACTOR SHALL COORDINATE DIFFUSER LAYOUTS WITH ALL SUB-CONTRACTORS AND TRADES, PRIOR TO ANY FABRICATION OF DUCTWORK.

- 6. PROVIDE MANUAL VOLUME DAMPER WITH LOCKING QUADRANT IN EASILY ACCESSIBLE LOCATION WHEN POSSIBLE. PROVIDE DIFFUSER MOUNTED DAMPERS WHERE DUCT MOUNTED DAMPER WOULD BE INACCESSIBLE. TYPICAL OF BACK OF HOUSE.

- 7. PROVIDE BOWDEN CABLE CONTROLS AS SHOWN (VD-1). COORDINATE EXACT VOLUME DAMPER LOCATION IN FIELD. SEE M-101 FOR PRODUCT SPECIFICATIONS.
- 8. FLEXIBLE DUCT ALLOWED FOR FINAL CONNECTION TO DIFFUSER ONLY. FLEXIBLE DUCT NOT TO EXCEED 5'-0" IN TOTAL LENGTH.
