Report: TAB Report
Function: Test, Adjust, & Balance
Date: 09/23/2025
Completed By: National TAB

PROJECT
09-22-25 WAWA #6625 LYNCHBURG, VA

Project: 09-22-25 WAWA #6625 LYNCHBURG, VA

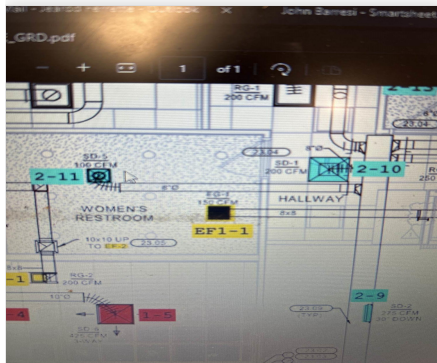
Issue Name : Missing women's restroom damper
Description : Woman's supply damper/ face damper missing. Currently at 275% off design.
Created By : National TAB **Assigned To :** National TAB - Brianna Biggs
Status : Open
Priority : Low **Asset Tag :** SGRD11
Originated Date : 09/23/2025 - Jearod Ferrette - National TAB

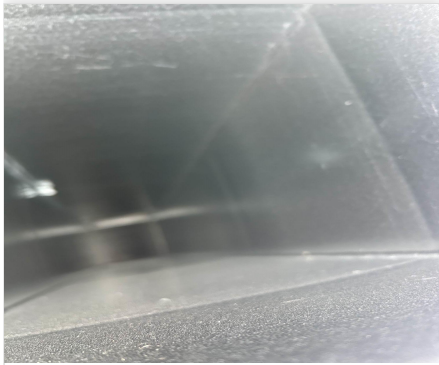
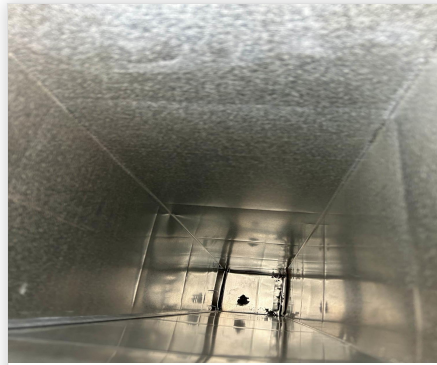
Issue Name : No backdraft damper
Description : EF 1 does not have backdraft damper
Created By : National TAB **Assigned To :** National TAB - Brianna Biggs
Status : Open
Priority : High **Asset Tag :** HVAQ EQUIPMENT 1
Originated Date : 09/23/2025 - Jearod Ferrette - National TAB

EF-1 and EF-2 have no back draft damper.

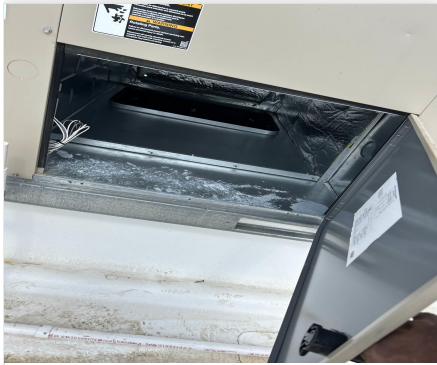
Issue Name : RTU 1 electric heater missing
Description : The electric heater is missing inside the unit.
Created By : National TAB **Assigned To :** National TAB - Brianna Biggs
Status : Closed
Priority : High **Asset Tag :**
Originated Date : 09/22/2025 - Jearod Ferrette - National TAB

Electric heat on site. Electric heater not installed RTU-1. Pending issue. RTU-3/ EAT 71F/LAT 79F

- **10/07/2025 National TAB - Tyler Youells**
 - Unit is not supposed to be equipped with heat Item closed

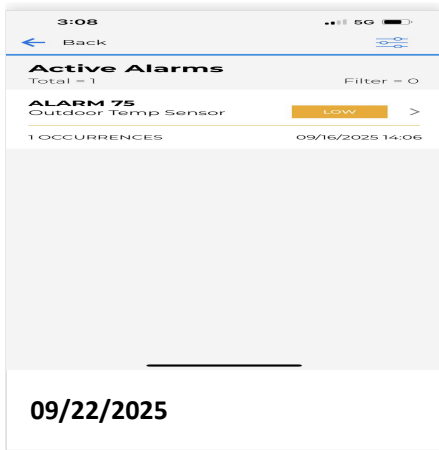
Issue Name : RTU 2 in alarm
Description : RTU 2 in alarm
Created By : National TAB **Assigned To :** National TAB - Brianna Biggs
Status : Open
Priority : Medium **Asset Tag :** RTU2
Originated Date : 09/22/2025 - Jearod Ferrette - National TAB

RTU 2/3 IN ALARM

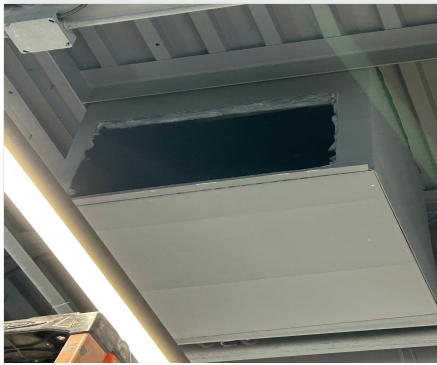
Issue Name : RTU 2 return grill missing
Description : Tech cut out the return for RTU 2 but hasn't place a grill on it.
Created By : National TAB **Assigned To :** National TAB - Brianna Biggs
Status : Open
Priority : Low **Asset Tag :** RTU2
Originated Date : 09/23/2025 - Jearod Ferrette - National TAB

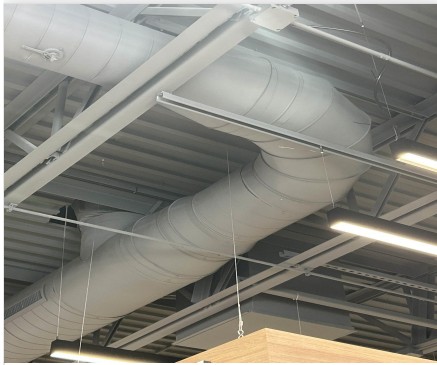
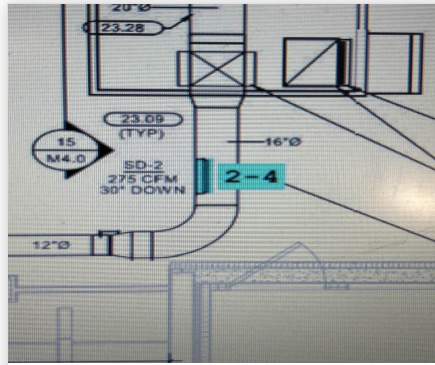
Issue Name : RTU 2 short 1 diffuser
Description : RTU 2 SGRD2-4 not installed on ductwork. Unit short 1 supply diffuser.
Created By : National TAB **Assigned To :** National TAB - Brianna Biggs
Status : Open
Priority : Medium **Asset Tag :** SGRD4
Originated Date : 09/22/2025 - Jearod Ferrette - National TAB

Notes:
SGRD2-4 ON DRAWINGS NOT INSTALLED ON DUCTWORK

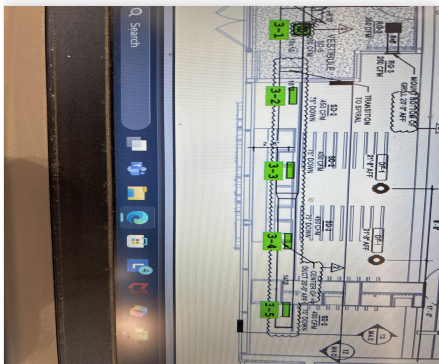
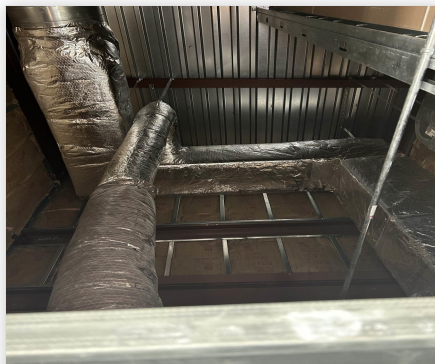
Issue Name : RTU 3 dampers inaccessible
Description : RTU 3 diffusers 3-1 & 3-5 are inaccessible with lift/ladder. Unit currently at total flow.
Created By : National TAB **Assigned To :** National TAB - Brianna Biggs
Status : Open
Priority : InfoOnly **Asset Tag :**
Originated Date : 09/22/2025 - Jearod Ferrette - National TAB

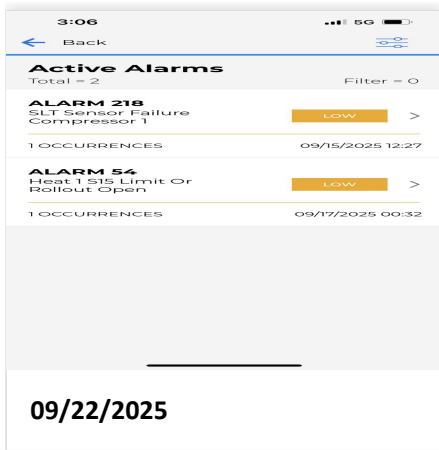
Issue Name : RTU 3 in alarm
Description : RTU 3 in alarm
Created By : National TAB **Assigned To :** National TAB - Brianna Biggs
Status : Open
Priority : Medium **Asset Tag :** RTU3
Originated Date : 09/22/2025 - Jearod Ferrette - National TAB

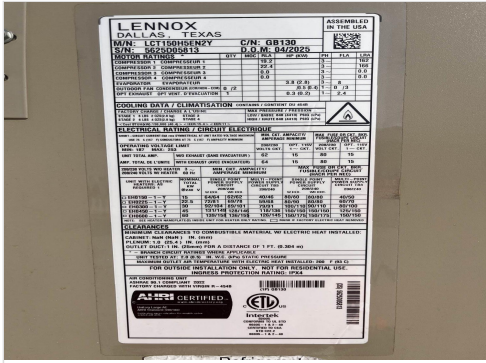
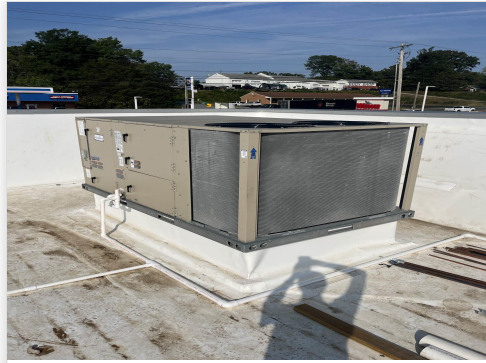
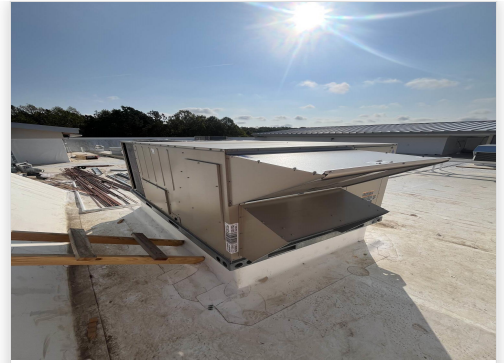
Asset: RTU1

Unit Data		
	Design	Actual
MFG	LENNOX	LENNOX
Serial Num	-	5625D05813
Model Num	LCT150H5E	LCT150H5E
Type	RTU	RTU
Configuration	VERTICAL	VERTICAL
Num OA Filters 1	-	2
OA Filter Size 1	-	14"X23.5"
Num Final Filter 1	-	4
Final Filter Size 1	-	20"X25"X2"

Test Data		
	Design	Actual
SF CFM	4500	4426
SF RPM	-	DD/80%
MOTOR RPM	-	DD/80%
RA CFM	3800	3704
OA CFM	700	722
RL Voltage	-	215.5/ 214.3/216.3
RL Amperage	-	3.6/ 3.6/ 3.7
SF System SetPt	-	80%
RA Damper Position	-	75%
RA Damper Type	-	ECON
OA Damper Position	-	25%
OA Damper Type	-	ECON

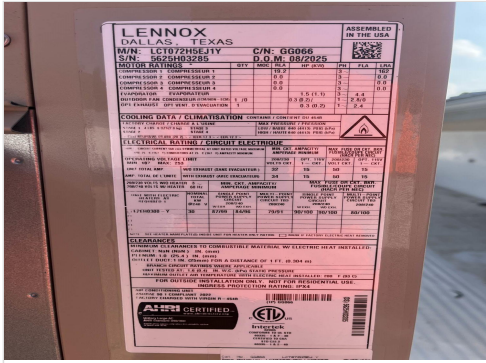
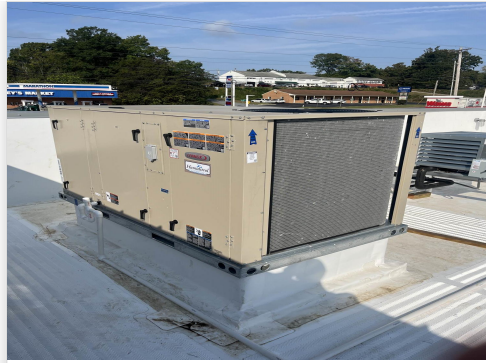
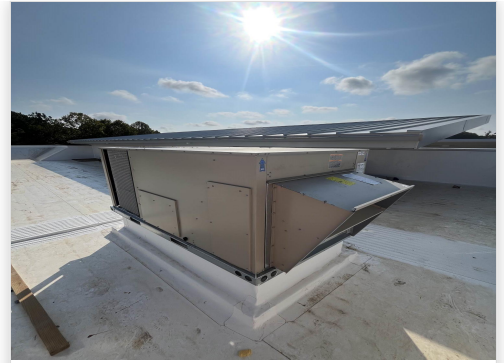
Asset: RTU3

Unit Data		
	Design	Actual
MFG	LENNOX	LENNOX
Serial Num	-	5625H03285
Model Num	LCT072H5E	LCT072H5E
Type	RTU	RTU
Configuration	VERTICAL	VERTICAL
Num OA Filters 1	-	1
OA Filter Size 1	-	28.25"X14
Num Final Filter 1	-	4
Final Filter Size 1	-	20"X20"X2"

Test Data		
	Design	Actual
SF CFM	2400	2298
SF RPM	-	DD/85%
MOTOR RPM	-	DD/85%
RA CFM	2200	2090
OA CFM	200	208
RL Voltage	-	214.7/213.8/215.1
RL Amperage	-	3.0/2.9/2.9
SF System SetPt	-	85%
RA Damper Position	-	76%
RA Damper Type	-	ECON
OA Damper Position	-	24%
OA Damper Type	-	ECON

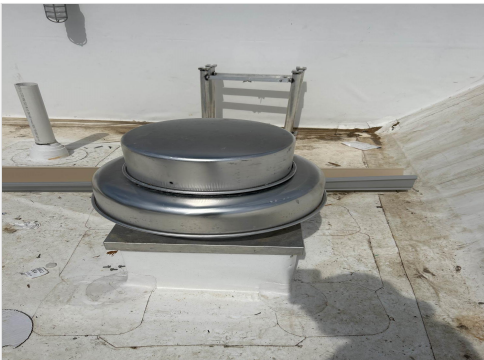
Asset: EF1

Unit Data		
	Design	Actual
MFG	GREENHECK	GREENHECK
Model Num	GB-098-6	GB-098-6
Serial Num	-	26477653
Type	DOWNBLAST	DOWNBLAST
Configuration	VERTICAL	VERTICAL

Test Data		
	Design	Actual
CFM	375	369
Fan RPM	-	DD
Fan Rotation	-	CW
Motor RPM	-	DD
System SetPt	-	6 ON DIAL
RL Voltage	-	N/A
RL Amperage	-	N.A
Total ESP	0.38"	0.18"
Fan Inlet SP	-	-0.18"
Fan Discharge SP	-	ATM

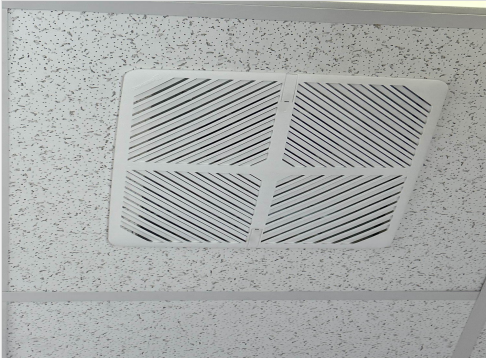
Asset: EF3

Unit Data		
	Design	Actual
MFG	GREENHECK	GREENHECK
Model Num	SP-B200	SP-B200
Serial Num	-	N/L
Type	CEILING	CEILING
Configuration	VERTICAL	VERTICAL

Test Data		
	Design	Actual
CFM	200	204
Fan RPM	-	DD
Fan Rotation	-	CCW
Motor RPM	-	DD
System SetPt	-	HIGH
RL Voltage	-	121
RL Amperage	-	2.05
Total ESP	0.50"	N/R
Fan Inlet SP	-	N/R
Fan Discharge SP	-	ATMO
