Report: TAB Report
Function: Test, Adjust, & Balance
Date: 09/23/2025
Completed By: National TAB

PROJECT
09-22-25 WAWA #6625 LYNCHBURG, VA

Project: 09-22-25 WAWA #6625 LYNCHBURG, VA

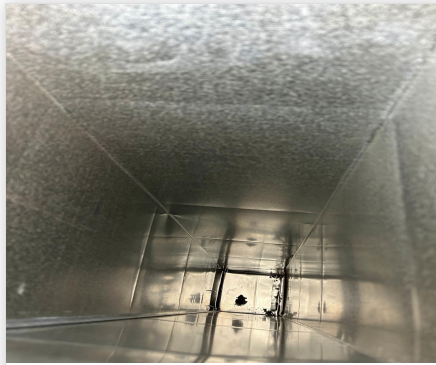
Issue Name : No backdraft damper
Description : EF 1 does not have backdraft damper
Created By : National TAB **Assigned To :** National TAB - Brianna Biggs
Status : Open
Priority : High **Asset Tag :** HVAQ EQUIPMENT 1
Originated Date : 09/23/2025 - Jearod Ferrette - National TAB

EF-1 and EF-2 have no back draft damper.

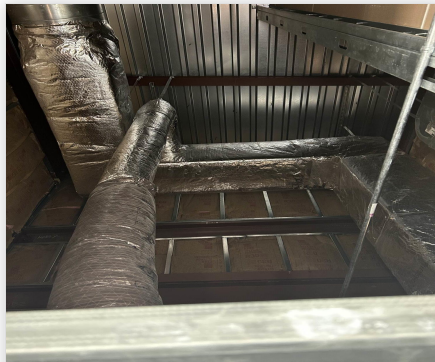
Issue Name : RTU 3 dampers inaccessible
Description : RTU 3 diffusers 3-1 & 3-5 are inaccessible with lift/ladder. Unit currently at total flow.
Created By : National TAB **Assigned To :** National TAB - Brianna Biggs
Status : Open
Priority : InfoOnly **Asset Tag :**
Originated Date : 09/22/2025 - Jearod Ferrette - National TAB

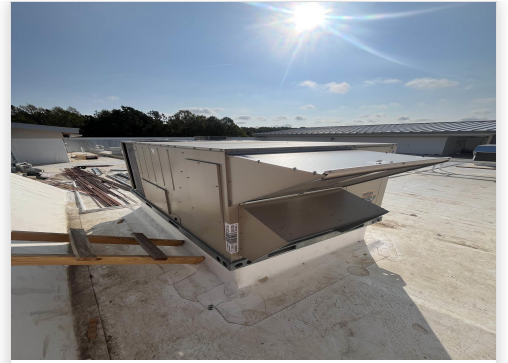
Unit Data - PHOTO LOG

Unit Data		
	Design	Actual
MFG	LENNOX	LENNOX
Serial Num	-	5625D05813
Model Num	LCT150H5E	LCT150H5E
Type	RTU	RTU
Configuration	VERTICAL	VERTICAL
Num OA Filters 1	-	2
OA Filter Size 1	-	14"X23.5"
Num Final Filter 1	-	4
Final Filter Size 1	-	20"X25"X2"

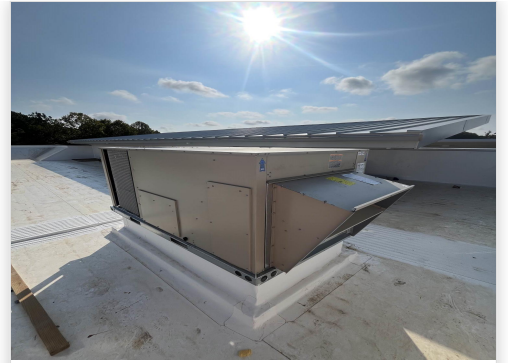
Unit Data - PHOTO LOG

Unit Data		
	Design	Actual
MFG	LENNOX	LENNOX
Serial Num	-	5625H03285
Model Num	LCT072H5E	LCT072H5E
Type	RTU	RTU
Configuration	VERTICAL	VERTICAL
Num OA Filters 1	-	1
OA Filter Size 1	-	28.25"X14
Num Final Filter 1	-	4
Final Filter Size 1	-	20"X20"X2"

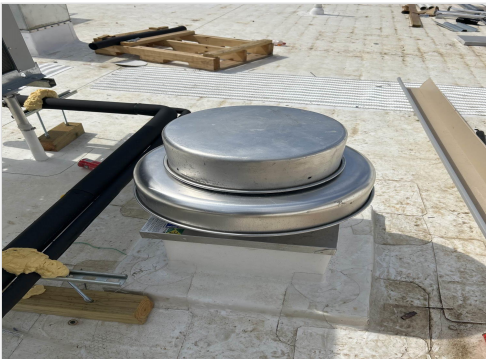
Unit Data - PHOTO LOG

Unit Data		
	Design	Actual
MFG	GREENHECK	GREENHECK
Model Num	GB-098-6	GB-098-6
Serial Num	-	26477654
Type	DOWNBLAST	DOWNBLAST
Configuration	VERTICAL	VERTICAL
