**Report: TAB Report**  
**Function: Test, Adjust, & Balance**  
**Date: 03/12/2026**  
**Completed By: National TAB**

**PROJECT**  
**03-02-26 QT #0419 MESA, AZ**

QUIKTRIP  
4705 SOUTH 129TH EAST AVENUE  
TULSA, OK 74134

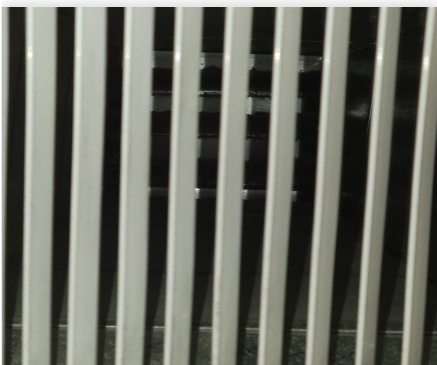
**Issue Name :** EXHAUST FANS TOO LOW @MAX  
**Description :** Both EF1 & EF2: Knob and inner potentiometer were turned both ways to make sure fans at max capability. Still not enough flow. VFD did not seem to change EF1 much, if at all, possibly wired incorrectly. High SP on EF1 and pic show backdraft damper not functioning - stuck shut blocking flow.  
**Created By :** National TAB                      **Assigned To :** National TAB - Dan Hertenstein  
**Status :** Open  
**Priority :** High                                      **Asset Tag :**  
**Originated Date :** 03/04/2026 - Christine Weale - National TAB

Notes:  
LOW DUE TO DAMPER STUCK SHUT, SEE 'REMARKS'.
