**Report: TAB Report**  
**Function: Test, Adjust, & Balance**  
**Date: 01/21/2026**  
**Completed By: Wesley John**

**PROJECT**  
**01-19-26 CHIPOTLE #5470 Edinburg, TX**

Project: 01-19-26 CHIPOTLE #5470 Edinburg, TX

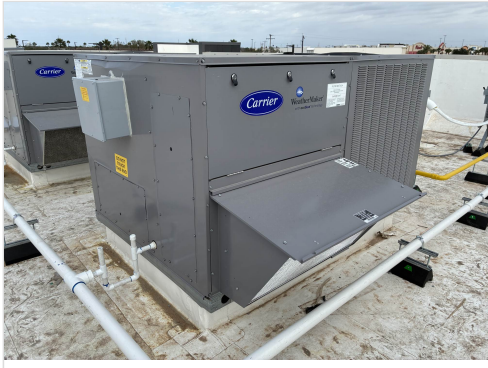
Asset: RTU1

Unit Data		
	Design	Actual
MFG	CARRIER	CARRIER
Serial Num	-	0424P63023
Model Num	48FCFN12	48FCFN12D3M5A6W4F0
Type	RTU	RTU
Configuration	VERTICAL DISCHARGE	VERTICAL DISCHARGE
Num OA Filters 1	-	1
OA Filter Size 1	-	20x36x1
Num Final Filter 1	-	4
Final Filter Size 1	-	20x20x2

Test Data		
	Design	Actual
SF CFM	3600	3679
SF RPM	-	1776
RA CFM	3100	3138
OA CFM	500	541
RL Voltage	-	213/212/212
RL Amperage	-	5.5/5.6/5.6
SF Rotation	-	CCW
SF System SetPt	-	6.4 VDC
RA Damper Position	-	72%
Min OA Damper Position	-	4.25 VDC (28%)
Min OA Damper Type	-	OPPOSED BLADE
OA Enthalpy Setpt	-	ES5

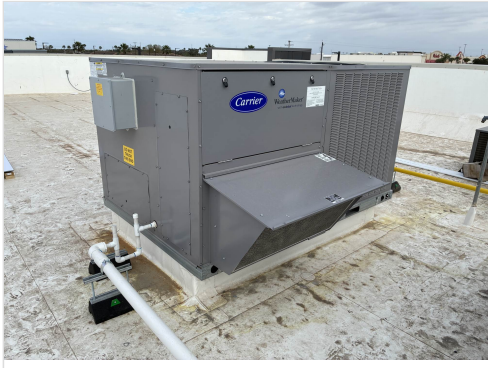
Asset: RTU2

Unit Data		
	Design	Actual
MFG	CARRIER	CARRIER
Serial Num	-	0424P62034
Model Num	48FCFN12	48FCFN12D3M5A6W4F0
Type	RTU	RTU
Configuration	VERTICAL DISCHARGE	VERTICAL DISCHARGE
Num OA Filters 1	-	1
OA Filter Size 1	-	20x36x1
Num Final Filter 1	-	4
Final Filter Size 1	-	20x20x2

Test Data		
	Design	Actual
SF CFM	4000	4066
SF RPM	-	1741
RA CFM	3000	3009
OA CFM	1000	1057
RL Voltage	-	212/213/212
RL Amperage	-	5.7/5.8/5.7
SF Rotation	-	CCW
SF System SetPt	-	6.3 VDC
RA Damper Position	-	59%
Min OA Damper Position	-	5.30 VDC (41%)
Min OA Damper Type	-	OPPOSED BLADE
OA Enthalpy Setpt	-	ES5

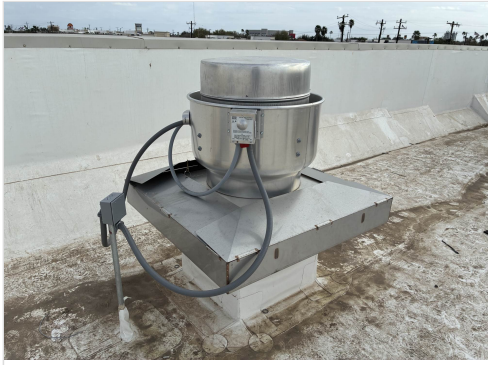
Asset: EF1

Unit Data		
	Design	Actual
<b>MFG</b>	ACCUREX	ACCUREX
<b>Model Num</b>	XCUE-160-VG	XCUE-160-20-VG-1-26-G
<b>Serial Num</b>	-	27804169
<b>Type</b>	CENTRIFUGAL	CENTRIFUGAL
<b>Configuration</b>	UPBLAST	UPBLAST

Test Data		
	Design	Actual
<b>CFM</b>	2550	2625
<b>Fan RPM</b>	1330	1188
<b>Fan Rotation</b>	-	CW
<b>Motor RPM</b>	-	1188
<b>System SetPt</b>	-	6.6 VDC
<b>RL Voltage</b>	-	212/212/212
<b>RL Amperage</b>	-	3.6/3.6/3.6
<b>Total ESP</b>	1.2"	1.08"
<b>Fan Inlet SP</b>	-	-1.08"
<b>Fan Discharge SP</b>	-	ATM

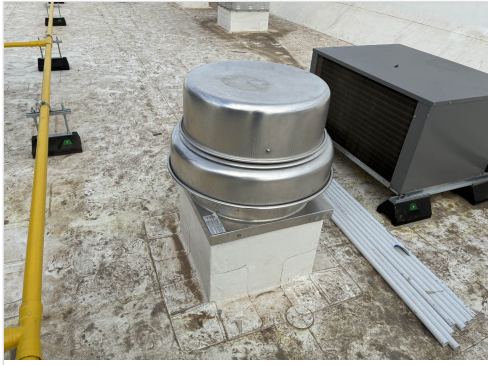
Asset: EF2

Unit Data		
	Design	Actual
MFG	ACCUREX	ACCUREX
Model Num	XRED-097-VG	XRED-097-4-VG-1-19-X
Serial Num	-	27804168
Type	CENTRIFUGAL	CENTRIFUGAL
Configuration	DOWNBLAST	DOWNBLAST

Test Data		
	Design	Actual
CFM	150	151
Fan RPM	1330	DIRECT DRIVE
Fan Rotation	-	CW
Motor RPM	-	DIRECT DRIVE
System SetPt	-	7/10
RL Voltage	-	122
RL Amperage	-	1.2
Total ESP	0.60"	0.21"
Fan Inlet SP	-	-0.21"
Fan Discharge SP	-	ATM

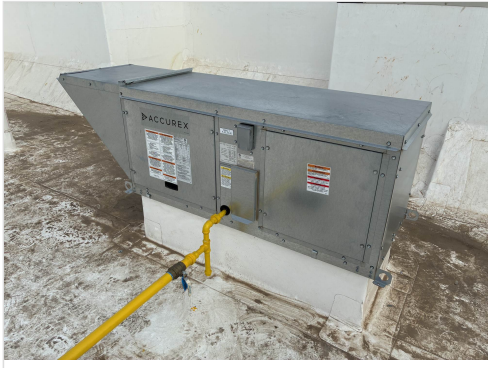
Asset: MAU1

Unit Data		
	Design	Actual
MFG	ACCUREX	ACCUREX
Model Num	XDGX-P115-H05-VG	XDGX-P115-H05-VG
Serial Num	-	27815431
Type	MAU	MAU
Configuration	VERTICAL DISCHARGE	VERTICAL DISCHARGE

Test Data		
	Design	Actual
CFM	1300	1266
SF RPM	-	1050
Motor RPM	-	1050
SF System SetPt	-	6/10
RL Voltage	-	122
RL Amperage	-	5.4
Total ESP	-	0.23"
Fan Discharge SP	-	0.23"

[1] GAS TO MAU WAS TURNED OFF. GAS HEAT NOT TESTED.
