**Report: TAB**

**Function: Test, Adjust, & Balance**

**Date: 07/22/2025**

**07-21-25 WHATABURGER #1610  
GREENWOOD, SC**

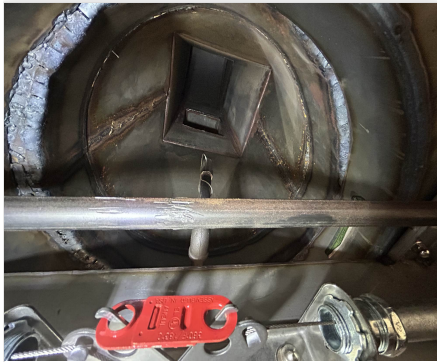
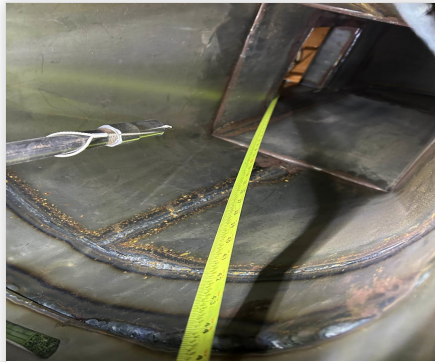
Project Issue File Details

**Issue Name :** KEF 1 fire access door missing.  
**Description :** KEF 1 fire access door missing which gave hood 1 low flow. Temporary cover in place until door is installed, to get desire flow.  
**Created By :** National TAB                      **Assigned To :** National TAB - Brianna Biggs  
**Status :** Open  
**Priority :** High                                      **Asset Tag :** KEF1  
**Originated Date :** 07/22/2025 - Jearod Ferrette - National TAB

Missing fire access door on KEF1, temp door in place. All units are on, no obvious area to speak of. Front door -0.005, Side -0.0002, Rear -0.004

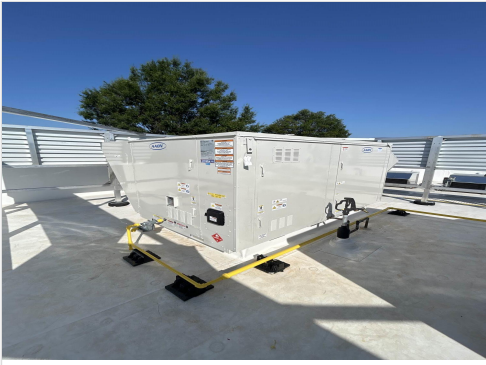
## Unit Data - PHOTO LOG

Asset: RTU1

Unit Data		
	Design	Actual
MFG	NA	AAON
Serial Num	-	202506-BNGN122916
Model Num	NA	RNA-018-C-A-8-BAB04-CB1L0
Num OA Filters 1	-	3
OA Filter Size 1	-	20X25X1
Num Final Filter 1	-	6
Final Filter Size 1	-	20X25X2

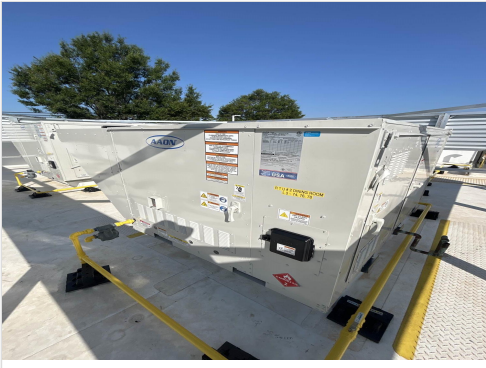
## Unit Data - PHOTO LOG

Asset: RTU2

Unit Data		
	Design	Actual
MFG	NA	AAON
Serial Num	-	202504- ANGK122850
Model Num	NA	RN-013-8-0- GB04-3F9
Num OA Filters 1	-	2
OA Filter Size 1	-	20X25X1
Num Final Filter 1	-	4
Final Filter Size 1	-	20X25X2

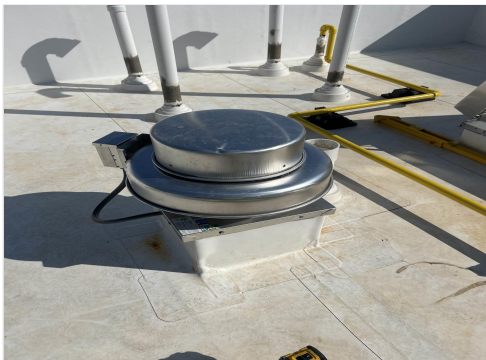
### Unit Data - PHOTO LOG

Asset: EF1

Unit Data		
	Design	Actual
MFG	GREENHECK	GREENHECK
Model Num	G-080-VG	G-080-VG
Serial Num	-	26421435
Type	DOWNBLAST	DOWNBLAST
Configuration	VERTICAL	VERTICAL

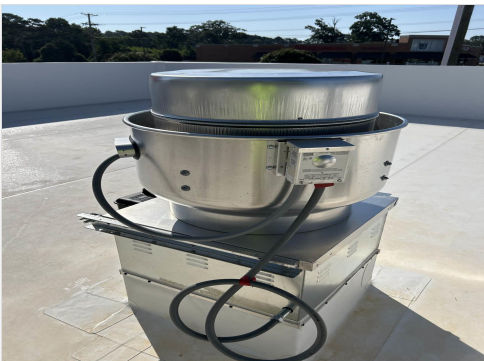
## Unit Data - PHOTO LOG

Asset: KEF1

Unit Data		
	Design	Actual
MFG	GREENHECK	GREENHECK
Model Num	CUE-140-VG	CUE-140-VG
Serial Num	-	26423982
Type	UPBLAST	UPBLAST
Configuration	VERTICAL	VERTICAL

Motor Data		
	Design	Actual
Motor MFG	-	VARI-GREEN
Frame	-	NA
Horsepower	1	3/4
Motor Rpm	-	1750
Phase	1	1
Voltage (rated)	208	208
Amperage (rated)	-	4.8
Service Factor	-	1

KEF-1 MOTOR IS UNDER SIZED. MSET CALLS FOR 1 HP BUT HAS 3/4HP INSTALLED. CURRENTLY GETTING 1128 CFMS BUT NEEDS 1994 CFMS. (56%) OF DESGIN.

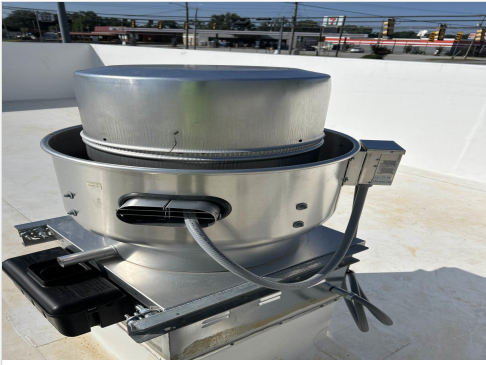
## Unit Data - PHOTO LOG

Asset: KEF2

Unit Data		
	Design	Actual
MFG	GREENHECK	GREENHECK
Model Num	CUE-120-VG	CUE-120-VG
Serial Num	-	26423983
Type	UPBLAST	UPBLAST
Configuration	VERTICAL	VERTICAL

Notes:  
MOTOR SET 7.5/10

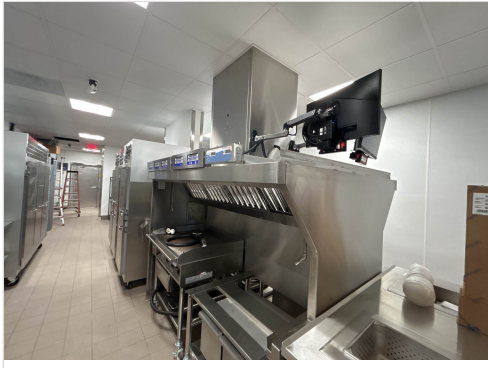
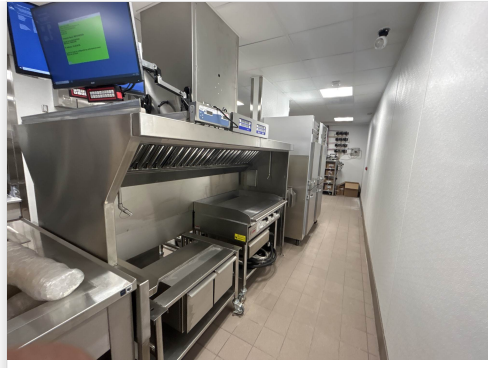
**Unit Data - PHOTO LOG**

Asset: HD1

Unit Data		
	Design	Actual
MFG	H&K DALLAS	H&K DALLAS
Model Num	MH16346	MH16346
Job / Serial Num	-	8160531-001
Type	TYPE I CANOPY	TYPE I CANOPY
Hood length	86"	86"
Hood Width	55"	55"

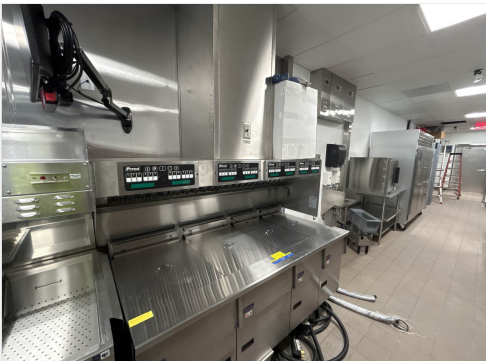
## Unit Data - PHOTO LOG

Asset: HD2

Unit Data		
	Design	Actual
MFG	H&K DALLAS	H&K DALLAS
Model Num	MH16346	MH16346
Job / Serial Num	-	8157824-001
Type	TYPE I CANOPY	TYPE I CANOPY
Hood length	73"	73"
Hood Width	22"	22"
