**Report: TAB**

**Function: Test, Adjust, & Balance**

**Date: 07/22/2025**

**07-21-25 WHATABURGER #1610  
GREENWOOD, SC**

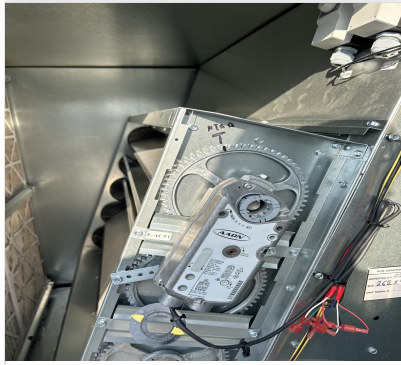
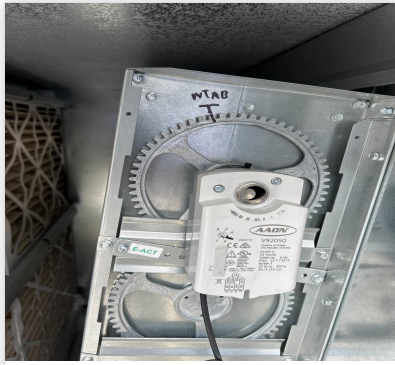
<b>Final outside air damper position is set manually and marked with permanent marker?</b>	Pass
--	------

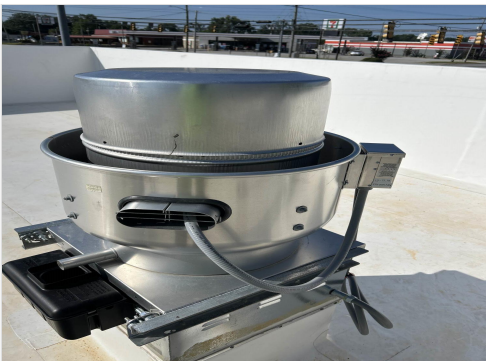
## Unit Data - PHOTO LOG

Unit Data		
	Design	Actual
MFG	GREENHECK	GREENHECK
Model Num	CUE-120-VG	CUE-120-VG
Serial Num	-	26423983
Type	UPBLAST	UPBLAST
Configuration	VERTICAL	VERTICAL

Test Data		
	Design	Actual
CFM	1216	1185
Fan RPM	1539	DD/ SET 6.8
Fan Rotation	-	CW
Motor RPM	-	DD/ SET 6.8
RL Voltage	-	206/207/206
RL Amperage	-	2.6/2.8/.2.6
Suction ESP	-	-0.46"
Discharge ESP	-	ATMO
Total ESP	0.75"	0.46"

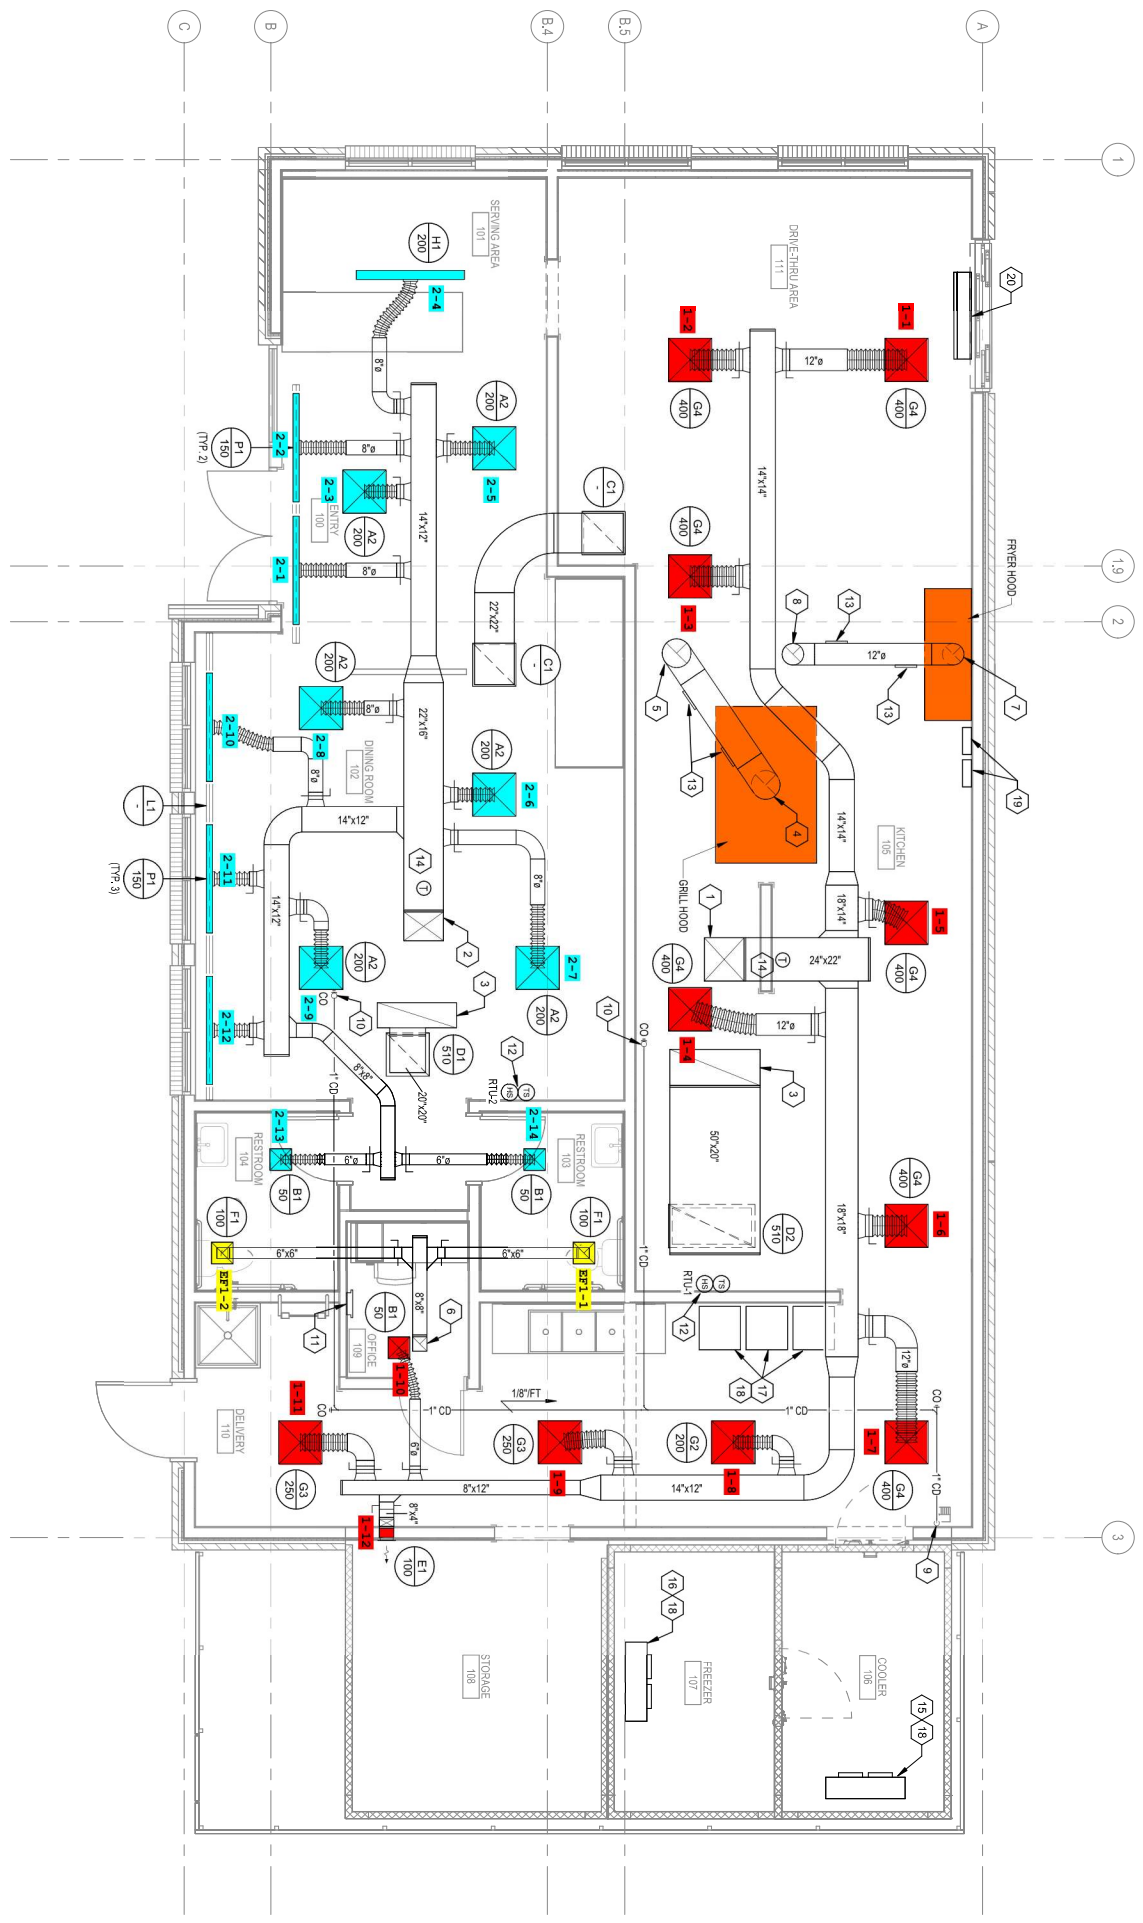
M1  
MECHANICAL FLOOR PLAN  
1/4" = 1'-0"

19) REFER TO ANNOT. 5'S FOR MOUNTING ON WALL, CARRIER FINAL LOCATION OF STATION WITH OWNER, ARCHITECT,  
AND OTHER TRADES. REFER TO DETAILS AND SPECIFICATIONS.  
20) AIR CURTAIN MOUNTED ON WALL, FINISHED BY OWNER, INSTALLED BY MFC IN COORDINATION WITH GC.
