**Report: TAB Report**  
**Function: Test, Adjust, & Balance**  
**Date: 01/20/2026**  
**Completed By: National TAB**

**01-12-26 WAWA #6618 RICHMOND, VA**

7351 IRON BRIDGE ROAD

Wawa  
260 West Baltimore Pike  
Wawa, PA 19063

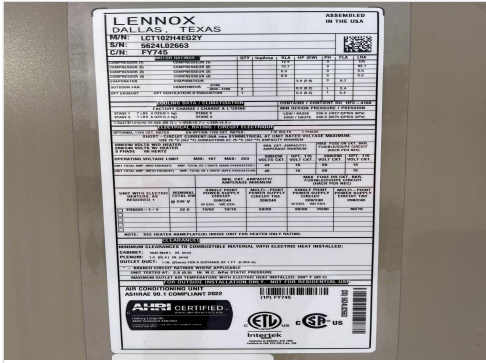
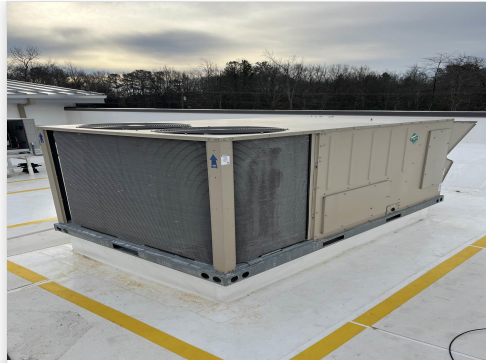
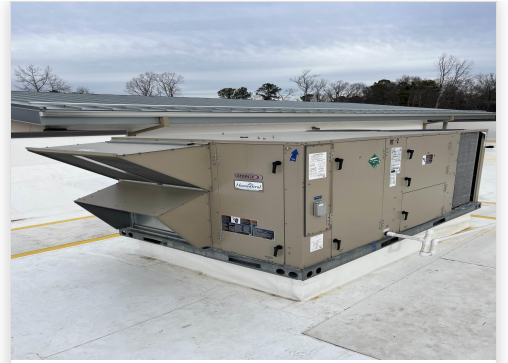
Notes:  
RTU2 Final filters dirty, recommend replacing.

**Issue Name :** RTU-2 Dirty Filters  
**Description :** Unit's final filters are dirty. Recommend replacing with clean MERV filters.  
**Created By :** National TAB                      **Assigned To :** National TAB - Brianna Biggs  
**Status :** Open  
**Priority :** [Medium](#)                                      **Asset Tag :**  
**Originated Date :** 01/20/2026 - John Barresi - National TAB

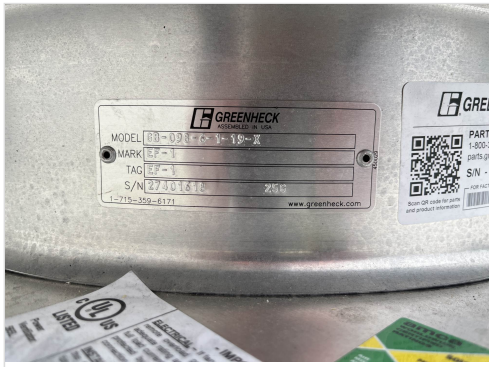
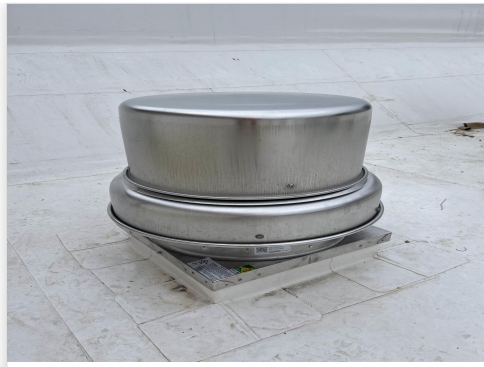
Notes:  
EF1 no backdraft damper installed into duct.

**Issue Name :** EF Backdraft Damper  
**Description :** EF-1 and EF-2 both do not have a backdraft damper installed.  
**Created By :** National TAB                      **Assigned To :** National TAB - Brianna Biggs  
**Status :** Open  
**Priority :** Low                                      **Asset Tag :**  
**Originated Date :** 01/14/2026 - John Barresi - National TAB

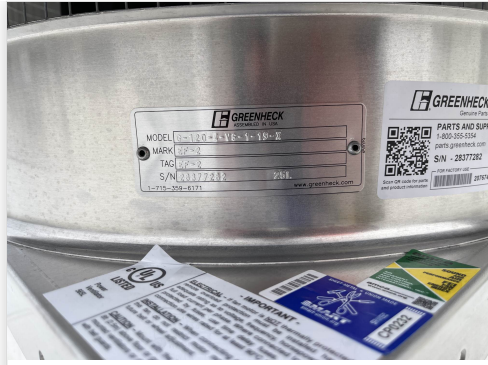
EF2 no backdraft damper installed.

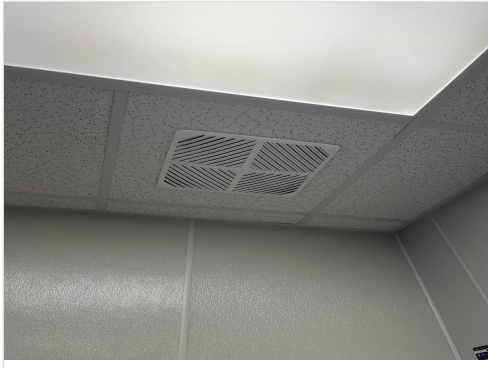
EF3 no speed controller connected, fan operating at max speed.

**Issue Name :** EF-3 Missing Speed Controller  
**Description :** Exhaust fan doesn't have a variable speed controller installed. Fan currently exhausting 240CFM out of 200CFM design. (120%)  
**Created By :** National TAB                      **Assigned To :** National TAB - Will Turnbough  
**Status :** Open  
**Priority :** Urgent                                      **Asset Tag :**  
**Originated Date :** 01/20/2026 - John Barresi - National TAB
