Report: TAB Report
Function: Test, Adjust, & Balance
Date: 01/20/2026
Completed By: National TAB

01-12-26 WAWA #6618 RICHMOND, VA

Project: 01-12-26 WAWA #6618 RICHMOND, VA

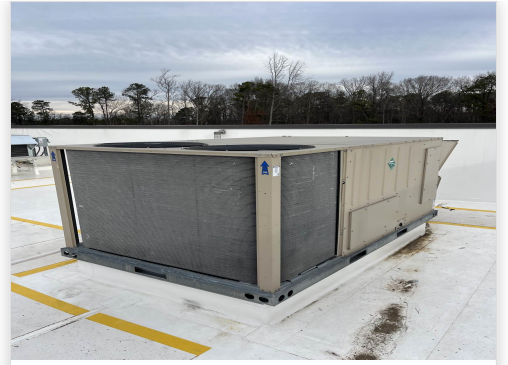
Asset: RTU1

Unit Data		
	Design	Actual
MFG	LENNOX	LENNOX
Serial Num	-	5624L02335
Model Num	LCT150H4E	LCT150H4E
Type	RTU	RTU
Configuration	VERTICAL	VERTICAL
Num OA Filters 1	-	2
OA Filter Size 1	-	14.1875"X23.25"
Num Final Filter 1	-	4
Final Filter Size 1	-	20"X25"X2"

Test Data		
	Design	Actual
SF CFM	4500	4435
SF RPM	-	1335
MOTOR RPM	3800	1335
RA CFM	3800	3725
OA CFM	700	710
RL Voltage	-	214.7/215.4/215.4
RL Amperage	-	3.2/3.1/3.1
SF System SetPt	-	75%
RA Damper Position	-	77%
RA Damper Type	-	ECONOMIZER
OA Damper Position	-	23%
OA Damper Type	-	ECONOMIZER

Performance Data		
	Design	Actual
MA Plenum SP	-	-0.50"
Fan Suction SP	-	-0.81"
Fan Discharge SP	-	0.36"
Total ESP	0.70"	0.86"
Fan Total SP	-	1.17"

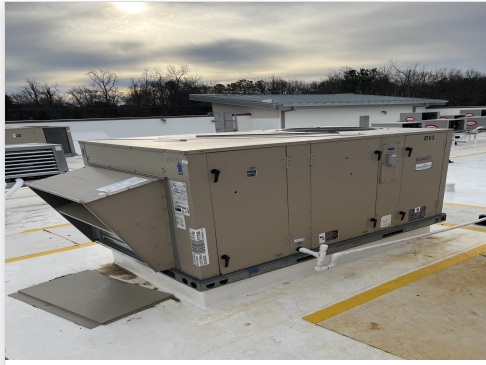
Asset: RTU3

Test Data		
	Design	Actual
SF CFM	2400	2458
SF RPM	-	2343
MOTOR RPM	-	2343
RA CFM	2200	2256
OA CFM	200	202
RL Voltage	-	213.9/214.6/214.8
RL Amperage	-	2.1/2.1/2.1
SF System SetPt	-	71%
RA Damper Position	-	81%
RA Damper Type	-	ECONOMIZER
OA Damper Position	-	19%
OA Damper Type	-	ECONOMIZER

Performance Data		
	Design	Actual
MA Plenum SP	-	-0.44"
Fan Suction SP	-	-0.57"
Fan Discharge SP	-	0.32"
Total ESP	0.50"	1.01"
Fan Total SP	-	0.89"

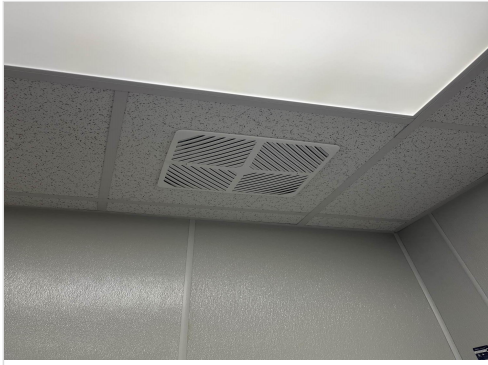
Asset: EF3

Test Data		
	Design	Actual
CFM	200	240
Fan RPM	-	1000
Fan Rotation	-	CCW
Motor RPM	-	1000
System SetPt	-	100%
RL Voltage	-	N/A
RL Amperage	-	N/A
Total ESP	0.50"	0.05"
Fan Inlet SP	-	-0.05"
Fan Discharge SP	-	ATM

EF3 no speed controller connected, fan operating at max speed.
