**Report: TAB Report**  
**Function: Test, Adjust, & Balance**  
**Date: 01/20/2026**  
**Completed By: National TAB**

## 01-12-26 WAWA #6618 RICHMOND, VA

7351 IRON BRIDGE ROAD

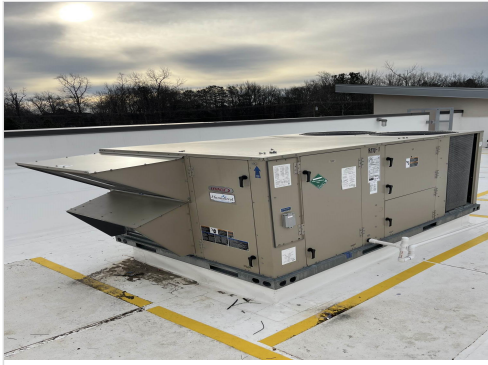
# Unit Data - PHOTO LOG

Unit Data		
	Design	Actual
MFG	LENNOX	LENNOX
Serial Num	-	5624L02335
Model Num	LCT150H4E	LCT150H4E
Type	RTU	RTU
Configuration	VERTICAL	VERTICAL
Num OA Filters 1	-	2
OA Filter Size 1	-	14.1875"X23.25"
Num Final Filter 1	-	4
Final Filter Size 1	-	20"X25"X2"
