Report: TAB Report
Function: Test, Adjust, & Balance
Date: 01/20/2026
Completed By: National TAB

01-12-26 WAWA #6618 RICHMOND, VA

7351 IRON BRIDGE ROAD

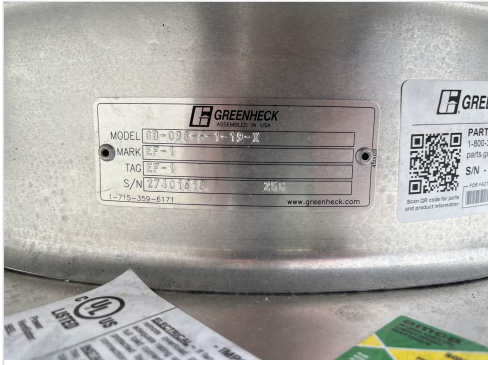
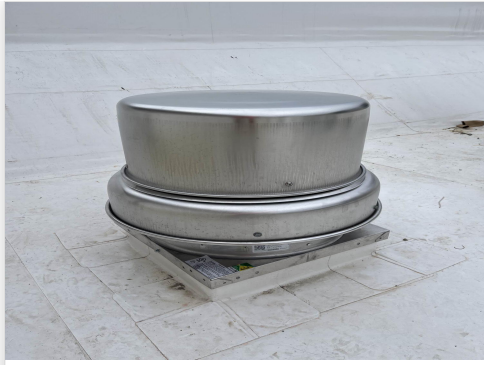
Issue Name : EF Backdraft Damper
Description : EF-1 and EF-2 both do not have a backdraft damper installed.
Created By : National TAB **Assigned To :** National TAB - Brianna Biggs
Status : Open
Priority : Low **Asset Tag :**
Originated Date : 01/14/2026 - John Barresi - National TAB

Notes:
EF1 no backdraft damper installed into duct.
