Report: TAB Report
Function: Test, Adjust, & Balance
Date: 01/20/2026
Completed By: National TAB

01-12-26 WAWA #6618 RICHMOND, VA

7351 IRON BRIDGE ROAD

RICHMOND, VA 23234

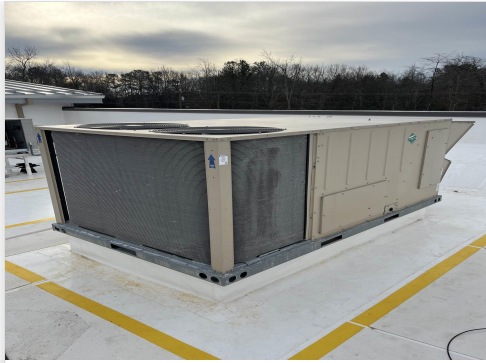
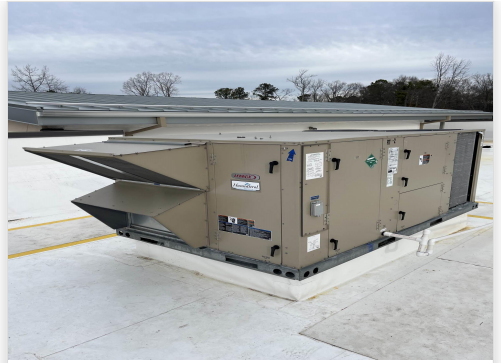
Unit Data - PHOTO LOG

Unit Data		
	Design	Actual
MFG	LENNOX	LENNOX
Serial Num	-	5624L02663
Model Num	LCT102H4E	LCT102H4E
Type	RTU	RTU
Configuration	VERTICAL	VERTICAL
Num OA Filters 1	-	2
OA Filter Size 1	-	14.1875"X23.25"
Num Final Filter 1	-	4
Final Filter Size 1	-	20"X25"X2"

Test Data		
	Design	Actual
SF CFM	3400	3449
SF RPM	-	926
MOTOR RPM	-	926
RA CFM	3020	3060
OA CFM	380	389
RL Voltage	-	210.9/211.0/211.3
RL Amperage	-	1.6/1.7/1.6
SF System SetPt	-	52%
RA Damper Position	-	76%
RA Damper Type	-	ECONOMIZER
OA Damper Position	-	24%
OA Damper Type	-	ECONOMIZER

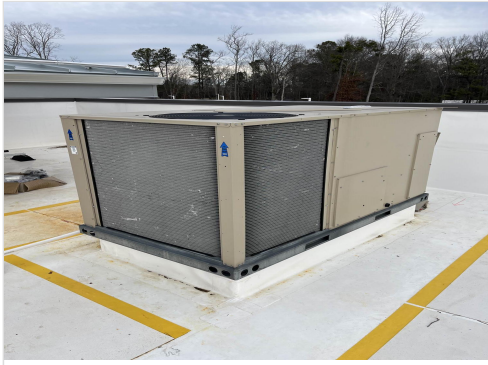
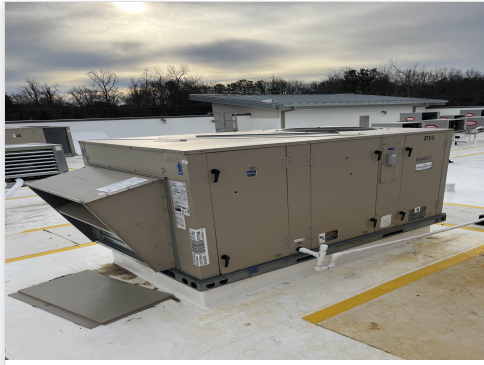
Unit Data - PHOTO LOG

Unit Data		
	Design	Actual
MFG	LENNOX	LENNOX
Serial Num	-	5624L05432
Model Num	LCT072H4E	LCT072H4E
Type	RTU	RTU
Configuration	VERTICAL	VERTICAL
Num OA Filters 1	-	1
OA Filter Size 1	-	27.625"X14.25"
Num Final Filter 1	-	4
Final Filter Size 1	-	20"X20"X2"

Test Data		
	Design	Actual
SF CFM	2400	2439
SF RPM	-	2343
MOTOR RPM	-	2343
RA CFM	2200	2216
OA CFM	200	223
RL Voltage	-	214/214/213
RL Amperage	-	3.1/3.1/3.0
SF System SetPt	-	71%
RA Damper Position	-	81%
RA Damper Type	-	ECONOMIZER
OA Damper Position	-	19%
OA Damper Type	-	ECONOMIZER

Notes:
Total supply traversed ~2439CFM

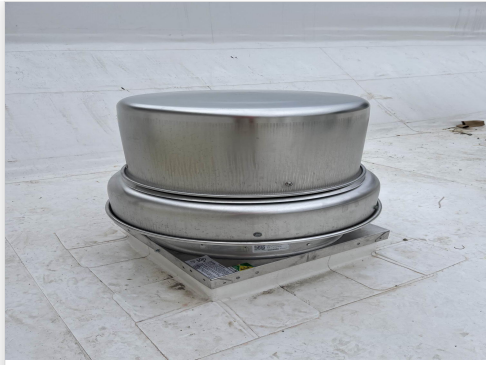
Unit Data - PHOTO LOG

Unit Data		
	Design	Actual
MFG	GREENHECK	GREENHECK
Model Num	GB-098-6	GB-098-6
Serial Num	-	27401618 25G
Type	DOWNBLAST	DOWNBLAST
Configuration	VERTICAL	VERTICAL

Test Data		
	Design	Actual
CFM	375	349
Fan RPM	-	1087
Fan Rotation	-	CW
Motor RPM	-	1755
System SetPt	-	2.5 TURNS OUT
RL Voltage	-	N/A
RL Amperage	-	N/A
Total ESP	0.38"	0.12"
Fan Inlet SP	-	-0.12"
Fan Discharge SP	-	ATM
