**Report: TAB Report**  
**Function: Test, Adjust, & Balance**  
**Date: 01/20/2026**  
**Completed By: National TAB**

**01-12-26 WAWA #6618 RICHMOND, VA**

7351 IRON BRIDGE ROAD

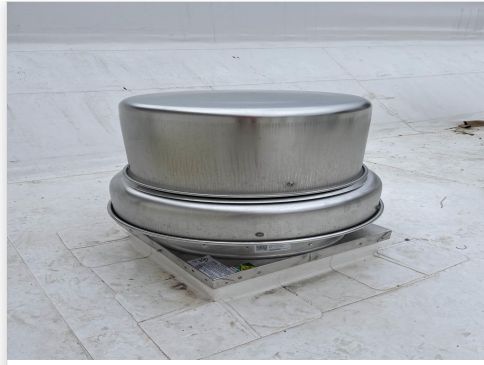
# Unit Data - PHOTO LOG

Asset: EF1

AREA:RESTROOM

Unit Data		
	Design	Actual
MFG	GREENHECK	GREENHECK
Model Num	GB-098-6	GB-098-6
Serial Num	-	27401618 25G
Type	DOWNBLAST	DOWNBLAST
Configuration	VERTICAL	VERTICAL

Test Data		
	Design	Actual
CFM	375	349
Fan RPM	-	1087
Fan Rotation	-	CW
Motor RPM	-	1755
System SetPt	-	2.5 TURNS OUT
RL Voltage	-	N/A
RL Amperage	-	N/A
Total ESP	0.38"	0.12"
Fan Inlet SP	-	-0.12"
Fan Discharge SP	-	ATM
