**Report: TAB REPORT
Function: Test, Adjust, & Balance
Date: 08/23/2024**

**PROJECT
08-05-24 PF CHANGS AUSTIN, TX**

Project: 08-05-24 PF CHANGS AUSTIN, TX

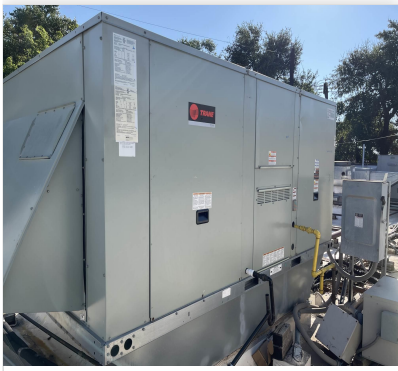
Issue Name : RTU-1
Description : RTU-1 is operating at 89% of design flow with fan speed maximized. Recommend pulley change to bring air flow to within tolerance.
Created By : National TAB **Assigned To :** National TAB - Will Turnbough
Status : Open
Priority : Urgent **Asset Tag :**
Originated Date : 08/23/2024 - Wesley John - National TAB

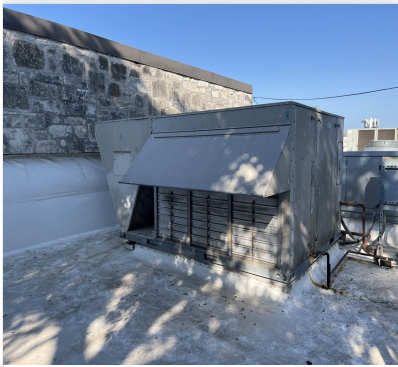
Issue Name : RTU-2
Description : RTU-2 is operating at 89% of air flow with fan speed maximized. A pulley change will help to bring air flow to within tolerance, however supply fan motor is operating near full load amp rating. Supply air CFM would not be able to be increased much.
Created By : National TAB **Assigned To :** National TAB - Will Turnbough
Status : Open
Priority : Urgent **Asset Tag :**
Originated Date : 08/23/2024 - Wesley John - National TAB

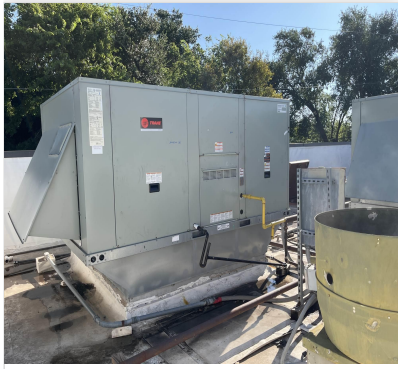
Issue Name : RTU-3
Description : RTU-3 is operating at 80% of design flow with fan speed maximized. Recommend pulley change to bring air flow to within tolerance.
Created By : National TAB **Assigned To :** National TAB - Will Turnbough
Status : Open
Priority : Urgent **Asset Tag :**
Originated Date : 08/23/2024 - Wesley John - National TAB

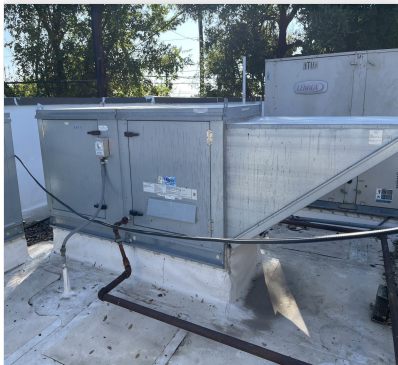
MAU-1

Test Data		
	Design	Actual
CFM	7095	6742
SF RPM	-	NA
Motor RPM	-	NA
SF System SetPt	-	NA
RL Voltage	-	207/208/207
RL Amperage	-	9.7/9.9/9.7
Total ESP	-	0.87"
Fan Discharge SP	-	0.87"

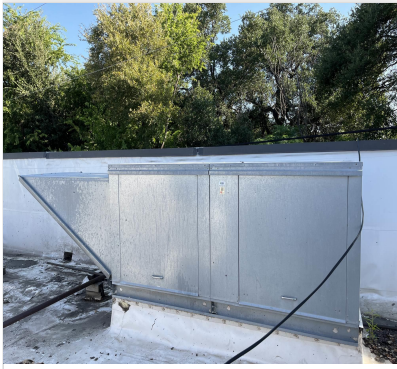
MAU-2

Test Data		
	Design	Actual
CFM	6240	6486
SF RPM	-	NA
Motor RPM	-	NA
SF System SetPt	-	NA
RL Voltage	-	207/207/208
RL Amperage	-	10.1/10.2/10.1
Total ESP	-	0.98"
Fan Discharge SP	-	0.98"

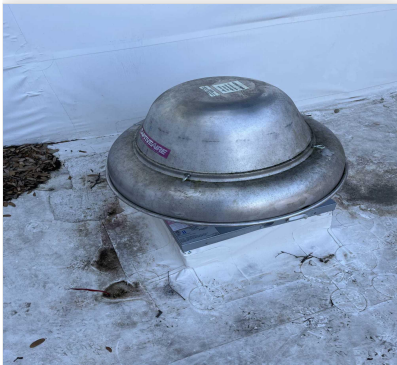
EF-1

Test Data		
	Design	Actual
CFM	750	705
Fan RPM	-	1564
Fan Rotation	-	CCW
Motor RPM	-	1564
System SetPt	-	65%
RL Voltage	-	115
RL Amperage	-	2.3
Total ESP	0.50"	0.43"
Fan Inlet SP	-	-0.43"
Fan Discharge SP	-	ATM

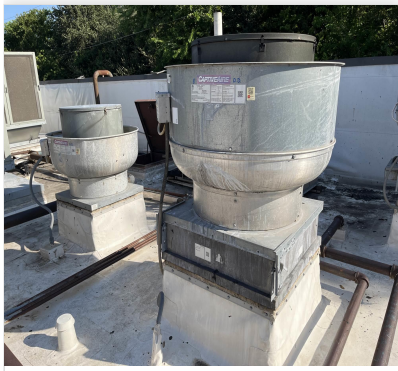
KEF-1

Test Data		
	Design	Actual
CFM	4730	4724
Fan RPM	-	(1)
Fan Rotation	-	CCW
Motor RPM	-	(1)
RL Voltage	-	207
RL Amperage	-	5.9/5.8/5.8
Suction ESP	-	-0.47"
Discharge ESP	-	ATM
Total ESP	1.25"	0.47"

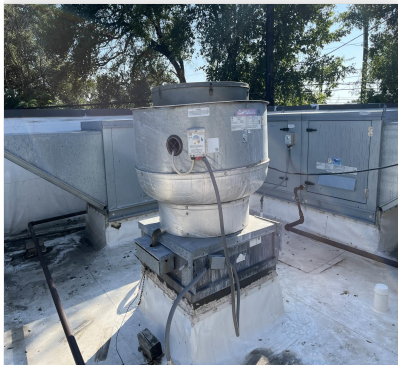
KEF-2

Test Data		
	Design	Actual
CFM	4730	4677
Fan RPM	-	1124
Fan Rotation	-	CCW
Motor RPM	-	1124
RL Voltage	-	209
RL Amperage	-	3.1/3.0/3.0
Suction ESP	-	-0.86"
Discharge ESP	-	ATM
Total ESP	1.25"	0.86"

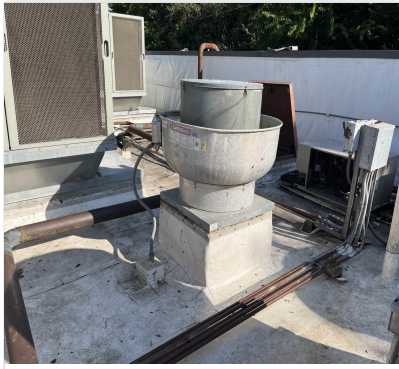
KEF-3

Test Data		
	Design	Actual
CFM	4800	3996
Fan RPM	-	1751
Fan Rotation	-	CCW
Motor RPM	-	1751
RL Voltage	-	207
RL Amperage	-	4.6/4.7/4.8
Suction ESP	-	-0.96"
Discharge ESP	-	ATM
Total ESP	1.25"	0.96"

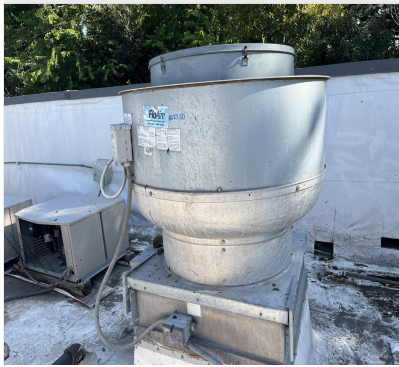
KEF-4

Test Data		
	Design	Actual
CFM	3000	2175
Fan RPM	-	1118
Fan Rotation	-	CCW
Motor RPM	-	1118
RL Voltage	-	208
RL Amperage	-	5.8
Suction ESP	-	1.15"
Discharge ESP	-	ATM
Total ESP	1.25"	1.15"
