**Report: TAB REPORT**  
**Function: Test, Adjust, & Balance**  
**Date: 07/14/2023**

**06-05-23 SWEETGREEN - PEABODY, MA**  
**(TAB, IAQ)**

210 ANDOVER ST

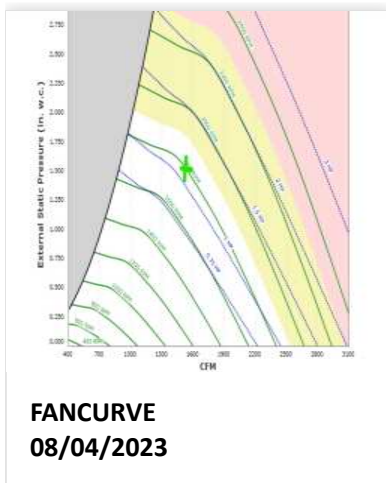
**Issue Name :** GX-1 AIRFLOW IS LOW  
**Description :** GX1 airflow is low (758 CFM out of 1200 CFM design). Initially a closed backdraft damper was found and was resolved. The fan is not fully accessible due to hard ceiling. Ductwork that was accessible looked to be installed properly. Recommend ensuring that the fan is rotating correctly and no other obstructions inside of the fan or at discharge.  
**Created By :** National TAB                      **Assigned To :** National TAB - Brianna Biggs  
**Status :** Open  
**Originated Date :** 06/29/2023 - Jordan Best - National TAB

- **08/04/2023 National TAB - Will Turnbough**
  - Fan curve indicates airflow should be closer to 1500 CFM.

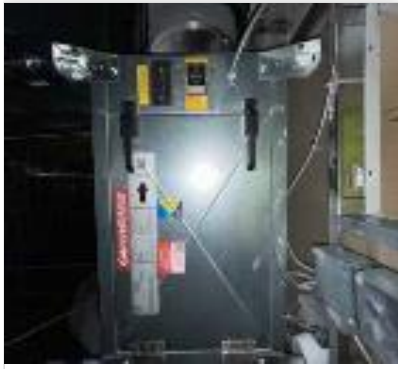
**IMG\_0955**  
**07/17/2023**

GX-1

Fan nearly inaccessible due to hard ceiling. Only able to adjust set point and view RPM. Flow was originally hindered by stuck backdraft damper, addressed this issue but was still unable to raise flow to design. Suspect leakage in duct work but could not verify due to hard ceiling throughout space.

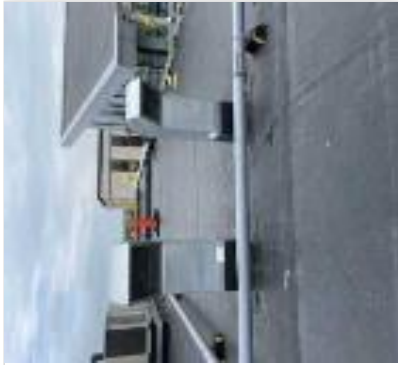
**IMG\_0957**  
**07/17/2023**

EXHAUST DISCHARGE POINT
