## Chipotle

Store 11-4735

1737 S Meridian Rd, Meridian, ID 83642

## Certified Test, Adjust and Balance Report

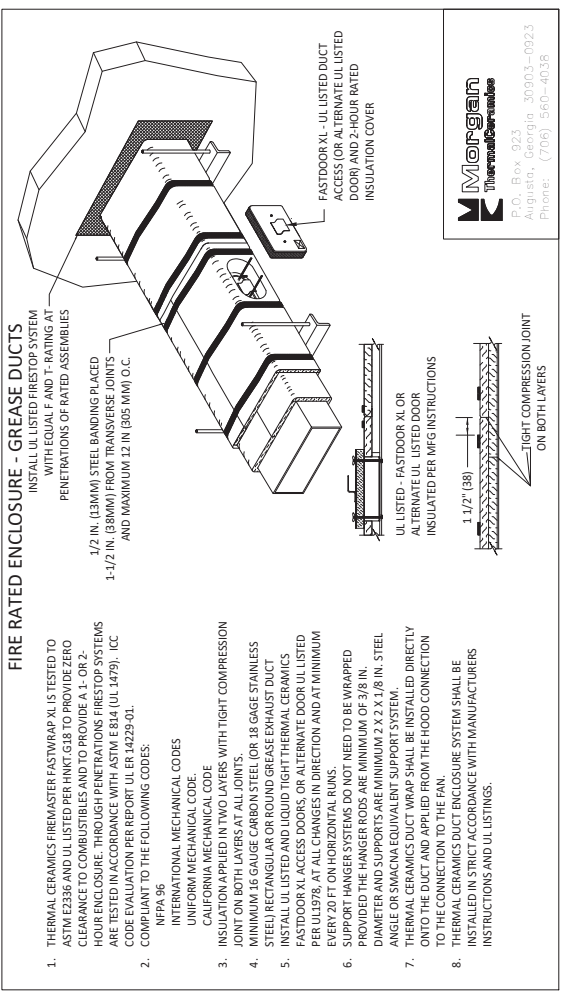
**FIREMASTER DUCT WRAP - UL HNK1-G18**  
 3 W700 N.T.S.

- THERMAL CERAMICS FIREMASTER FASTWRAP XL IS TESTED TO ASTM E838 AND UL LISTED PER HNK1-G18 TO PROVIDE ZERO CLEARANCE TO COMBUSTIBLES AND TO PROVIDE A 1- OR 2-HOUR ENCLOSURE. THROUGH PENETRATIONS FIRESTOP SYSTEMS ARE TESTED IN ACCORDANCE WITH ASTM E 814 (UL 1479), ICC CODE EVALUATION PER REPORT UL ER 14229-01.

- MINIMUM 16 GAUGE CARBON STEEL OR 18 GAUGE STAINLESS STEEL PERMANENTLY ATTACHED TO THE SUPPORT SURFACE.
- INSTALL UL LISTED AND LIQUID TIGHT THERMAL CERAMICS FASTWRAP XL ACCESS DOORS, OR ALTERNATE DOOR UL LISTED PER UL1578, AT ALL CHANGES IN DIRECTION AND AT MINIMUM EVERY 20 FT ON HORIZONTAL RUNS.

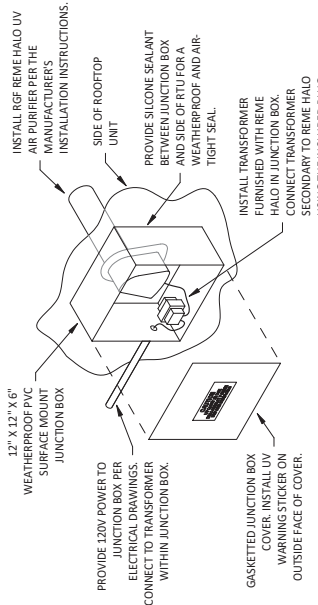
**UV AIR PURIFIER INSTALLATION**  
 6 W700 N.T.S.

**INSTALLATION LOCATION**  
 INSTALL AIR PURIFIER WITH JUNCTION BOX ON OUTSIDE FACE OF ROOFTOP UNIT AND WITH UV LAMP TUBE EXTENDING INTO THE INTERIOR OF THE ROOFTOP UNIT. FIELD VERIFY EXACT LOCATION TO AVOID DAMAGING, TOUCHING, OR INTERFERING WITH ANY RTU INTERIOR COMPONENTS. INSTALLATION LOCATION SHALL BE IN THE SUPPLY AIR STREAM THROUGH THE REMOVABLE PANEL COVERING THE HORIZONTAL DISCHARGE SUPPLY AIR OPENING.  
**NOTE:** INSTALL INTO THE SUPPLY AIR PLENUM FROM THE BACK SIDE OF THE UNIT JUST ABOVE THE HEAT EXCHANGER.
