**Report: TAB REPORT**  
**Function: Test, Adjust, & Balance**  
**Date: 03/12/2024**

**PROJECT**  
**03-11-24 FREDDY'S LAURINBURG, NC**

Project: 03-11-24 FREDDY'S LAURINBURG, NC

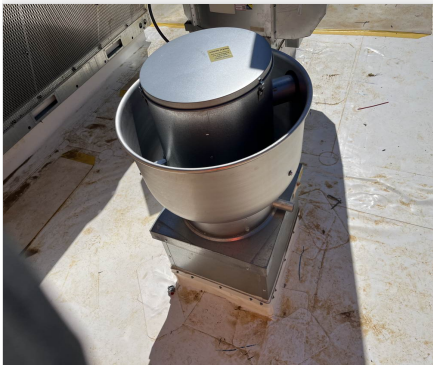
KEF3\_MISSING\_HINGE.jp..  
03/12/2024

**Issue Name :** KEF3-DU33HFA Missing Hinge Kit  
**Description :** KEF3 hinge kit is not installed.  
**Created By :** National TAB                      **Assigned To :** National TAB - Brianna Biggs  
**Status :** Open  
**Priority :** Low    **Asset Tag :** KEF3  
**Originated Date :** 03/12/2024 - RJ Cervantes - National TAB

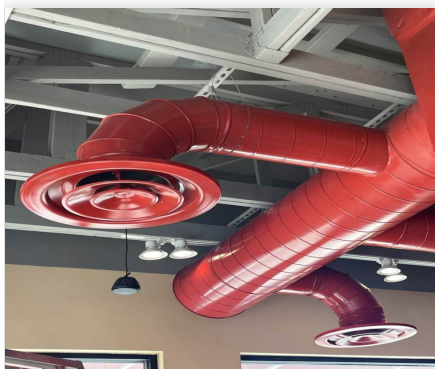
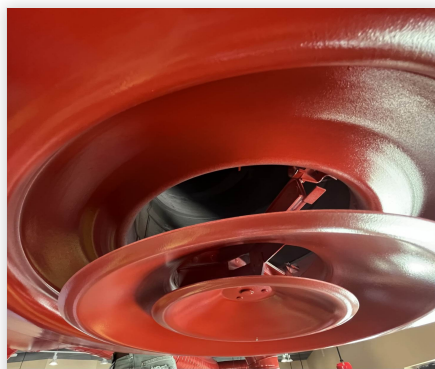
RTU1\_no\_damper\_2  
03/12/2024

**Issue Name :** RTU1 Missing Dampers  
**Description :** RTU1 (dining unit) dampers are not installed on supply grills SGRD4 through SGRD12. Unit total was set due to this issue.  
**Created By :** National TAB                      **Assigned To :** National TAB - Brianna Biggs  
**Status :** Open  
**Priority :** Urgent                                      **Asset Tag :** RTU1  
**Originated Date :** 03/12/2024 - RJ Cervantes - National TAB

RTU1 DINING AREA DAMPERS ARE NOT INSTALLED, UNIT TOTAL HAD TO BE SET,

[1] SGRD4 THROUGH SGRD12 DAMPERS ARE NOT INSTALLED. UNIT TOTAL WAS SET DUE TO THIS ISSUE.
